DEPRECIATION REPORT OF:  
1536 HILLSIDE AVENUE  
STRATA PLAN VIS2630  
VICTORIA, BRITISH COLUMBIA

JUNE 2018

Prepared for:  
The Owners of Strata Plan VIS2630  
c/o: The Strata Council for Strata Plan VIS2630  
1536 Hillside Avenue, Victoria, B.C.  
File # DP070H

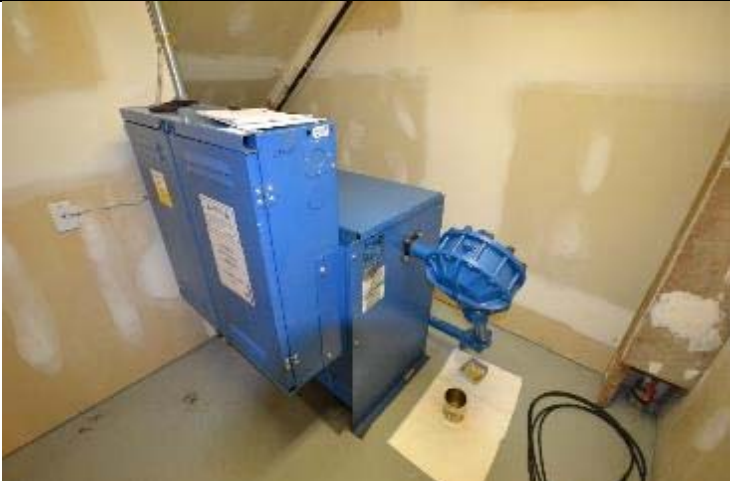
<b>Reserve Component: (17) Water Supply and Drainage</b>									
<b>Component Description</b>	This component is a reserve for replacement and refurbishment of all plumbing and plumbing fixtures in the common elements of the building. This is primarily the water supply pipes and drainage pipes. The water supply and drainage typically in a building of this era involves ¾ inch to 2 inch copper supply lines, and 4" ABS or cast-iron drain pipes. Both horizontal and vertical piping are included. The reserve will be a repair allowance for targeted replacement of the described piping as needed.								
<b>Financial Analysis / Repair History</b>	There have been some historical repairs to piping due to pin holes, mainly in the area of the first floor. These were reportedly remedied immediately with appropriate isolation valves and access covers installed as required.								
<b>Potential Deterioration</b>	Piping can experience several issues such as breakage in copper solder joints, pipe leakage due to damage from freezing and construction activities and decreased flow due to sediment build up or corrosion. As piping becomes older, more issues can be expected.

<b>Condition Analysis</b>	The majority of the piping is enclosed, therefore not visible. It is assumed that the condition of the piping is commensurate with its chronological age. There were no reported immediate concerns.								
<b>Life Cycle Analysis</b>	<table> <tbody> <tr> <td>Date of Acquisition:</td> <td>1993</td> </tr> <tr> <td>Normal Life Span</td> <td>5 Year repair allowance</td> </tr> <tr> <td>Effective Age</td> <td>2 years</td> </tr> <tr> <td>Remaining Life Span</td> <td>3 years</td> </tr> </tbody> </table>	Date of Acquisition:	1993	Normal Life Span	5 Year repair allowance	Effective Age	2 years	Remaining Life Span	3 years
Date of Acquisition:	1993								
Normal Life Span	5 Year repair allowance								
Effective Age	2 years								
Remaining Life Span	3 years								
<b>Unit Quantity And Cost Estimates</b>	<table> <tbody> <tr> <td>Unit Quantity</td> <td>1</td> </tr> <tr> <td>Unit Cost Estimate</td> <td>Allowance</td> </tr> <tr> <td>Current Repair Cost Estimate</td> <td>\$5,000</td> </tr> <tr> <td>Estimated Year/s of Major Repair or Replacement</td> <td>2021, 2026, 2031 etc.</td> </tr> </tbody> </table>	Unit Quantity	1	Unit Cost Estimate	Allowance	Current Repair Cost Estimate	\$5,000	Estimated Year/s of Major Repair or Replacement	2021, 2026, 2031 etc.
