SLOPE STABILITY EVALUATION

**8606 SASKATCHEWAN DRIVE NW
EDMONTON, ALBERTA**

LOT 2, BLOCK A, PLAN 2010HW

CTA File No. 02-1781

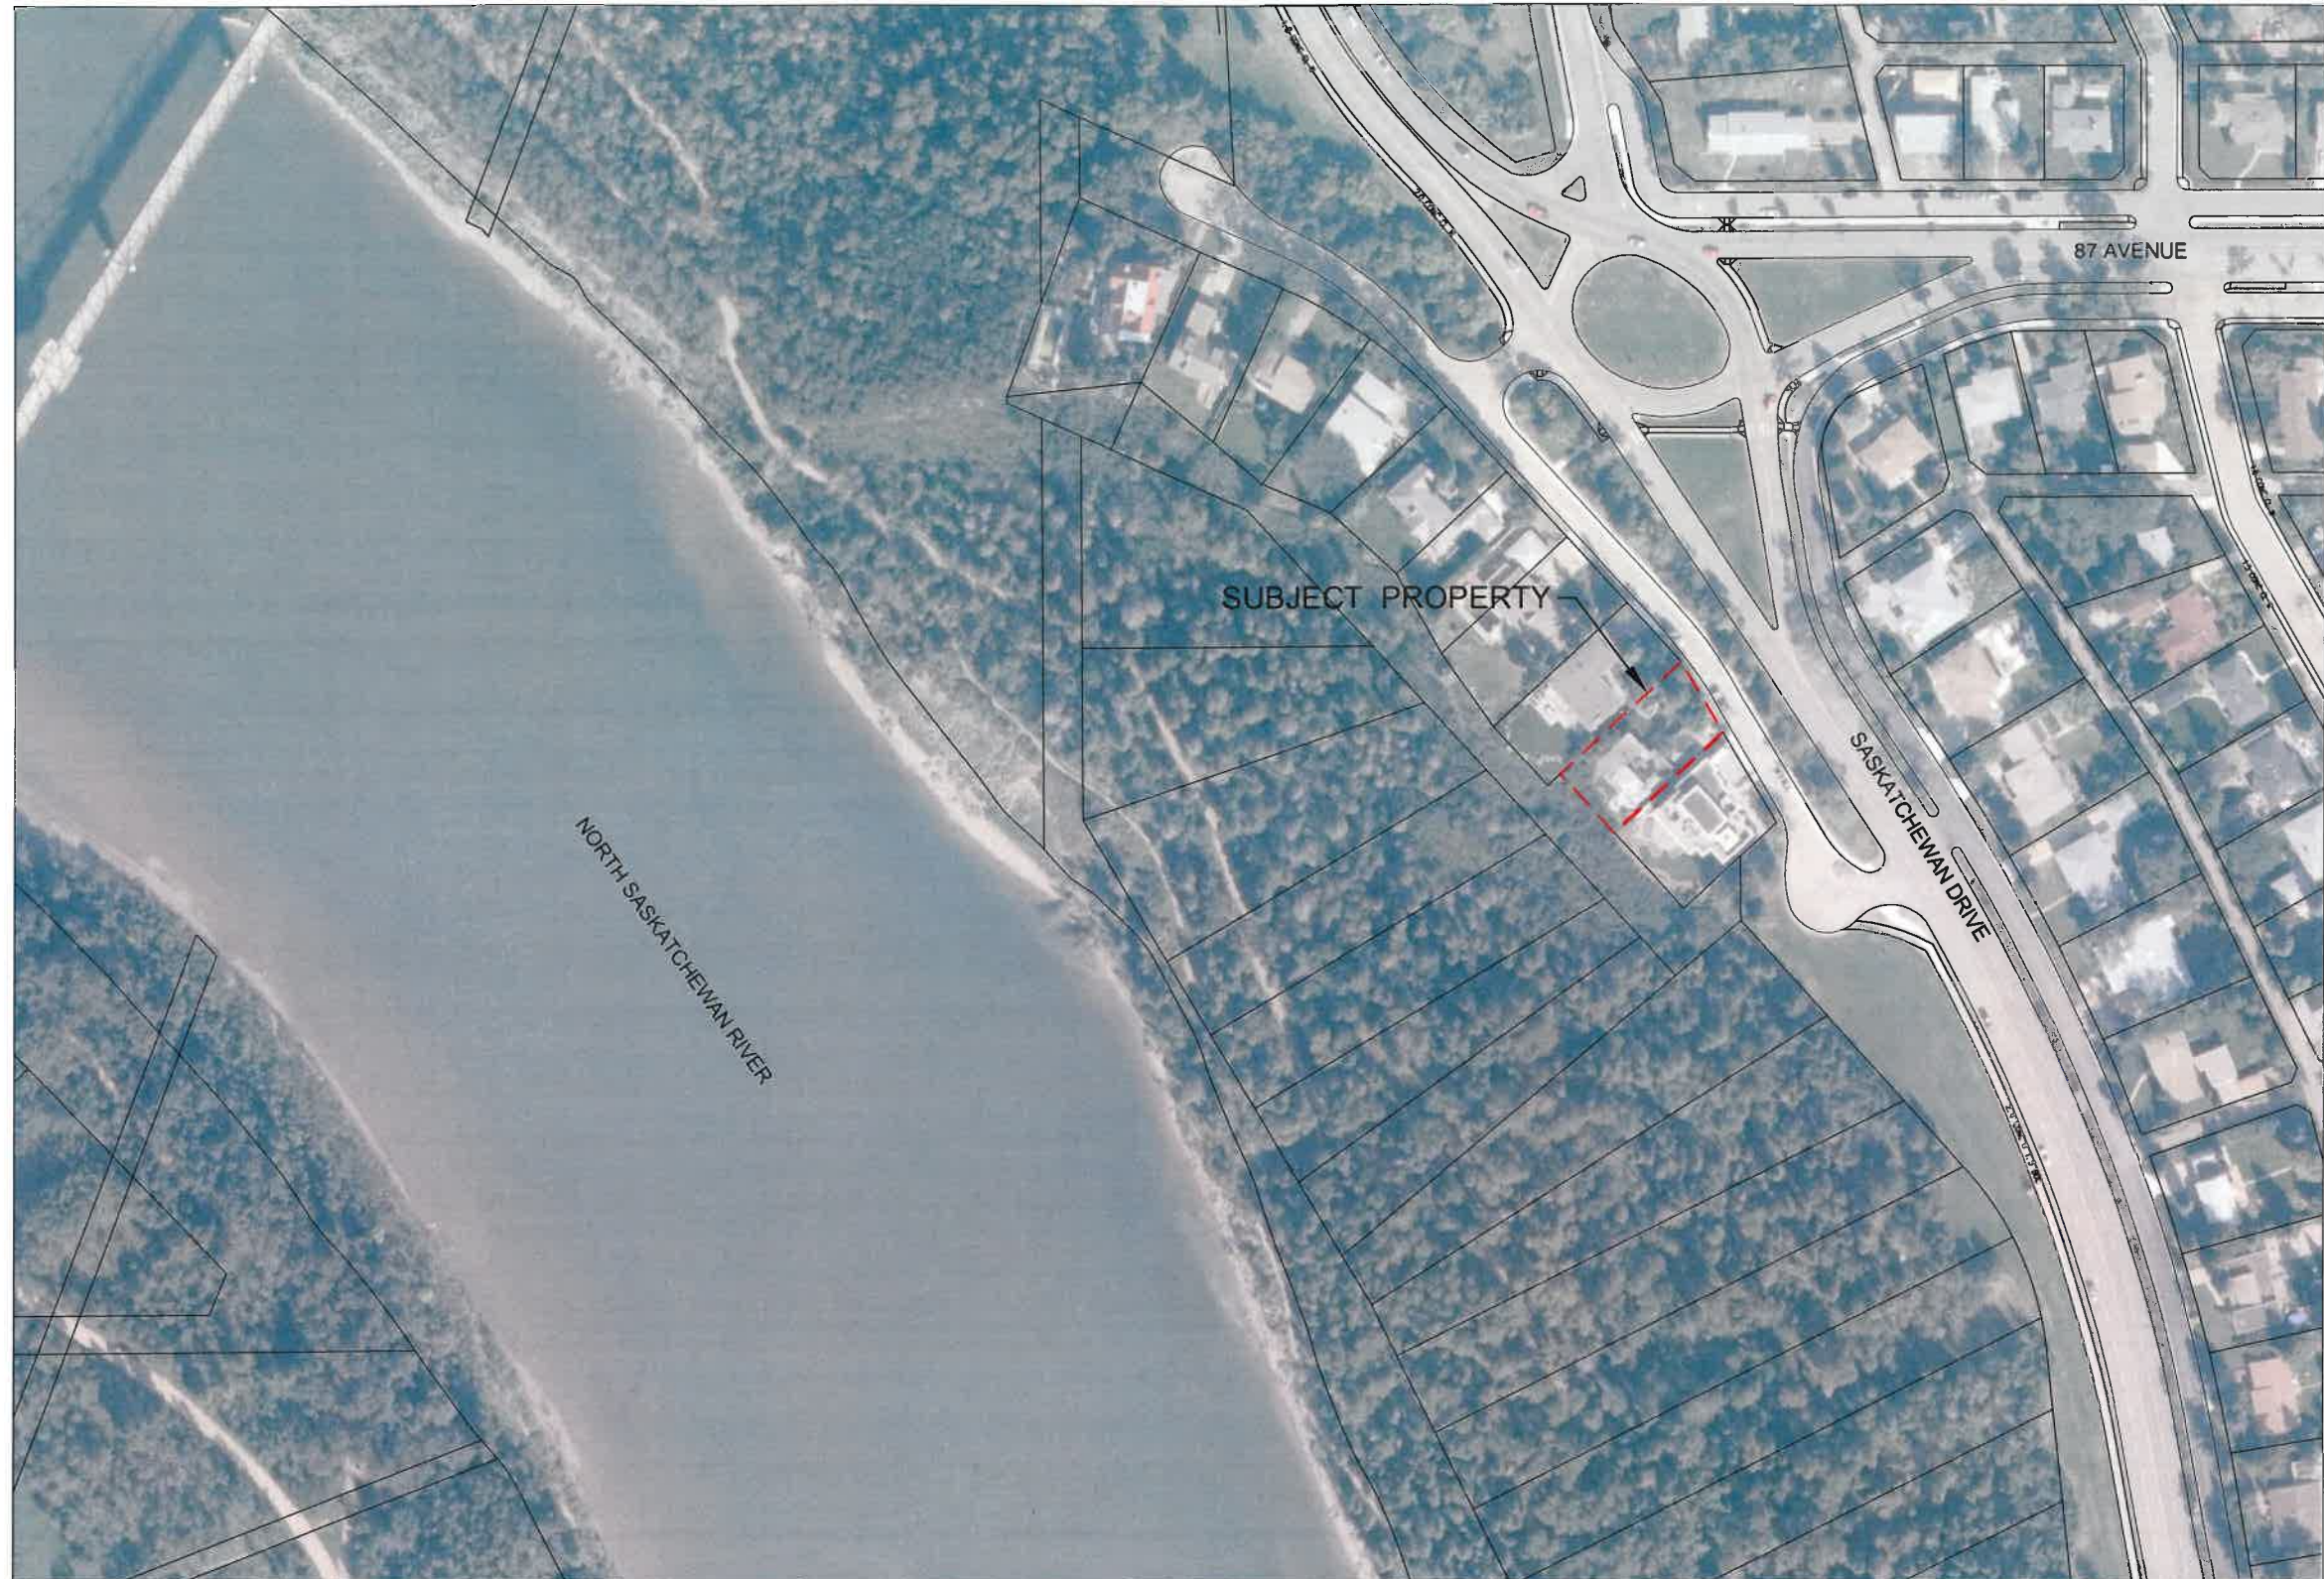
Additionally, about 130 m downstream of the subject site, some slumping of a tall steep (portion of the valley slope that extends directly to the river was observed (as indicated on Drawing No. A-2, Location No. 1), to be further discussed in Section 7.1.2.

As outlined in Section 6.1.2, about 130 m downstream of the subject site, some slumping of a tall steep (portion of the valley slope that extends directly to the river was observed (as indicated on Drawing No. A-2, Location No. 2), was observed during the site review and historically identified during the air photo study.

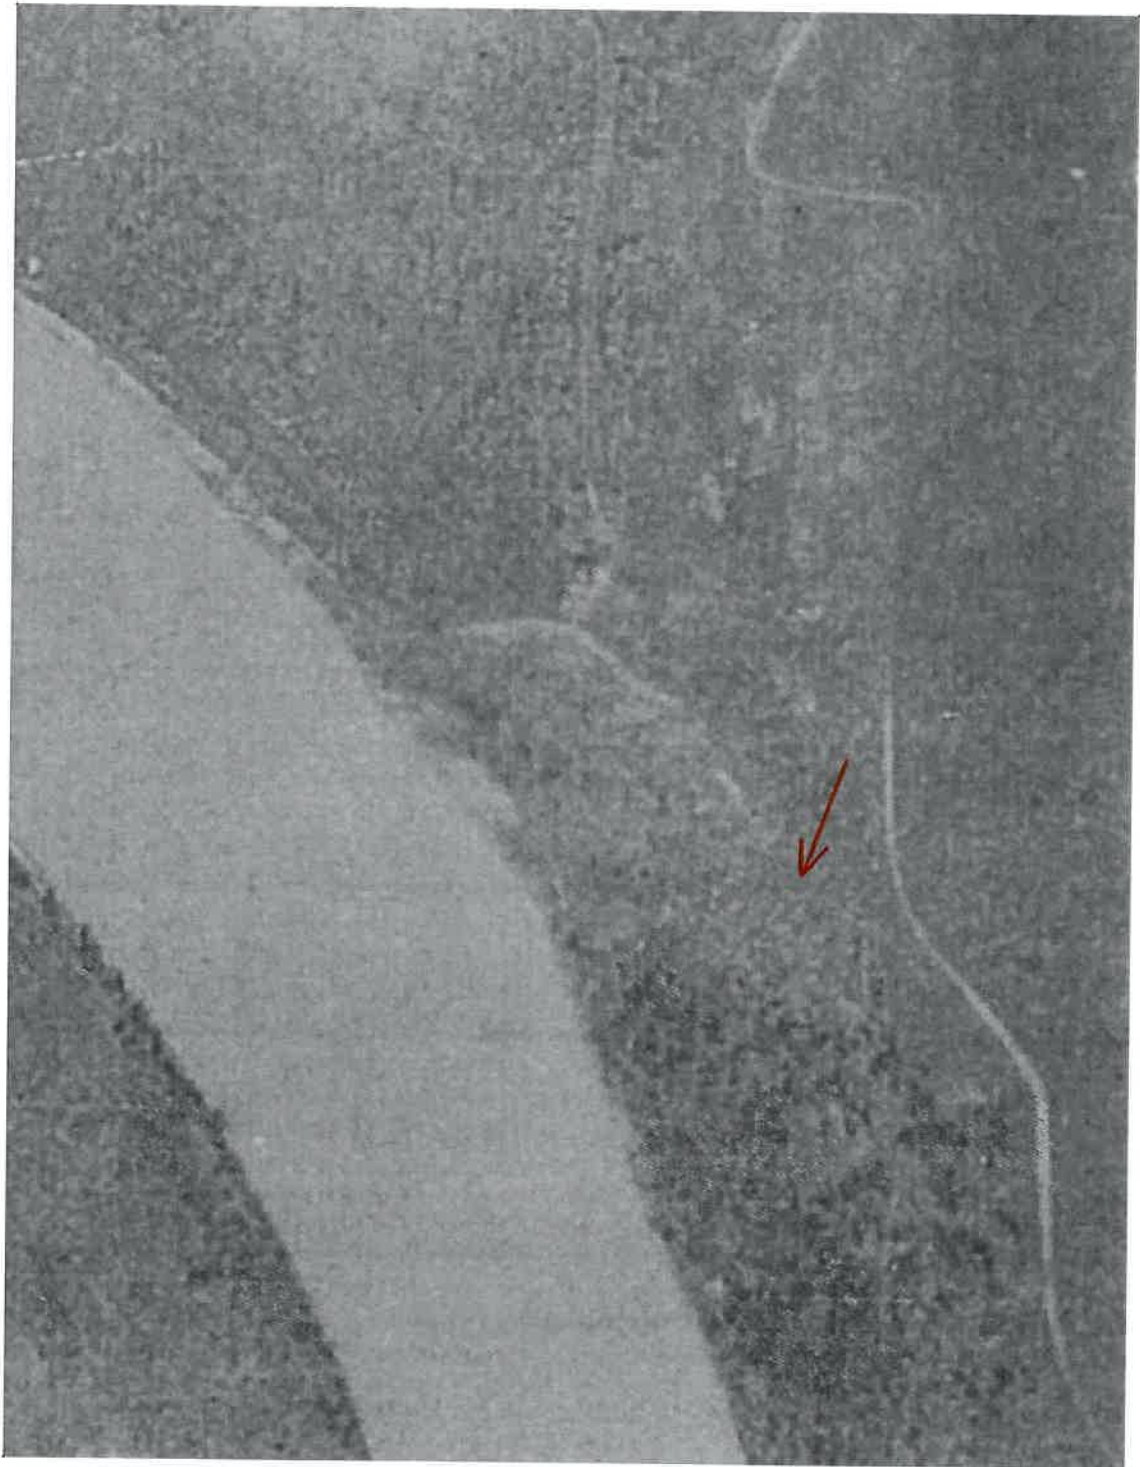
CT & ASSOCIATES ENGINEERING INC.			PROJECT SLOPE STABILITY EVALUATION 8606 SASKATCHEWAN DRIVE EDMONTON, ALBERTA	
CLIENT LOUIS CSABA			TITLE SITE AIR PHOTO - 1924	
DATE 05/29/14	DWN. MLW	CHKD. DSN	FILE NO. 02-1781-C1	DWG. NO. C-1

- 1924 - Subject site and upland area vacant of development with no instabilities noted on the adjacent slope. A small access road present at the location of the existing Saskatchewan Drive though portions are closer to the top-of-bank;

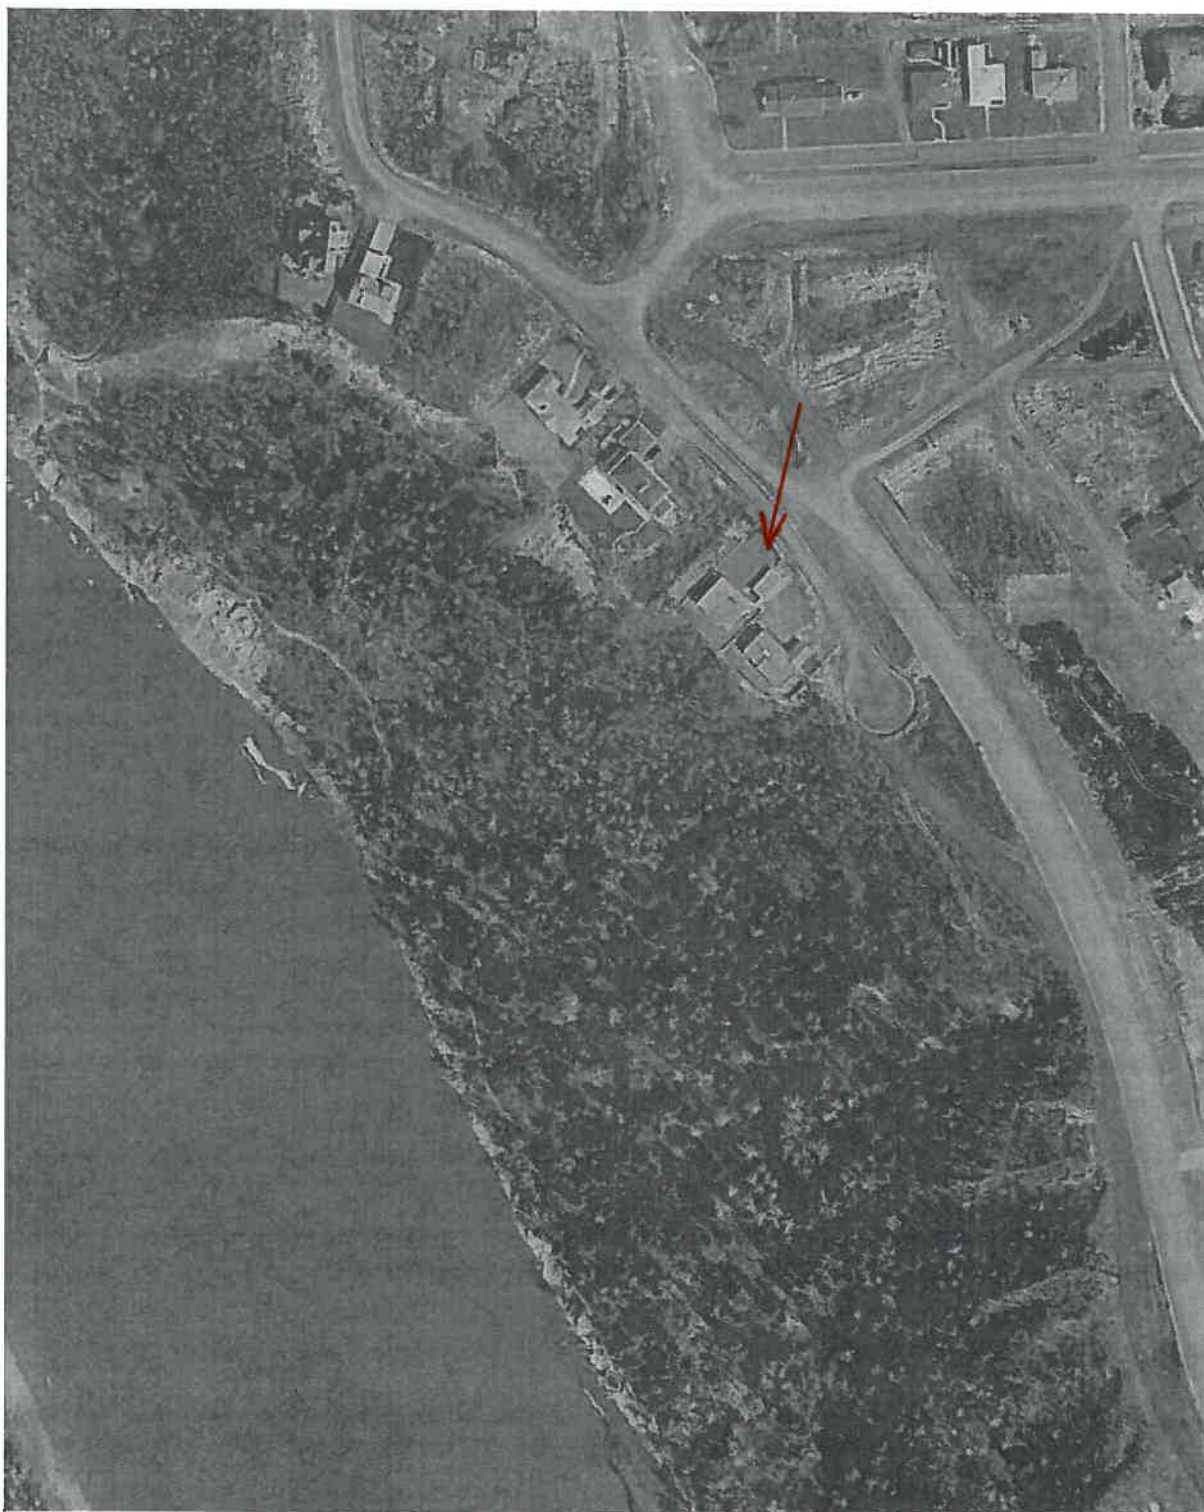
CTA CT & ASSOCIATES ENGINEERING INC.				PROJECT SLOPE STABILITY EVALUATION 8606 SASKATCHEWAN DRIVE EDMONTON, ALBERTA	
CLIENT LOUIS CSABA				TITLE SITE AIR PHOTO - 1954	
DATE 05/29/14	DWN. MLW	CHKD. DSN	FILE NO. 02-1781-C6	DWG. NO. C-6

- 1954 - Construction of additional residences in the area has occurred, and of the adjacent service road. Residential development upland to the east commenced, as had additional development to the northwest. No changes to the condition of the adjacent slope though a tall steep slope is observed to the northwest, clear of vegetation;
