DEPRECIATION REPORT

VR 1551—"145 on Twelfth"
145 East 12th Street
North Vancouver, BC
2013

October 30, 2013

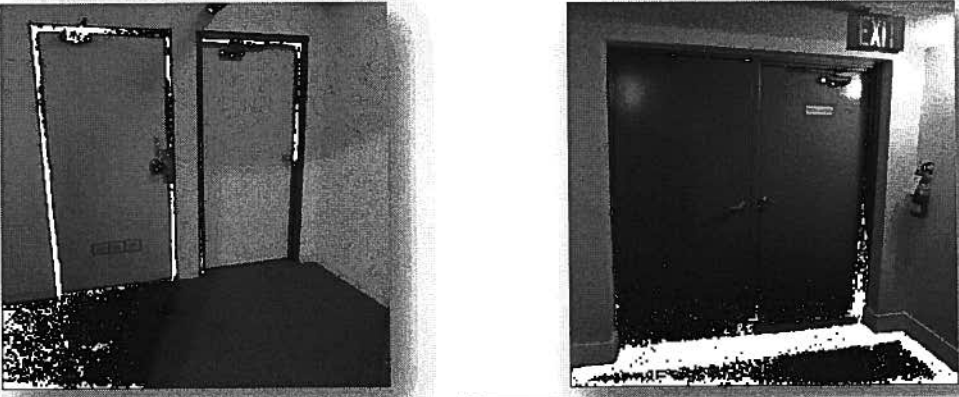
Component 3		Building - Structural and Architectural		Common Door Assemblies - Metal

Quantity	17 Doors			
	Job Cost	\$2,916.67			
Deficiency Analysis	No major deficiencies were noted at the time of visual inspection. Regular maintenance of lock assemblies and inspection and repair of door assemblies as required may extend the life of this component.

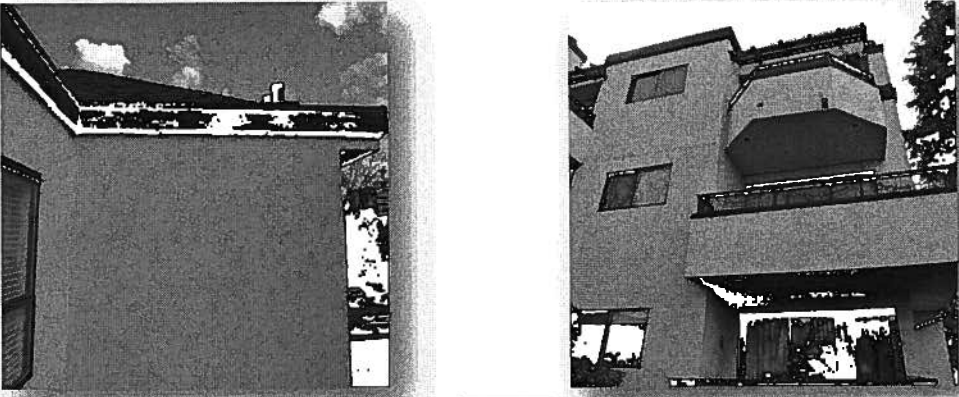
Component 5		Building - Structural and Architectural		Wall Assemblies - Stucco Siding

Condition Analysis	Based upon a partial visual-inspection, this component appears to be in average condition for its age.				
Life Cycle Analysis	Expected Lifespan	35 years			
	Effective Age	25 years			
	Remaining Lifespan	10 years			
Funding Analysis	Description	Unknown expenditures have been spent on this component to date.			
	Work	Removal and disposal of existing assembly, repairs or replacement as required. Appropriate safety precautions will be required. A budget equal to 25% of the estimated cost of the component is provided for periodic major repairs every 35 years.			
	Quantity	9,000 SF			
	Job Cost	\$64,850.11			
Deficiency Analysis	No major deficiencies were noted at the time of visual inspection. The life of this component may be prolonged by effective maintenance which could include patch work, painting, caulking to avoid water penetration, regular inspection for impact / cracking / water ingress / environmental damages, and repair/replace as required. If condition is of concern, an envelope inspection would be recommended.

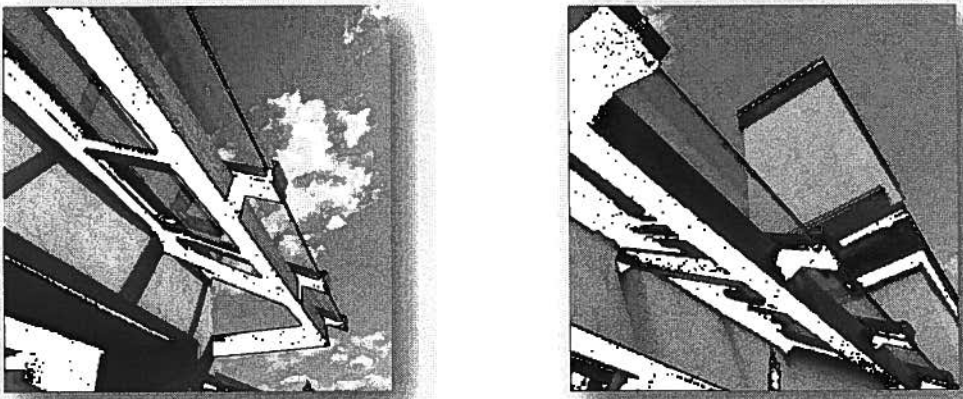
Component 8		Building - Structural and Architectural		Canopy - Glass

Component Description	This component is a glass canopy system. The component consists of a metal support structure with glazing. These are affixed to the side of the building with metal fasteners and bolts. System includes sealant and gaskets for limiting moisture ingress.				
Reserve History	Year of Acquisition	1985			
	Description	Original to the building construction.			
Potential Deterioration	Physical impacts can break glass. Exposure to elements can undermine connectors and metal. Metal fatigue, seismic pressures and corrosion can affect structures stability. Seals and gaskets can deteriorate from UV light and exposure to elements.				
Condition Analysis	Based upon a partial visual-inspection, this component appears to be in average condition for its age.				
Life Cycle Analysis	Expected Lifespan	30 years			
	Effective Age	24 years

Remaining Lifespan	6 years			
Funding Analysis	Description	Unknown expenditure(s) have been spent on this component to date.			
	Work	Remove and replace as required. Ensure connection to building envelop remains sealed. A budget equal to 50% of the estimated cost of the component is provided for periodic major repairs every 30 years.			
	Quantity	13 Canopies			
	Job Cost	\$22,474.63			
Deficiency Analysis	No major deficiencies were noted at the time of visual inspection. The life of this component may be prolonged by effective maintenance which could include new caulking and sealant at regular intervals, and repairs as required.

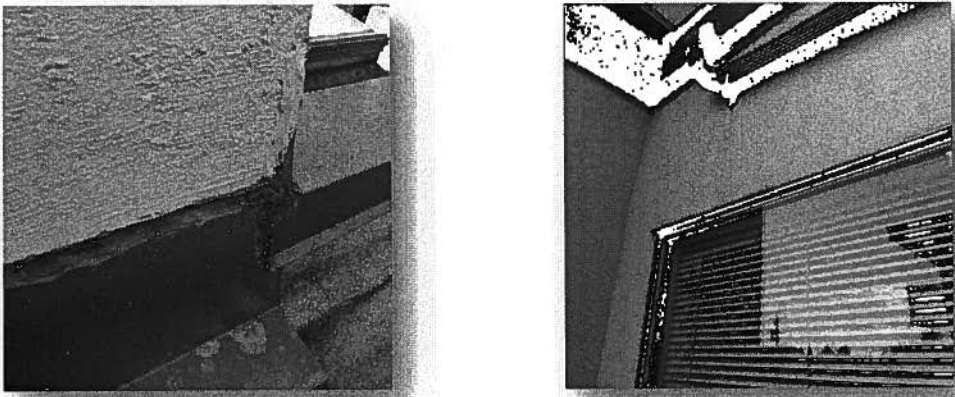
Component 9		Building - Structural and Architectural		Caulking and Weather-Stripping

Condition Analysis	Based upon a partial visual-inspection, this component appears to be in average condition for its age.				
Life Cycle Analysis	Expected Lifespan	7 years			
	Effective Age	2 years			
	Remaining Lifespan	5 years			
Funding Analysis	Description	Unknown expenditure totals have been spent on this component to date.			
	Work	Removal of existing caulking, installation of new caulking. Appropriate safety precautions will be required including safety harness and any require scaffolding. A budget equal to 50% of the estimated cost of the component is provided for periodic major repairs every 7 years.			
	Quantity	2,000 LF			
	Job Cost	\$4,591.10			
Deficiency Analysis	No major deficiencies were noted at the time of visual inspection. Regular upkeep of seals will prevent problems as a result of moisture infiltrating the building envelope and window assemblies and can extend the overall life of protected assemblies.

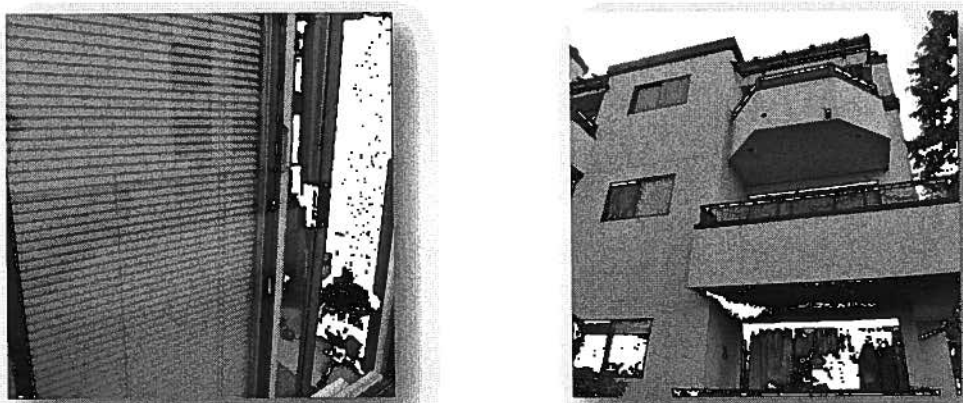
Component 10 - 11		Building - Structural and Architectural		Balcony Doors

Component Description	<p>A sliding glass door or patio door, a type of sliding door in architecture and construction, is a large glass window opening in a structure that provide door access from a room to the outdoors, and natural light. A sliding glass door is usually a single unit consisting of two panel sections, one being fixed and one being mobile to slide open.</p>				
Reserve History	Year of Acquisition	1985			
	Description	Original to the building construction.			
Potential Deterioration	<p>The roller, tracks, hinges, and handles are just a few of the replaceable parts of a sliding glass door. The most common problem is rollers, which can deteriorate with age, usage, rust and collect dirt and material. Physical damage can occur from impacts or building shifting.</p>				
Condition Analysis	<p>Based upon a partial visual-inspection, this component appears to be in average condition for its age.</p>

Life Cycle Analysis	Expected Lifespan	30 years			
	Effective Age	25 years			
	Remaining Lifespan	5 years			
Funding Analysis	Description	No known expenditures have been spent on this component to date.			
	Work	Remove and replace rollers or tracks; replace the glass if damaged. The entire assembly can be replaced at end-of-life. Care to ensure proper flashing and water diversion is required.			
	Quantity	26 Doors			
	Job Cost	\$61,997.10			
Deficiency Analysis	<p>No major deficiencies were noted at the time of visual inspection. The life of this component may be prolonged by effective maintenance which could include new rollers and springs as well as seals, and repairs as required.</p>

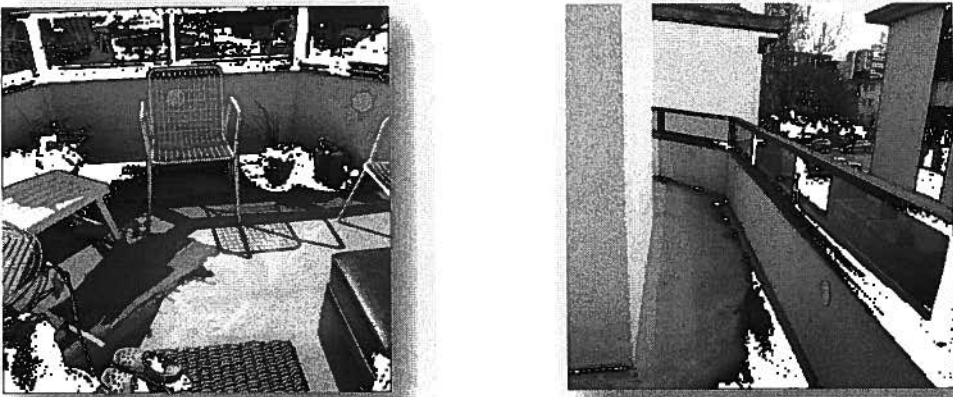
Component 12		Building - Structural and Architectural		Balcony Floor Construction - Wood

Condition Analysis	Based upon a partial visual-inspection, this component appears to be in average condition for its age.				
Life Cycle Analysis	Expected Lifespan	25 years			
	Effective Age	10 years			
	Remaining Lifespan	15 years			
Funding Analysis	Description	Emergency repairs of two balconies at a cost of \$12,000 are funded as a one-time expenditure in 2013.			
	Work	Removal and disposal of existing assembly, repairs or replacement as required. Appropriate safety precautions will be required.			
	Quantity	1,675 SF			
	Job Cost	\$65,411.10			
Deficiency Analysis	No major deficiencies were noted at the time of visual inspection. The life of this component may be prolonged by effective maintenance which could include regular inspection for moisture seepage and keeping the floor free from debris.

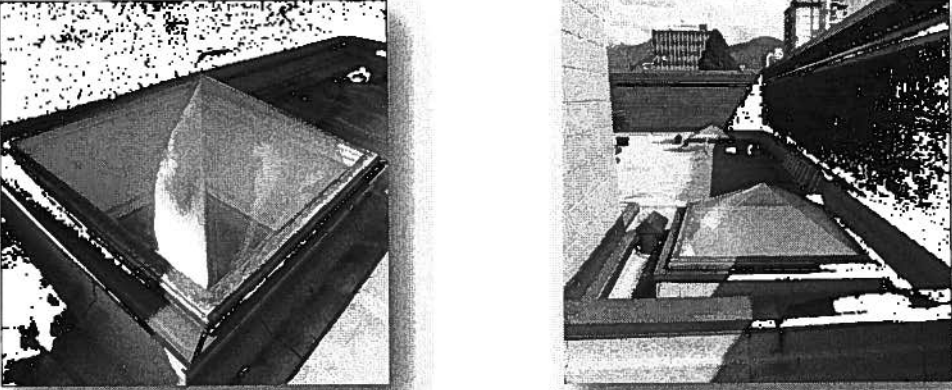
Component 17		Building - Structural and Architectural		Skylights

Component Description	<p>A skylight is defined as an overhead window forming part of the roof, allowing light into the interior of a structure. Skylights form part of the roof structure and can be constructed of aluminum and glass or plexi-glass. These are boxed with flashing and trim to secure to the roofing structure.</p>				
Reserve History	Year of Acquisition	1985			
	Description	Original to the building.			
Potential Deterioration	<p>Skylights are susceptible to the environment and weathering. They can fail and develop leaks. Leaks are due to small cracks caused by an object hitting the skylight, or a deteriorating seal around the edges. Improperly installed flashing can contribute to skylight failure.</p>				
Condition Analysis	<p>Based upon a partial visual-inspection, this component appears to be in average condition for its age.</p>

Life Cycle Analysis	Expected Lifespan	30 years			
	Effective Age	20 years			
	Remaining Lifespan	10 years			
Funding Analysis	Description	No known expenditures have been spent on this component to date.			
	Work	Remove old skylight system. Take care to pull back roofing flashing and material, install new skylight system and secure. Flashing and seal materials for trim, and reapply roofing finish. A budget equal to 50% of the estimated cost of the component is provided for periodic major repairs every 30 years.			
	Quantity	6 Skylights			
	Job Cost	\$6,697.02			
Deficiency Analysis	<p>No major deficiencies were noted at the time of visual inspection. The life of this component may be prolonged by effective maintenance which could include replacing flashing as required.</p>

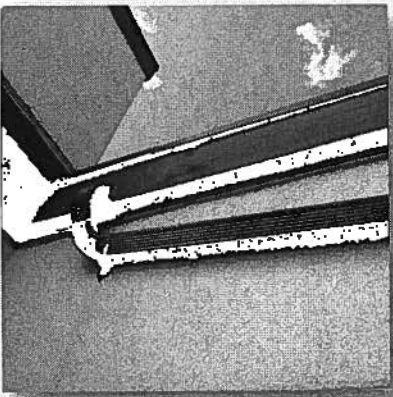
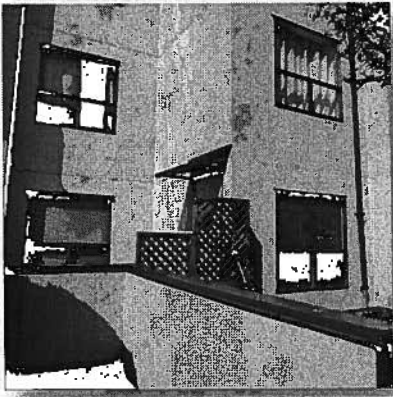
Component 18		Building - Structural and Architectural		Gutters & Downspouts

Component Description	Gutters protect a building's foundation by channeling water away from its base. They can be constructed from a variety of materials, including cast iron, lead, zinc, galvanized steel, painted steel, copper, painted aluminum, PVC (and other plastics), concrete, stone, and wood. Downspouts are the vertical pipes that are used to divert rain water away from a building's foundation.				
Reserve History	Year of Acquisition	1985			
	Description	Original to the building.			
Potential Deterioration	Debris such as leaves, weeds, and grass in gutters can cause clogging and deterioration. Determining factors include proximity of trees to the roof line, the type of trees, the slope of the roof, and the type of roof.				
Condition Analysis	Based upon a partial visual-inspection, this component appears to be in average condition for its age.

Life Cycle Analysis	Expected Lifespan	30 years			
	Effective Age	20 years			
	Remaining Lifespan	10 years			
Funding Analysis	Description	No known expenditures have been spent on this component to date.			
	Work	Removal and replacement of sections of gutters / downspouts as required. A budget equal to 50% of the estimated cost of the component is provided for periodic major repairs every 30 years.			
	Quantity	1 Allowance			
	Job Cost	\$5,822.74			
Deficiency Analysis	No major deficiencies were noted at the time of visual inspection. The life of this component may be prolonged by effective maintenance.

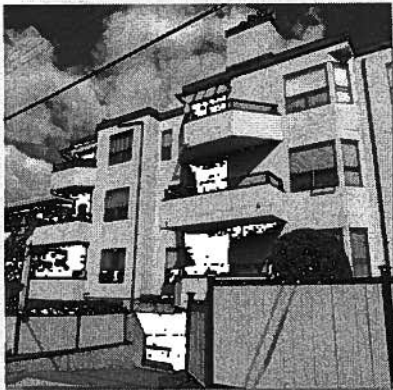
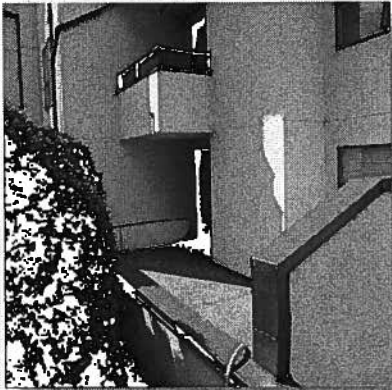
Component 19		Building - Finishes and Decoration		Exterior Building Painting

Condition Analysis	Based upon a partial visual-inspection, this component appears to be in average condition for its age. Some blistering due to moisture has been repaired by strata on an ongoing basis as necessary.				
Life Cycle Analysis	Expected Lifespan	16 years			
	Effective Age	10 years			
	Remaining Lifespan	6 years			
Funding Analysis	Description	Unknown total expenditures have been spent on this component to date.			
	Work	Surface preparation, potentially including sanding, scraping, masking, primer coat(s), finish coats, and clean up. Additional special conditions may include scaffolding where required, safety precautions, and safeguarding the work area perimeter.			
	Quantity	9,000 SF			
	Job Cost	\$30,331.34			
Deficiency Analysis	No major deficiencies were noted at the time of visual inspection, however some blistering is being repaired on an ongoing basis by strata. The life of this component may be prolonged by effective maintenance which could include regular inspection for damage and subsequent touch-ups / repairs as required.

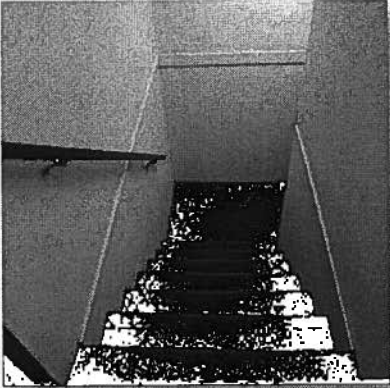
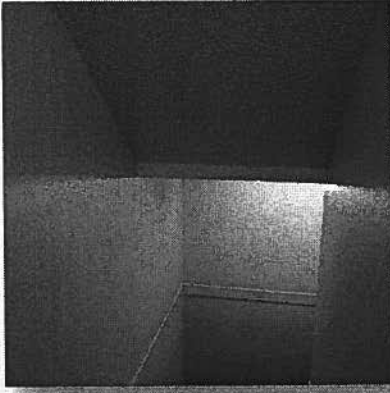
Component 20		Building - Finishes and Decoration		Interior Stairwell Painting

Job Cost	\$4,836.03			
Deficiency Analysis	No major deficiencies were noted at the time of visual inspection. The life of this component may be prolonged by effective maintenance which could include regular inspection for paint fading due to wear and tear and repaint as required.

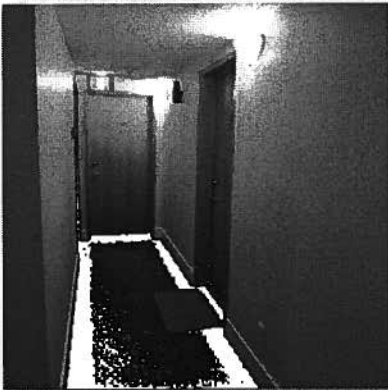
Component 21		Building - Finishes and Decoration		Interior Common Corridor Painting

Component Description	This component refers to the common corridors inside the building. Component includes paint on walls and trim, and includes preparation for masking and finish. Interior latex paint is applied on common area walls and ceilings over a seal coat. Interior wood trim is painted with lacquer or gloss paint. Includes common side of doors. Excludes integrated construction unless noted. Excludes damage from repair work. Includes doors, casings, and trims as appropriate.				
Reserve History	Year of Acquisition	2009			
	Description	Component has been repaired / replaced since original construction.			
Potential Deterioration	Interior paint can deteriorate from UV sources, physical damage or water / moisture ingress. Repainting can also be done for aesthetic reasons.				
Condition Analysis	Based upon a visual-inspection, this component appears to be in good condition for its age.

Life Cycle Analysis	Expected Lifespan	12 years			
	Effective Age	3 years			
	Remaining Lifespan	9 years			
Funding Analysis	Description	Unknown total expenditure has been spent on this component to date.			
	Work	Preparation of painted surface is required. Typically includes washing, sanding and priming surface. Two coats are applied on the surface. Masking of fixtures and painting of trim.			
	Quantity	6,390 SF			
	Job Cost	\$15,845.02			
Deficiency Analysis	No major deficiencies were noted at the time of visual inspection. The life of this component may be prolonged by effective maintenance which could include cleaning and maintaining a controlled environment. The strata council indicated that the paint is touched up often, which extends the lifespan of this component.

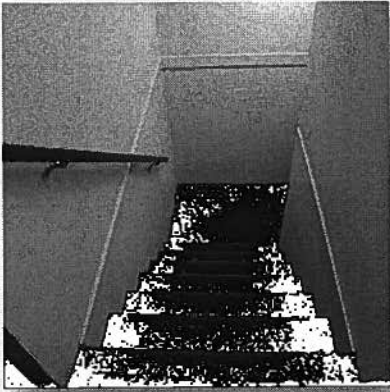
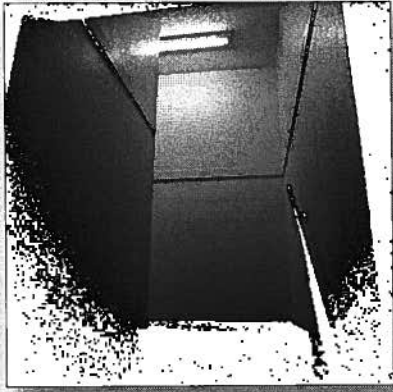
Component 22		Building - Finishes and Decoration		Interior Common Corridor Flooring - Stairwells

Work	Replacing the damaged area or replacement of the entire area depending on the scope of the deterioration.			
	Quantity	1,150 SF			
	Job Cost	\$13,811.94			
Deficiency Analysis	No major deficiencies were noted at the time of visual inspection. The life of this component may be prolonged by effective maintenance including carpet cleaning and repairs as required.

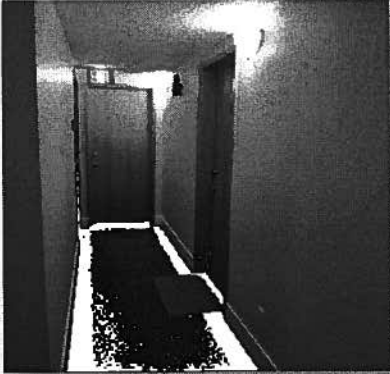
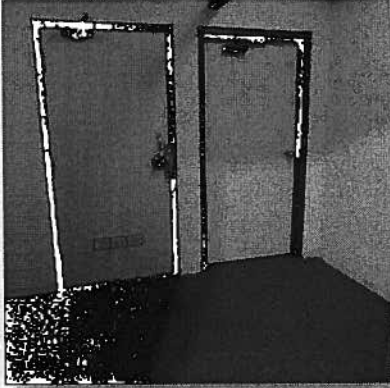
Component 23		Building - Finishes and Decoration		Interior Common Corridor Flooring - Hallways

Work	Replacing the damaged area or replacement of the entire area depending on the scope of the deterioration.			
	Quantity	1,950 SF			
	Job Cost	\$22,271.05			
Deficiency Analysis	No major deficiencies were noted at the time of visual inspection. The life of this component may be prolonged by effective maintenance including carpet cleaning and repairs as required.

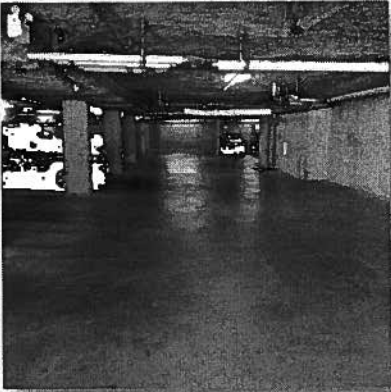
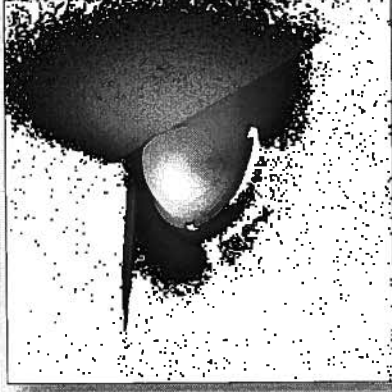
Component 24		Building - Finishes and Decoration		Interior Common Area Lighting

Condition Analysis	Based upon a partial visual-inspection, this component appears to be in average / good condition for its age.				
Life Cycle Analysis	Expected Lifespan	25 years			
	Effective Age	15 years			
	Remaining Lifespan	10 years			
Funding Analysis	Description	Unknown expenditures have been spent on this component to date.			
	Work	Removal and disposal of existing assembly, repairs or replacement as required to the drywall and installation of the new assembly. Upon replacement, it may be advisable to switch to LED lighting depending on cost, repayment time, and availability. A budget equal to 33% of the estimated cost of the component is provided for periodic major repairs every 25 years.			
	Quantity	1 Allowance			
	Job Cost	\$6,800.94			
Deficiency Analysis	No major deficiencies were noted at the time of visual inspection. The life of this component may be prolonged by effective maintenance which could include regular inspections and repairs as required.

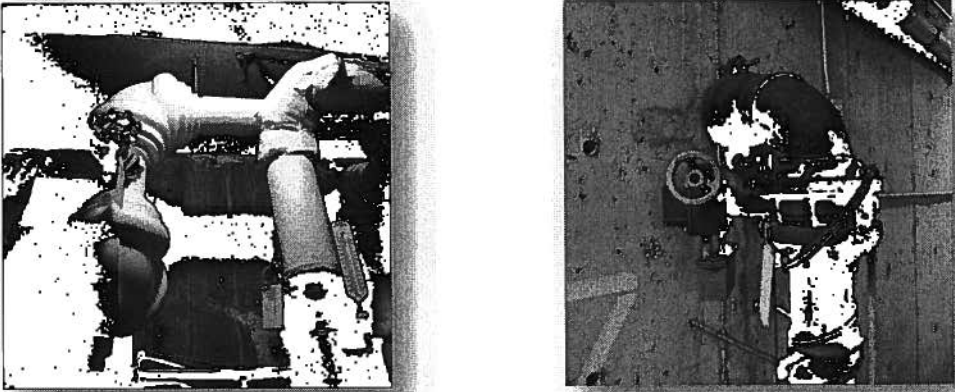
Component 27		Building - Mechanical Systems		Domestic Water Supply

Component Description	Supply system to provide hot and cold water to the building via a main distribution system. Typically includes risers, branch lines, valves and backflow preventers. Backflow preventers are required on the main service and where irrigation and fire sprinkler systems connect to the water supply.				
Reserve History	Year of Acquisition	2009			
	Description	Replacement completed March 2009 by Brighter Mechanical.			
Potential Deterioration	Pinhole leaks at elbows. Contact between dissimilar metals can cause deleterious electrochemical reactions. Turbulence caused by improper bends and soldering can create leaks. Connections to fixtures can wear and break. Plastic resins can chemically change over time and become brittle. Vibration and stress can weaken joints. Valves can seize.				
Condition Analysis	Based upon a partial visual-inspection, this component appears to be in average condition for its age.

Life Cycle Analysis	Expected Lifespan	25 years			
	Effective Age	4 years			
	Remaining Lifespan	21 years			
Funding Analysis	Description	The substantial replacement in 2009 had a reported cost of \$163,413.			
	Work	Full-scale replacement of plumbing systems is not typical. A budget equal to 10% of the estimated cost of the component is provided for periodic major repairs every 25 years.			
	Quantity	1 System			
	Job Cost	\$21,910.88			
Deficiency Analysis	No major deficiencies were noted at the time of visual inspection. The life of this component may be prolonged by effective maintenance which could include replacing worn or corroded pipes as required.

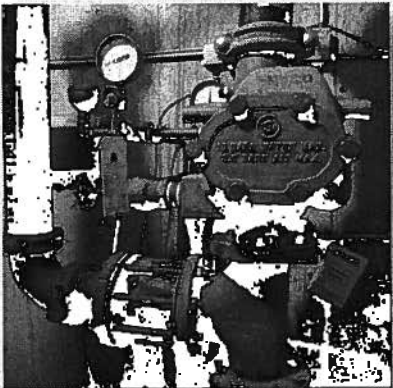
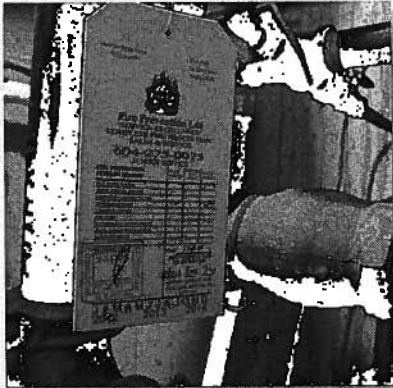
Component 28		Building - Mechanical Systems		Sprinkler System - Dry (Garage Only)

Condition Analysis	Based upon a partial visual-inspection, this component appears to be in average condition for its age, and is routinely inspected by Ace Fire Prevention Ltd, who noted in 2011 a valve may require replacement.				
Life Cycle Analysis	Expected Lifespan	25 years			
	Effective Age	24 years			
	Remaining Lifespan	1 years			
Funding Analysis	Description	Unknown total expenditures have been spent on this component to date.			
	Work	A fire sprinkler system needs to be maintained regularly to comply with numerous regulations. The System is inspected and tested for operational readiness, and parts failure. A budget equal to 7% of the estimated cost of the component is provided for periodic major repairs every 25 years.			
	Quantity	1 System			
	Job Cost	\$8,599.02			
Deficiency Analysis	No major deficiencies were noted at the time of visual inspection, with exception of recommended replacements described above. The life of this component may be prolonged by effective maintenance.

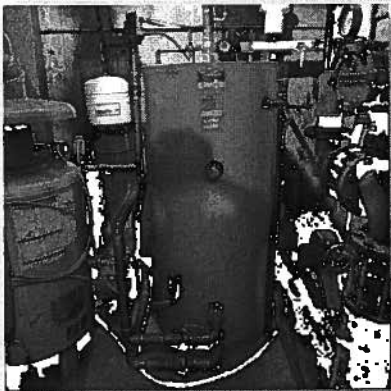
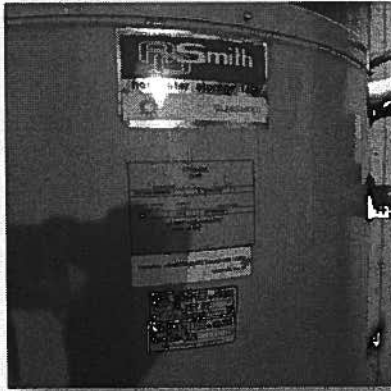
Component 30		Building - Mechanical Systems		Hot Water Storage Tank

Component Description	A hot water storage tank is used to store hot water for domestic use. Hot water tanks may have built-in heaters or may use an external heat-exchanger from another system, including gas, oil, and electric. The subject system uses a natural gas fired boiler connected to the 119 gallon A. O. Smith hot water storage tank.				
Reserve History	Year of Acquisition	2009			
	Description	Component has been replaced since original construction.			
Potential Deterioration	Corrosion and limestone deposits can build up inside the tanks causing leaks. The burners and thermal coupling units may fail.				
Condition Analysis	Based upon a visual-inspection, this component appears to be in good condition for its age.				
Life Cycle Analysis	Expected Lifespan	15 years			
	Effective Age	4 years			
	Remaining Lifespan	11 years

Funding Analysis	Description	Unknown total expenditures have been spent on this component to date.			
	Work	Removal and disposal of old tank. Replace with new tank.			
	Quantity	1 Tank			
	Job Cost	\$3,567.61			
Deficiency Analysis	No major deficiencies were noted at the time of visual inspection. Replacement is recommended at the end of the manufacturer's recommended life.

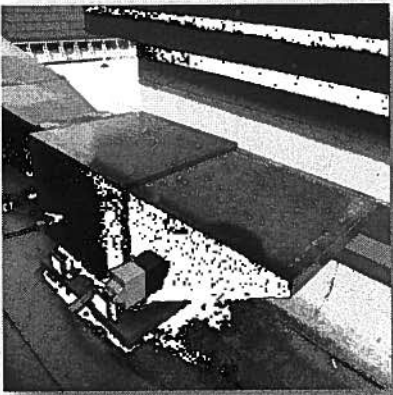
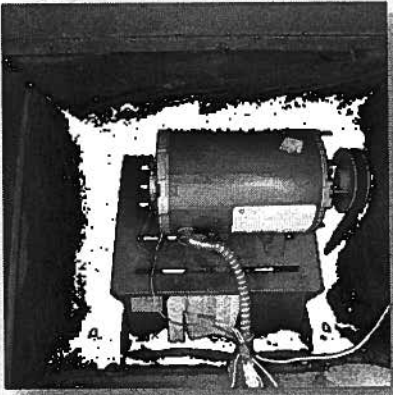
Component 31 - 32		Building - Mechanical Systems		Terminal & Packaged Units - Air Handling

Condition Analysis	Based upon a partial visual-inspection, this component appears to be in average condition for its age.				
Life Cycle Analysis	Expected Lifespan	20 years			
	Effective Age	11 years			
	Remaining Lifespan	9 years			
Funding Analysis	Description	Unknown total expenditures have been spent on this component to date.			
	Work	Remove existing equipment and controls so connections can be reused, replace with similar equipment, and balance and re-commission the system.			
	Quantity	2 Unit			
	Job Cost	\$25,543.74			
Deficiency Analysis	No major deficiencies were noted at the time of visual inspection. The life of this component may be prolonged by effective maintenance which could include periodic inspection and repair or replacement of damaged motors and air handling systems.

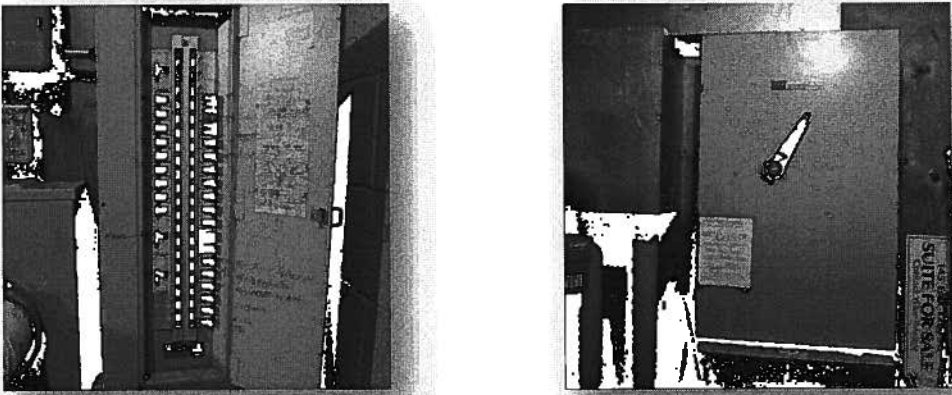
Component 35		Building - Electrical Systems		Electrical Distribution System and Fixtures

Component Description	<p>The building is served by a 600 amp main electrical service. The power is stepped down in a main electrical room, with a subpanel for common electrical services. There are individual breaker panels in the strata lots for each strata unit, which are not included in this component. The wiring consists of shielded cable and copper wire inside metal conduit.</p>				
Reserve History	Year of Acquisition	1985			
	Description	Original to the building construction.			
Potential Deterioration	<p>Includes potential loosening of connections, component failure, degrading of wire.</p>				
Condition Analysis	<p>Based upon a partial visual-inspection, this component appears to be in average condition for its age.</p>				
Life Cycle Analysis	Expected Lifespan	20 years			
	Effective Age	7 years

Remaining Lifespan	13 years			
Funding Analysis	Description	Unknown total expenditures have been spent on this component to date.			
	Work	Removal and replacement of components as required. A budget equal to 10% of the estimated cost of the component is provided for periodic major repairs every 20 years.			
	Quantity	1 System			
	Job Cost	\$16,717.82			
Deficiency Analysis	<p>No major deficiencies were noted at the time of visual inspection. The life of this component may be prolonged by effective maintenance which could include regular inspection and subsequent repairs as required.</p>

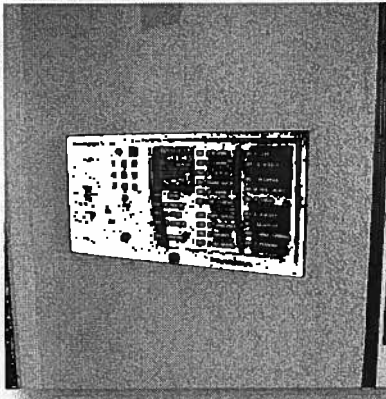
Component 36		Building - Electrical Systems		Entry System - Intercom

Condition Analysis	Based upon a partial visual-inspection, this component appears to be in average condition for its age.				
Life Cycle Analysis	Expected Lifespan	20 years			
	Effective Age	15 years			
	Remaining Lifespan	5 years			
Funding Analysis	Description	No known expenditures have been spent on this component to date.			
	Work	Removal of old system installation and setup of replacement system. Integration with connected components where required.			
	Quantity	1 System			
	Job Cost	\$8,876.54			
Deficiency Analysis	No major deficiencies were noted at the time of visual inspection. The life of this component may be prolonged by effective maintenance and adequate protection from the elements.

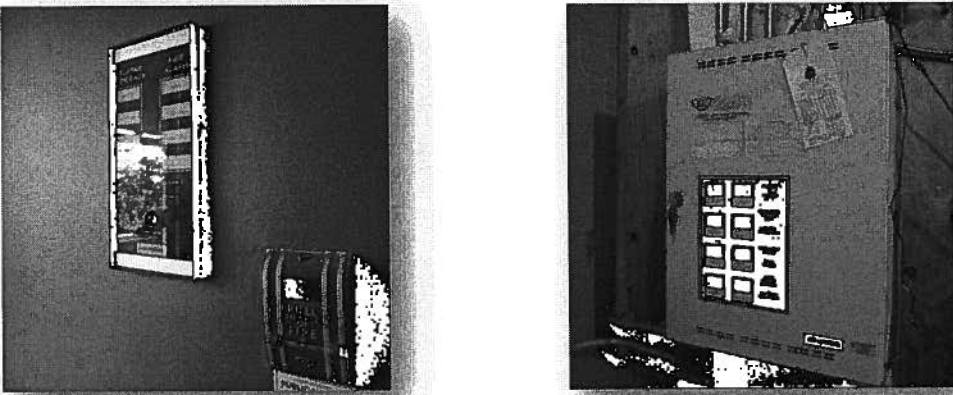
Component 37		Building - Electrical Systems		Fire Alarm System

Component Description	An automatic fire alarm system is designed to detect fire by monitoring environmental changes associated with combustion. In general, a fire alarm system is classified as either automated, manual, or both. Automatic fire alarm systems are intended to notify the building occupants and emergency service responders in the event of a fire or other emergency. The system may include pull stations, enunciators, a fire panel, heat and smoke detectors, fire hoses, and fire extinguishers.				
Reserve History	Year of Acquisition	2012			
	Description	Component has been repaired / replaced since original construction.			
Potential Deterioration	Includes electrical failure, vandalism, and functional obsolescence. Exterior terminals will tend to have a shorter service life.				
Condition Analysis	Based upon a partial visual-inspection, this component appears to be in average condition for its age.

Life Cycle Analysis	Expected Lifespan	15 years			
	Effective Age	1 years			
	Remaining Lifespan	14 years			
Funding Analysis	Description	Unknown total expenditures have been spent on this component to date.			
	Work	Repair and / or replacement of system after results of regular testing periods.			
	Quantity	1 System			
	Job Cost	\$14,655.37			
Deficiency Analysis	No major deficiencies were noted at the time of visual inspection. Periodic fire alarm testing is required.

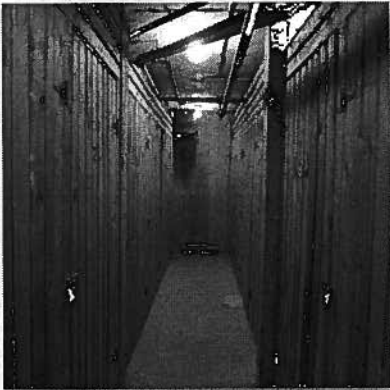
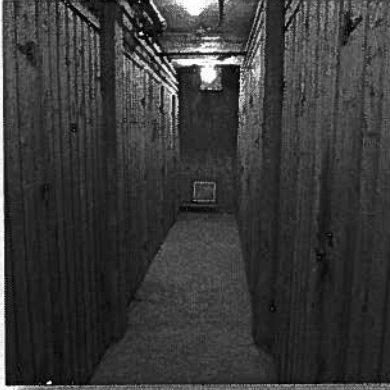
Component 38		Building - Amenities		Storage Lockers

Work	Repairs or replacement as required to the lockers, latches, hinges, and floor fasteners. A budget equal to 50% of the estimated cost of the component is provided for periodic major repairs every 40 years.			
	Quantity	24 Lockers			
	Job Cost	\$7,734.21			
Deficiency Analysis	No major deficiencies were noted at the time of visual inspection. The life of this component may be prolonged by effective maintenance which could include regular inspection for damaged lockers / latches / hinges / floor fasteners and repair / replace as required.

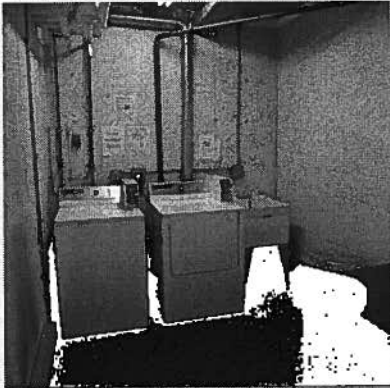
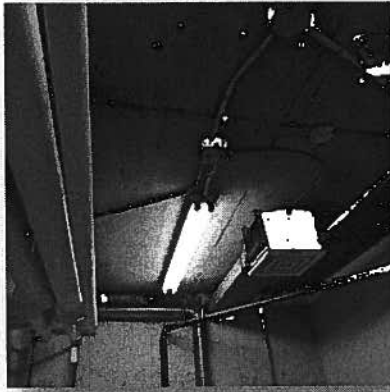
Component 39		Building - Amenities		Laundry Room

Component Description	This component comprises all of the reserve items and materials of the common laundry room, including flooring, wall finish, ceiling finish, fixtures, furnishings, appliances and decorations. The appliances are Maytag Commercial models.				
Reserve History	Year of Acquisition	1985			
	Description	Laundry room original to the building construction, washer and dryer replaced in 2003.			
Potential Deterioration	This component will typically experience wear and tear from owner and visitor use, which could include marking / damage to the wall surfaces including impact damage, damage to the flooring due to use, obsolescence of fixtures and furnishings due to diminished utility or dated design / aesthetics. The washer and dryer will experience relatively heavy wear and tear and are Maytag Commercial models.				
Condition Analysis	Based upon a partial visual-inspection, this component appears to be in average condition for its age.

Life Cycle Analysis	Expected Lifespan	30 years			
	Effective Age	15 years			
	Remaining Lifespan	15 years			
Funding Analysis	Description	Unknown total reserve expenditures have been spent on this component to date.			
	Work	Removal and disposal of old furnishings and fixtures, potentially re-painting / re-flooring, and replacement of fixtures and furnishings. Special conditions may include staged project completion due to access limitations.			
	Quantity	110 SF			
	Job Cost	\$1,944,27			
Deficiency Analysis	No major deficiencies were noted at the time of visual inspection. The life of this component may be prolonged by effective maintenance which could include regular inspection for damage and subsequent repairs as required.

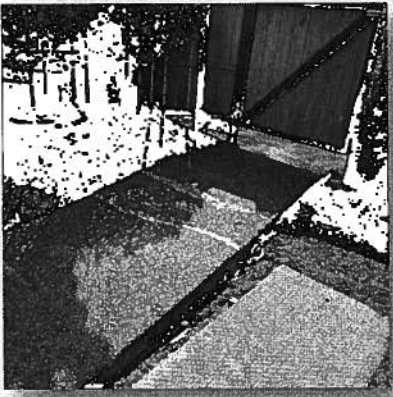
Component 40		Common Site Improvements	Site Services - Sewer and Water

Component Description	<p>This component refers to sub-surface piping such as sewer system and drainage, and water supply system from roadway to building main. Storm sewer system includes storm sewer lines, catch basins, man holes, and connections to the individual units. Sanitary sewer system includes lines and service connections. Also includes any ancillary equipment such as sump pumps and sewage pumps and tanks.</p>		
Reserve History	Year of Acquisition	1985	
	Description	Original to the building construction.	
Potential Deterioration	<p>This component can be affected by erosion, freeze / thaw cycles, corrosion, and in some cases physical damage from excavation.</p>		
Condition Analysis	<p>No visual-inspection possible, this component is assumed to be in average condition for its age.</p>		
Life Cycle Analysis	Expected Lifespan	35 years

Effective Age	28 years	
	Remaining Lifespan	7 years	
Funding Analysis	Description	<p>Unknown total reserve expenditures have been spent on this component to date.</p>	
	Work	<p>Excavation and replacement of damaged component on an item by item basis. Will require shut down of building service for the duration. A budget equal to 15% of the estimated cost of the component is provided for periodic major repairs every 35 years.</p>	
	Quantity	20 LF	
	Job Cost	\$1,639.91	
Deficiency Analysis	<p>No major deficiencies were noted. The life of this component may be prolonged by effective maintenance which could include repairs as required.</p>

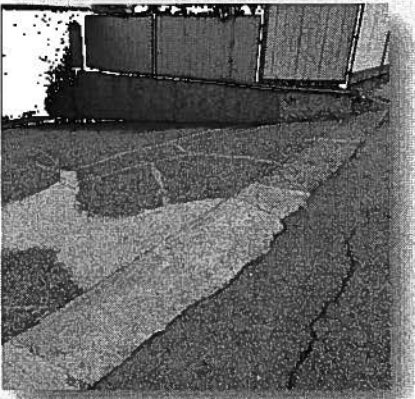
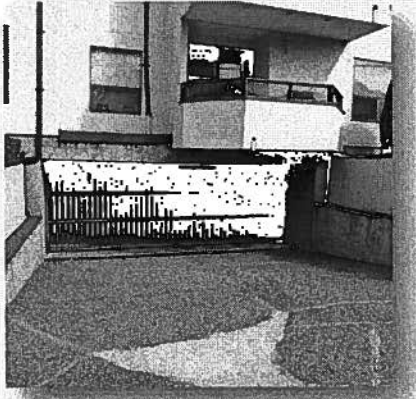
Component 41		Common Site Improvements		Concrete Paving

Condition Analysis	Based upon a partial visual-inspection, this component appears to be in fair / average condition for its age.				
Life Cycle Analysis	Expected Lifespan	30 years			
	Effective Age	28 years			
	Remaining Lifespan	2 years			
Funding Analysis	Description	Unknown total reserve expenditures have been spent on this component to date.			
	Work	Remove and replace damaged concrete. May have to be done in stages to allow access to continue. A budget equal to 25% of the estimated cost of the component is provided for periodic major repairs every 30 years.			
	Quantity	272 SF			
	Job Cost	\$1,506.23			
Deficiency Analysis	No major deficiencies were noted at the time of visual inspection, however much patchwork and past crack repair is evident. The life of this component may be prolonged by effective maintenance which could include applying sealant at regular intervals, and repairs as required.

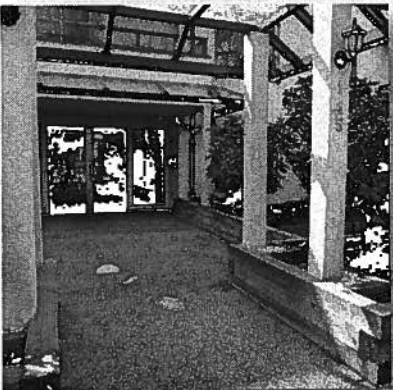
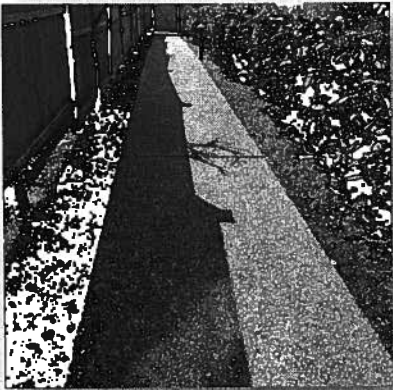
Component 42		Common Site Improvements		Concrete Paving - Walkways and Front Entry

Condition Analysis	Based upon a partial visual-inspection, this component appears to be in fair to good condition for its age.				
Life Cycle Analysis	Expected Lifespan	20 years			
	Effective Age	19 years			
	Remaining Lifespan	1 years			
Funding Analysis	Description	Unknown total reserve expenditures have been spent on this component to date.			
	Work	Remove and replace damaged concrete. May have to be done in stages to allow access to continue.			
	Quantity	250 SF			
	Job Cost	\$4,512.44			
Deficiency Analysis	Front entry and front walkway have had past patchwork, but is nearing end of life. The life of this component, once repaired/replaced, may be prolonged by effective maintenance which could include applying sealant at regular intervals, and repairs as required.

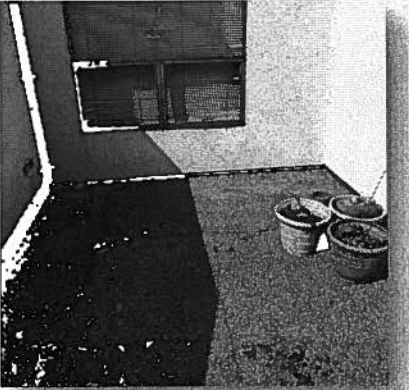
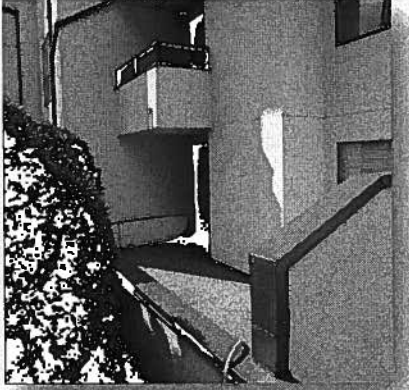
Component 43		Common Site Improvements		Concrete Patio

Component Description	This reserve item considers the concrete patio slab. Concrete is a composite construction material composed primarily of aggregate, cement, and water. Concrete is poured using Slip-form paving or Fixed-form paving.				
Reserve History	Year of Acquisition	1985			
	Description	Primarily original to the building construction.			
Potential Deterioration	Damage from substrate erosion, freeze / thaw cycles and salt damage. The majority of concrete pavement failures are not caused by failure of the concrete slab but by problems with the materials beneath the slab. Impact damage, cracking, water fractures due to freezing.				
Condition Analysis	Based upon a partial visual-inspection, this component appears to be in poor / average / good condition for its age.				
Life Cycle Analysis	Expected Lifespan	25 years

Effective Age	20 years			
	Remaining Lifespan	5 years			
Funding Analysis	Description	Unknown total reserve expenditures have been spent on this component to date.			
	Work	Remove and replace damaged concrete. May have to be done in stages to allow access to continue. A budget equal to 25% of the estimated cost of the component is provided for periodic major repairs every 25 years.			
	Quantity	785 SF			
	Job Cost	\$3,120.67			
Deficiency Analysis	No major deficiencies were noted at the time of visual inspection. The life of this component may be prolonged by effective maintenance which could include applying sealant at regular intervals, and repairs as required.

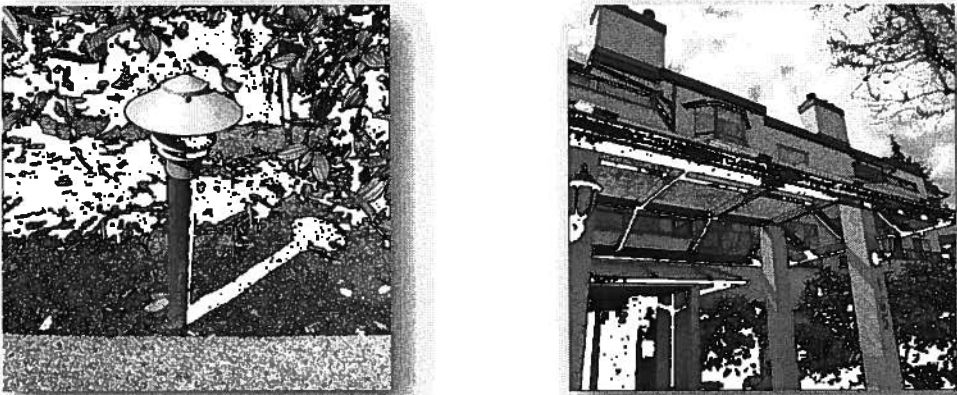
Component 44		Common Site Improvements		Exterior Lighting

Quantity	1 Allowance			
	Job Cost	\$2,728.15			
Deficiency Analysis	No major deficiencies were noted at the time of visual inspection. The life of this component may be prolonged by effective continuous maintenance.

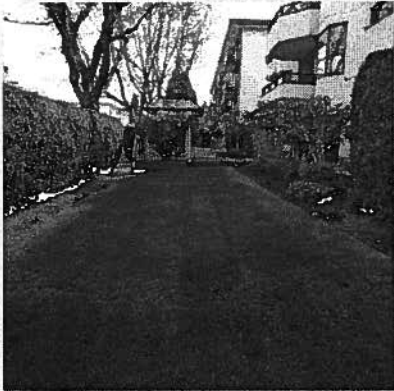
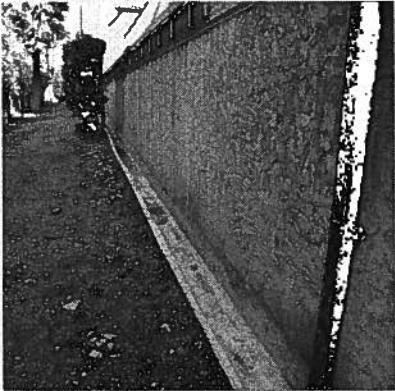
Component 45		Common Site Improvements	Exterior Landscaping

Component Description	Exterior landscaping may be comprised of grass, trees, shrubbery, associated gardens, walkways, irrigation system, and various plants.		
Reserve History	Year of Acquisition	1985	
	Description	Primarily original to the building since original construction. Drainage work conducted in 2012 with installation of concrete for drainage.	
Potential Deterioration	Includes exposure to the elements, such as wind, rain, snow, freeze-thaw cycles, and extreme temperature / humidity changes. Some plants are subject to fungus and disease. Additional deterioration can be caused by lack of water and nutrients. Physical damage can occur to the plants.		
Condition Analysis	Based upon a visual-inspection, this component appears to be in average condition for its age.		
Life Cycle Analysis	Expected Lifespan	15 years	
	Effective Age	8 years

Remaining Lifespan	7 years	
Funding Analysis	Description	Unknown total reserve expenditures have been spent on this component to date.	
	Work	Replace / repair walkways, irrigation system, diseased or damaged trees, or change landscaping for aesthetic purposes. A budget equal to 10% of the estimated cost of the component is provided for periodic major repairs every 15 years.	
	Quantity	6,500 SF	
	Job Cost	\$2,150.36	
Deficiency Analysis	No major deficiencies were noted at the time of visual inspection. The life of this component may be prolonged by effective maintenance, including regular landscaping.

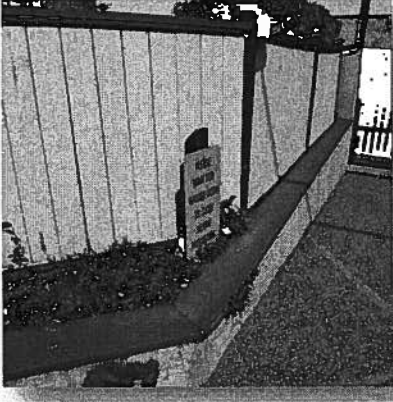
Component 46		Common Site Improvements		Retaining Walls - Concrete

Component Description	Includes concrete or wood retaining walls for the complex. Retaining walls over four feet high must be approved by a qualified engineer.				
Reserve History	Year of Acquisition	1985			
	Description	Original to the building construction.			
Potential Deterioration	Retaining walls are susceptible to hydraulic pressures, seismic movement, and physical damage from impact. Additional damage from substrate erosion, freeze / thaw cycles and salt damage. Wood is subject to weathering from the elements, rotting and insect damage.				
Condition Analysis	Based upon a partial visual-inspection, this component appears to be in average condition for its age.				
Life Cycle Analysis	Expected Lifespan	30 years			
	Effective Age	20 years			
	Remaining Lifespan	10 years			
Funding Analysis	Description	Unknown total expenditures have been spent on this component to date.

Work	Patch and replace as needed. An allowance equal to 10% of estimated cost of construction is provided for periodic major repairs. A budget equal to 25% of the estimated cost of the component is provided for periodic major repairs every 30 years.			
	Quantity	28 LF			
	Job Cost	\$1,917.00			
Deficiency Analysis	No major deficiencies were noted at the time of visual inspection. The life of this component may be prolonged by effective maintenance.

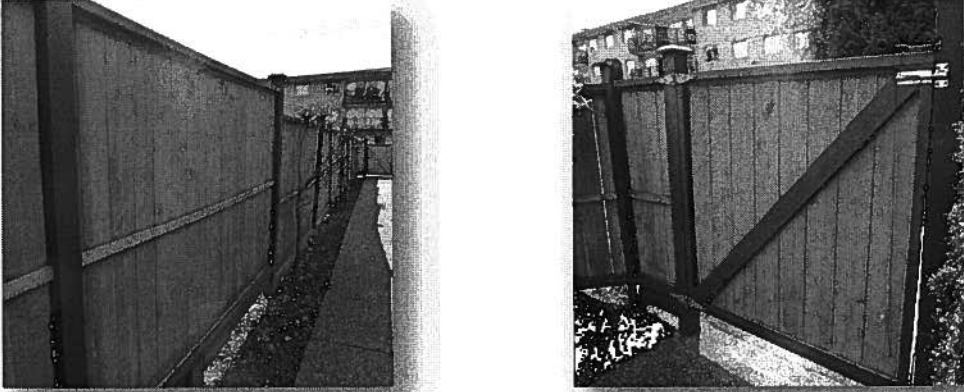
Component 47		Common Site Improvements		Fencing - Wood

Component Description	This component describes the perimeter fencing. The fencing is typically cedar with posts inset into concrete. Wood fencing adds a level of privacy.				
Reserve History	Year of Acquisition	2005			
	Description	Component has been replaced since original construction.			
Potential Deterioration	Wood fencing can suffer from impact damage, insect infestation, poor maintenance and seismic movement. Exposure to the elements, including rotting, and UV damage can deteriorate the fence. Concrete surfaces can crack or crumble with excessive movement or water ingress.				
Condition Analysis	Based upon a partial visual-inspection, this component appears to be in good condition for its age.				
Life Cycle Analysis	Expected Lifespan	20 years			
	Effective Age	7 years			
	Remaining Lifespan	13 years			
Funding Analysis	Description	Unknown total reserve expenditures have been spent on this component to date.

Work	Remove and replace fencing as required.			
	Quantity	300 LF			
	Job Cost	\$12,509.80			
Deficiency Analysis	No major deficiencies were noted at the time of visual inspection. The life of this component may be prolonged by effective maintenance and repairs as required.

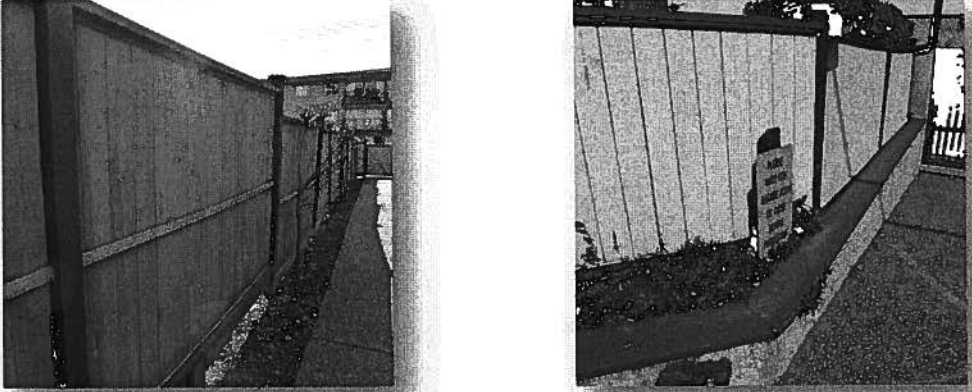
Component 48		Common Site Improvements		Fencing - Stain

Component Description	<p>This reserve item considers the preparation, painting or staining of the fencing component. The type of paint which is suitable will be dependent on several factors, including the type of surface and potentially old and obsolete paint. Surface preparation such as scraping, and differing application methods are included. If staining, the fencing must be clean and dry prior to application of stain, which may be followed up with a sealer coat.</p>				
Reserve History	Year of Acquisition	2011			
	Description	Component has been repaired / replaced since original construction.			
Potential Deterioration	<p>Includes exposure to the elements, such as wind, rain, snow, freeze-thaw cycles, and extreme temperature changes. UV light may deteriorate the paint / stain and cause fading. Physical surface damage may occur from debris, vandalism, and impact damage.</p>

Condition Analysis	<p>Based upon a partial visual-inspection, this component appears to be in good condition for its age.</p>				
Life Cycle Analysis	Expected Lifespan	5 years			
	Effective Age	2 years			
	Remaining Lifespan	3 years			
Funding Analysis	Description	Unknown total reserve expenditures have been spent on this component to date.			
	Work	Preparation of the surfaces to be painted or stained, including potentially sanding, scraping, masking, finish coats, followed by clean up. Additional special conditions may include safety precautions and safeguarding the work area perimeter.			
	Quantity	2,400 SF			
	Job Cost	\$8,730.37			
Deficiency Analysis	<p>No major deficiencies were noted at the time of visual inspection. The life of this component may be prolonged by effective maintenance which could include regular inspection for damage and subsequent repairs as required.</p>
