Winchester

5 Year Warranty Review

21867 50th Avenue
Langley, BC

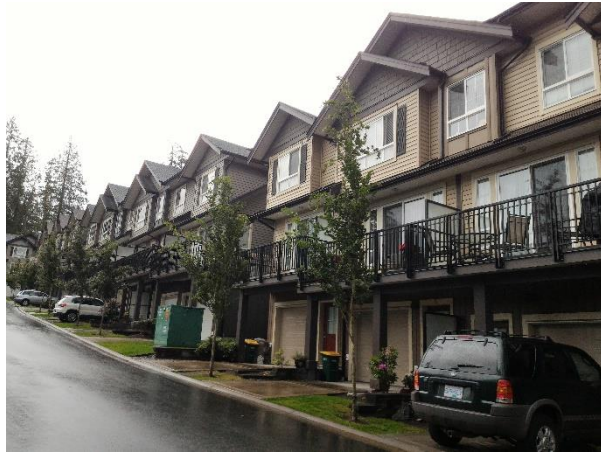
Photo 2.1: Typical townhome block.

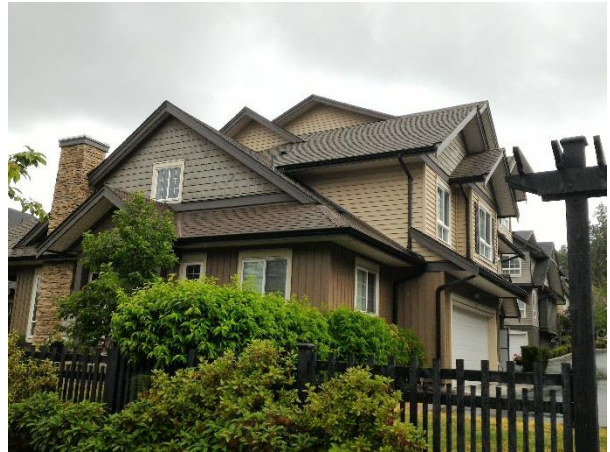
Photo 2.2: View of Winchester townhomes looking west off 218a Street.

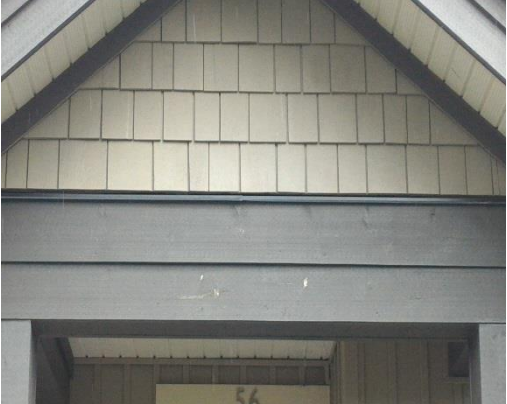
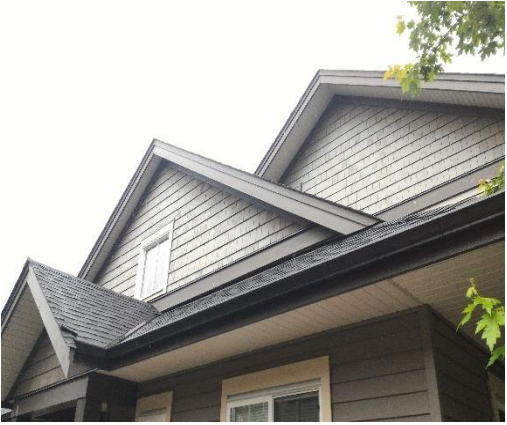
LOCATION:	All building elevations
------------------	-------------------------

<p>Cedar shingles are a durable siding and roofing material that has been around for a long time and generally perform well in our local climate. The shingles are painted and the paint finish will need to be renewed from time to time.</p> <p>All exterior wall cladding assemblies include a minimum 10mm rainscreen cavity and a moisture barrier installed on the exterior wood sheathing. The associated wood trim and metal flashings form part of the cladding assemblies.</p> <p>The drainage cavity is intended to allow for drainage of moisture that may penetrate through the outer cladding. The drainage cavity system (aka 'rainscreen design') has performed well in the lower mainland, and is currently mandated by the building regulations for exterior building envelope assemblies used on multiunit residential buildings.</p> <p>The cedar shingles appeared to be generally applied with good workmanship and appeared in good condition.</p> <p>The through wall flashings drain moisture from the weather/moisture barrier underneath and allow any moisture that gets past the face of the claddings to be diverted to the exterior. The through wall flashings at the base of the cedar shingles appeared to be in good condition with adequate slope and coverage.</p>

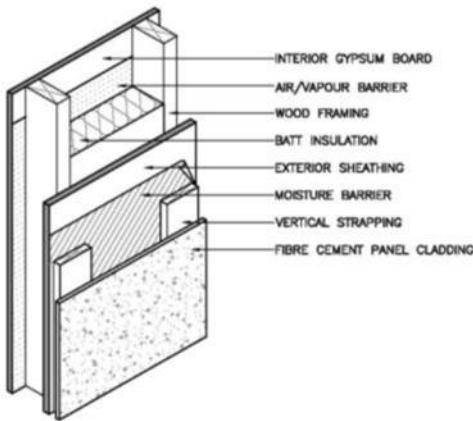
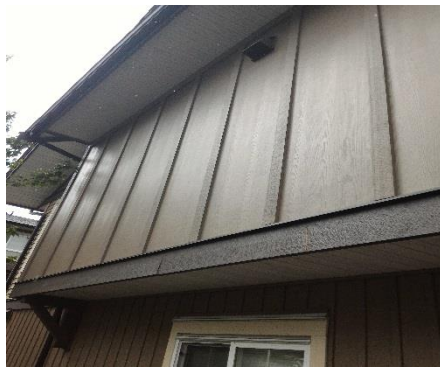
LOCATION: Localised areas of level 2

The composite cement panels and shingle siding, designed to deflect the majority of the rainwater, appeared generally well applied and in good condition.

We did not observe overall signs of damage, improper installation, staining or other signs of deterioration.

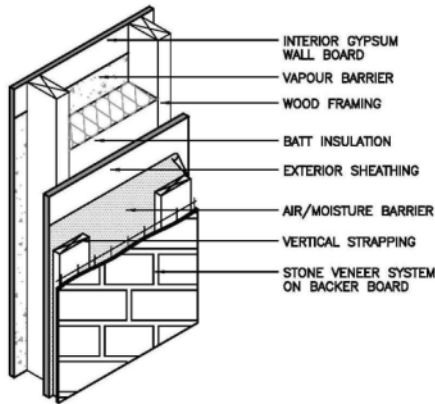
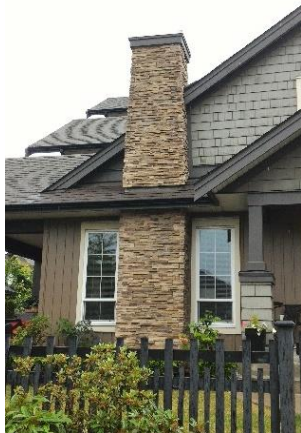
LOCATION: Localised chimney feature of some townhomes

The cultured stone cladding on the townhome feature chimneys appeared to be generally well applied and in good condition.

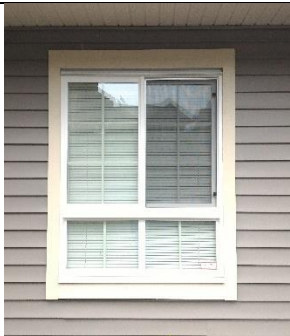
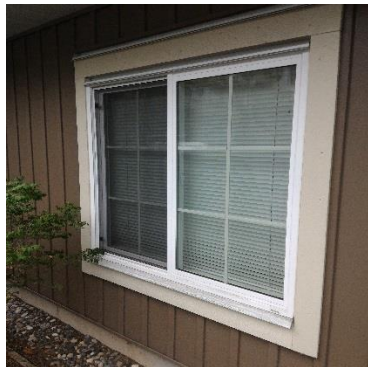
PVC Vinyl nail-on flange windows have been installed on this project, which is an industry standard.

The window frames and horizontal opening vents (sliders) appear to be in good operating condition.

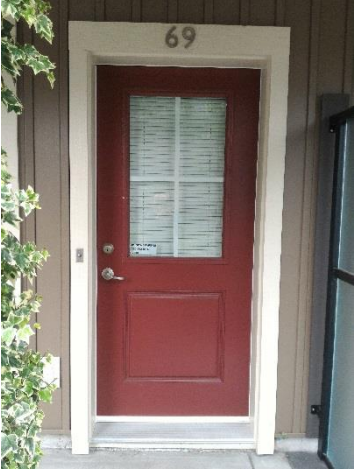
<p>Metal clad wood or fiberglass entry doors have been installed on this project, which is an industry standard.</p> <p>The doors and hardware generally appear to be in good operating condition, and the roof covering lowers the exposure of the assembly to precipitation and winds, which is considered good building practice.</p> <p>The entry doors are typically low maintenance, long lasting assemblies. Periodic repainting will be required.</p>

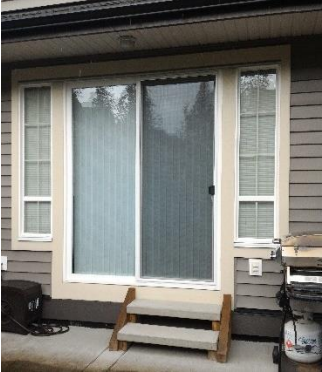
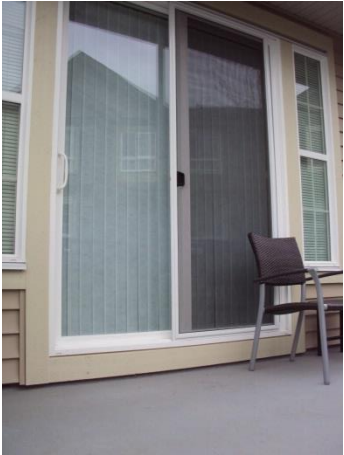
LOCATION:	All balcony elevations
------------------	------------------------

<p>PVC Vinyl nail-on flange patio sliding doors have been installed on this project, which is an industry standard.</p> <p>The sliders are installed on a raised curb, which keep the door sills above the water on the balcony membrane, which is considered good building practice. The wood trim and metal flashings installed around the patio sliders appeared to be in good condition and well applied. The metal flashings included end dams, which is a code requirement.</p> <p>Due to the low thermal conductivity of the vinyl frames, condensation is typically not an issue with this type of sliding door, as was confirmed by our observations.</p> <p>We did not observe overall signs of insulating glass unit (IGU) seal failure. Window manufacturers typically will provide an extended warranty on the IGU seals.</p> <p>The Strata should be aware that nothing should be applied to the interior of the window glass (tinting, tin foil, etc.), as that will likely void the IGU seal warranty.</p>

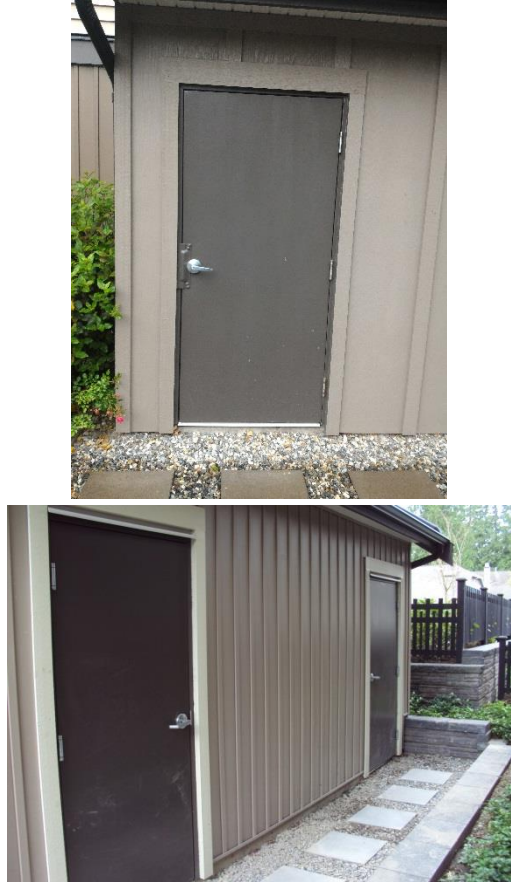
LOCATION:	Electrical closets.
------------------	---------------------

<p>The exterior utility doors and frames located at the electrical closets are constructed of hollow metal. The component assembly includes the door, frame and hardware.</p> <p>The service life of the hollow metal doors and frames is highly dependent on the frequency of use and maintenance of the door and frame paint finishes.</p> <p>As these doors will likely receive very little use, keeping the paint finish in good condition will help to maximize the service life of the components.</p>

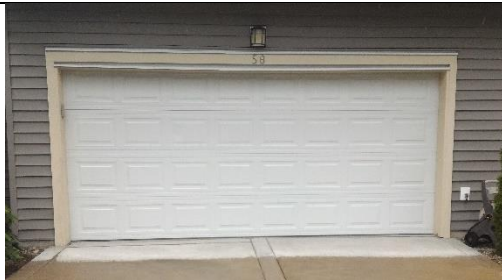
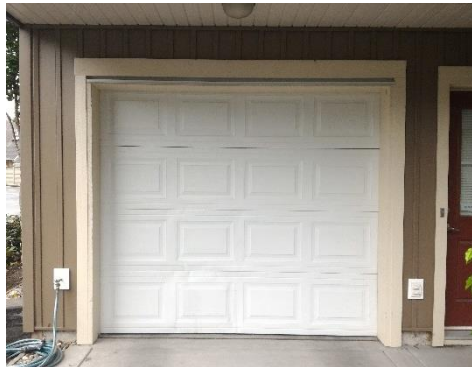
Rear elevation of each strata lot.

Garage doors are typically identified as Limited Common Property with maintenance of the interior components being the responsibility of the Strata Lot Owner. The exterior garage door is however part of the exterior envelope and the responsibility of the Strata to maintain.

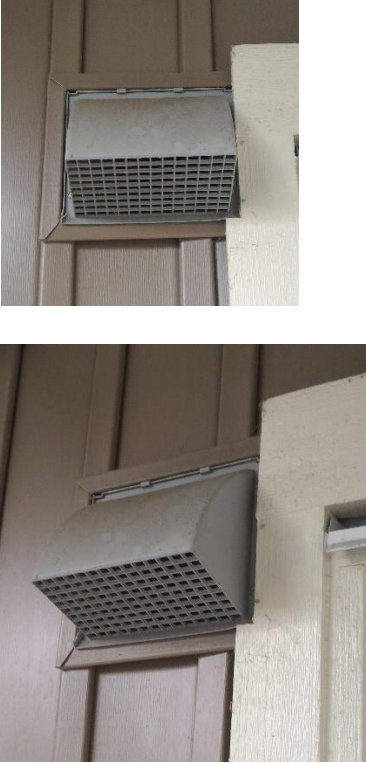
LOCATION:	All building elevations
------------------	-------------------------

<p>The kitchen, bathroom and dryer exhaust vents typically vent through either the roof or through vents located in the exterior walls.</p> <p>On this project, exterior PVC vents were located on the exterior walls. The manufactured PVC vents are typically lapped in with the weather barrier. The weather barrier is located on the exterior sheathing.</p> <p>The PVC vents are generally trouble free, but the dryer vents should be checked regularly for lint buildup.</p> <p>Lint buildup in the PVC vents or ducting to the dryer can be a fire hazard.</p> <p>The component assembly includes the PVC vents located on the exterior walls.</p>

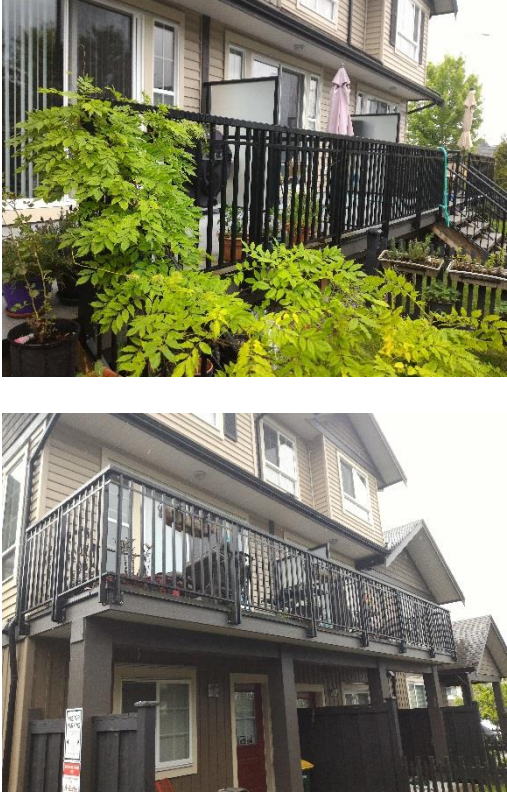
LOCATION:	All building balconies.
------------------	-------------------------

<p>The guards that have been installed at this project are mounted to the side of the fascia board. With side mounting, the guard fasteners do not penetrate the balcony membrane.</p> <p>Side mounted balcony guards are preferable to guards that are mounted through the top of the balcony membrane.</p> <p>The side mounted aluminum guardrails appeared to be in good condition. We did not observe loose fasteners on the balconies that were reviewed.</p> <p>The component assembly includes the balcony guards, guard posts, base plates and anchorage</p>

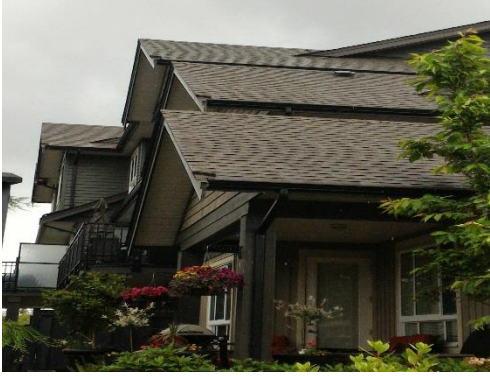
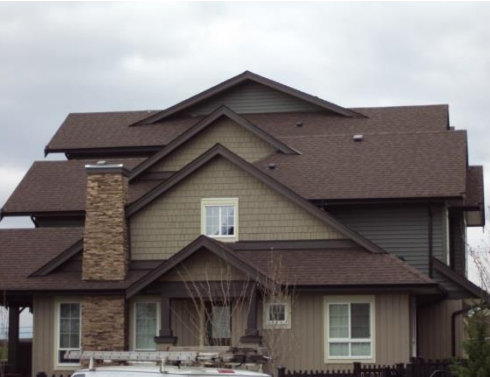
LOCATION:	All building roofs
------------------	--------------------

<p>The main pitched roof assembly on the townhome blocks is an asphalt coated shingle with granular ultraviolet protection.</p> <p>The top surface of the shingle incorporates a layer of mineral granules that are pressed into the asphalt during manufacture. The granules protect the layer of asphalt from the sun's rays. Without the granular layer, the asphalt would deteriorate quickly.</p> <p>The pitched roof shingle application generally appeared to be properly applied with straight horizontal installation lines and appropriate shingle exposure (i.e. the amount of overlap between adjacent shingles above and below each other).</p> <p>Roof vents have been incorporated into the roof assembly near the high point of the roof lines, which is appropriate. The roof vents act with the venting provided through the perforated vinyl roof soffits to provide cross flow ventilation of the roof attic.</p> <p>We did observe some minor moss growth and accumulations of dirt, leaves, etc. on many of the roofs. We recommend roof maintenance such as moss treatment, removal of dirt, leaves, etc. be carried out bi-annually.</p>

B SHELL	
B20 EXTERIOR VERTICAL ENCLOSURES	
B2010 Exterior Walls	<ol style="list-style-type: none"> 1. Repaint wood trim and composite cement panel within two years, renew window and other sealants at the same time. 2. Remove Ivy from column at unit 69. 3. Monitor siding and soffits for damage, or loose panels, monitor wood trim for deterioration.
B2020 Exterior Windows	<ol style="list-style-type: none"> 1. Monitor for operation problems, replace failed insulating glass units as they occur.
B2050 Exterior Doors	<ol style="list-style-type: none"> 1. Monitor for operation problems, replace or adjust hardware and replace weather stripping as needed.
B2070 Exterior Louvers & Vents	<ol style="list-style-type: none"> 1. Clean dryer vents annually or more frequently if required due to lint buildup.
B2080 Exterior Wall Appurtenances	None identified
B30 EXTERIOR HORIZONTAL ENCLOSURES	
B3010 Roofing	<ol style="list-style-type: none"> 1. Carry out regular roof maintenance such as annual review for damage or missing shingles, bi-annual moss treatment and removal of debris.

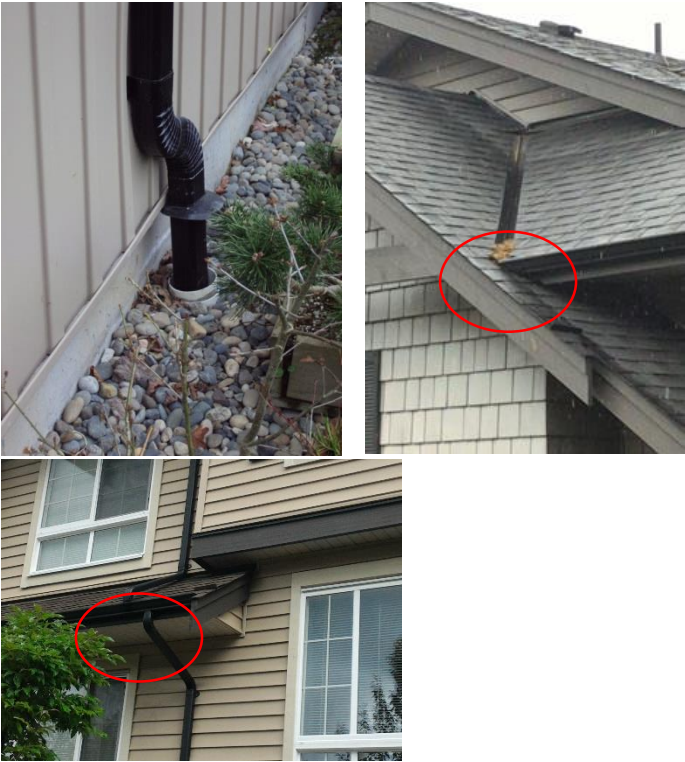
LOCATION:	All building elevations
------------------	-------------------------

<p>There is a gutter and downpipe system surrounding the soffits of the pitched roof areas.</p> <p>The downpipes extend down to grade and are connected to the projects storm drainage system.</p> <p>The gutter and downpipe system installed on this project appeared to have good coverage, and was generally well attached and undamaged. We did observe two locations near unit 5 on the North side of the complex. We recommend the downpipe be re-attached as a maintenance item.</p> <p>The buildings on the west side of the property are near large cedar trees.</p> <p>The gutters adjacent to the trees should be cleaned frequently, as the debris from the trees will clog the gutters quickly.</p>

B3020 Roof Appurtenances	<ol style="list-style-type: none"> 1. Clean gutters at least once a year, additional cleaning may be needed near treed areas. Repair damaged or dislodged gutters and downpipes as they occur.
B3040 Traffic Bearing Horizontal Enclosures	<ol style="list-style-type: none"> 1. Monitor wood fascia where the balcony stairs meet the wood fascia.
B3080 Overhead Exterior Enclosures	None identified
