**Visual Property Inspection**

**404 Bruneau Place  
Langley, BC V4W 3K9**

Date: 26-Apr-2017

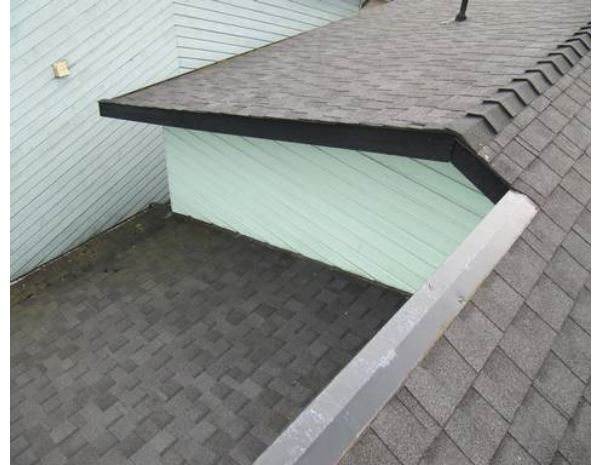
Patch work noted on the main roof above the water staining in the attic.

General view of the roof.

*Previous repairs noted on the main roof, this is above the stains I noted in the attic. Monitor.*

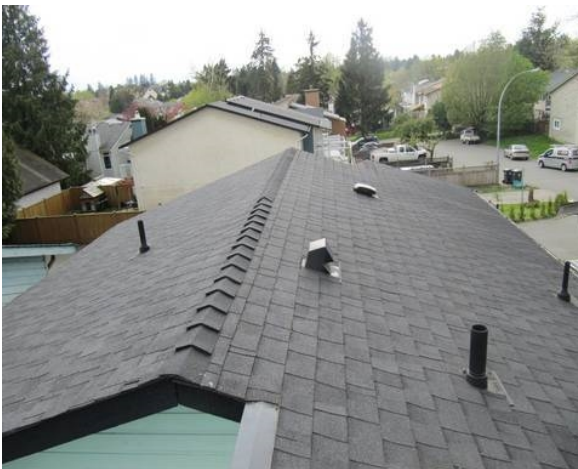
General view of the roof.

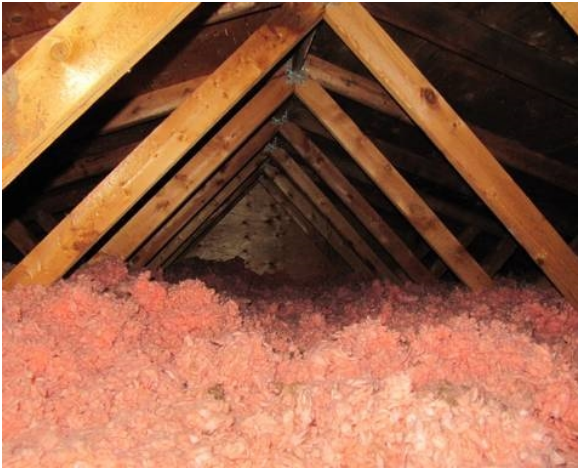
*Organic matter noted on the sheathing in the attic. This is common from houses in the 70's due to lack of vents. Additional vents were added 7 years ago and have likely stopped the growth. Clean as necessary.*

*Some water staining noted in the sheathing. It appears the issue was fixed, monitor and repair as necessary.*

General view of the attic.

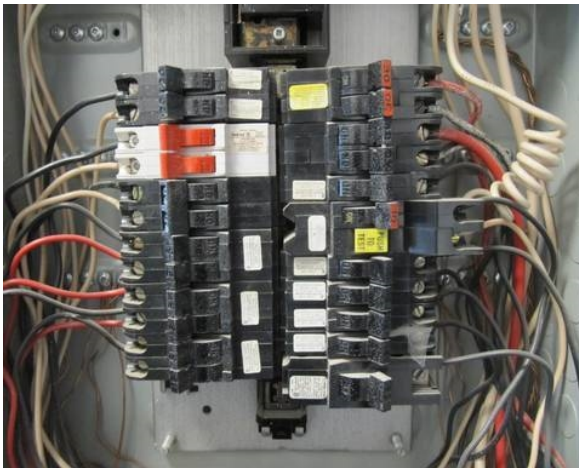
Each neutral (white) wire should be secured separately under a setscrew terminal in an electric panel. Recommend an electrician fix this issue.

General view of the panel with the cover off.

Provide permanent labeling for breaker identification.
