# Depreciation Report - Final

## The Boardwalk Strata Corporation VIS 3899

827 North Park St  
Victoria, BC

**Elevator  
Depreciation Report**

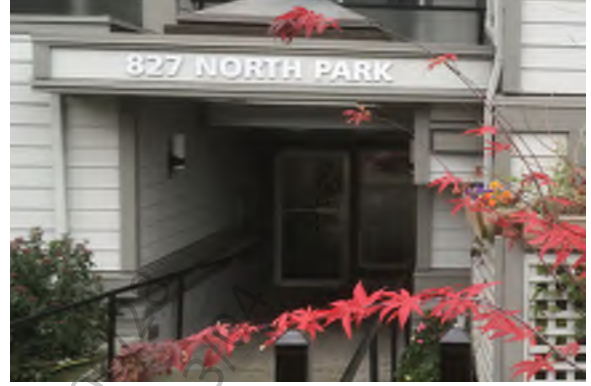
Photo 08

Photo #8	B203001	Swing Door - Front Entrance - Replacement	Metal framed storefront door w/ separate sidelight.	Fair	1996	Replace front door at the end of service life. Adjust and replace weatherstripping to prevent air gaps/leakage as part of maintenance program, where required. Paint door slabs and frames to refresh appearance during complex-wide cladding painting program.	Replacement	3 - Renewal	22	35	13	5%	100%	Y	\$12,000
Photo #9	B203001	Swing Doors - Parkade Entrance - Replacement	Metal framed fire rated doors.	Fair	1996	Replace rear doors at the end of service life. Adjust and replace weatherstripping to prevent air gaps/leakage as part of maintenance program, where required. Paint door slabs and frames to refresh appearance during complex-wide cladding painting program.	Replacement	3 - Renewal	22	30	8	5%	100%	Y	\$5,000
Photo #10	B203001	Swing Doors - Balconies - Replacement	Swing doors are present at some of the units and consist of insulate wood framed assemblies with vision lites.	Fair	1996	Replace swing doors at the end of service life. Adjust doors and replace weatherstripping to prevent air gaps/leakage as part of maintenance program, where required. Replace door hardware as required. Paint door slabs and frames to refresh appearance during complex-wide cladding painting program.	Replacement	3 - Renewal	22	30	8	5%	100%	N	\$2,000

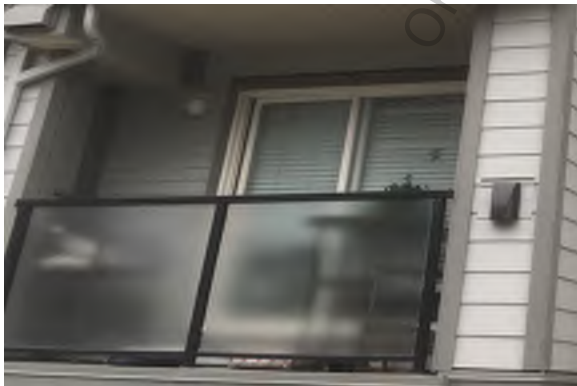
Photo 11

Photo #11	B203001	Sliding Glass Doors - Repair	Sliding glass doors provide access to balconies/patios and consist of vinyl framed assemblies.	Good	2003	Repair doors by replacing IGUs as required due to breakage or failure. Regularly inspect weatherstripping and hardware on operable vents for signs of wear or deterioration, and replace or repair accordingly. Adjust doors (including replacing rollers as required) and replace weatherstripping to prevent air gaps/leakage as part of maintenance program, where required.	Replacement	3 - Renewal	15	10	5	5%	100%	Y	\$7,000

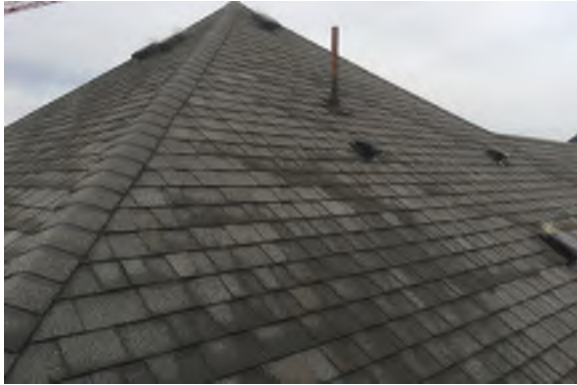
Photo 13

Photo #13	B301002	Sloped Roofs - Replacement	Fiberglass asphalt shingles are present throughout all sloped roofs. Where reviewed the shingles and associated flashings appeared to be in good condition. No leaks were reported or observed during the course of this review.	Good	2010	Replace shingles and underlayment at end of service life.	Replacement	3 - Renewal	8	25	17	5%	100%	Y	\$35,000
Photo #13	B301002	Sloped Roofs - Repair	Fiberglass asphalt shingles are present throughout all sloped roofs. Where reviewed the shingles and associated flashings appeared to be in good condition. No leaks were reported or observed during the course of this review.	Good	2010	Remove moss/organic growth accumulation on an annual basis as part of a roofing maintenance program. Replace torn, lifted or curled shingles on an as-needed basis as part of the operational budget to extend serviceability.	Replacement	3 - Renewal	8	5	2	5%	100%	N	\$3,000

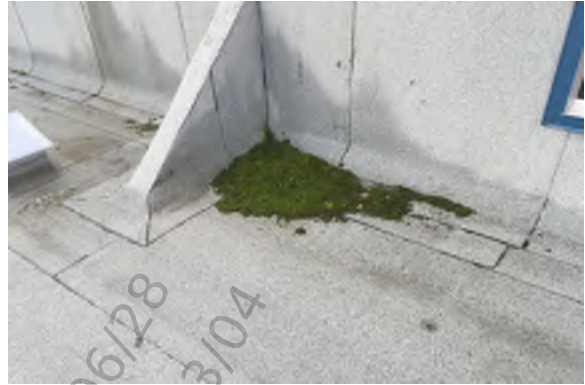
Photo 14

Photo #14	B301002	Flat Roof - Replacement	Flat roofs are covered with a modified bitumen membrane. Some moss accumulation was noted on the shaded roof areas. Where reviewed the membrane and associated flashings appeared to be in good condition. No leaks were reported or observed during the course of this review.	Good	2010	Replace roof membrane at end of service life. Replace roof scuppers/vents etc. at the same time to reduce costs.	Replacement	3 - Renewal	8	25	17	5%	100%	Y	\$165,000
Photo #14	B301002	Flat Roof - Repair	Flat roofs are covered with a modified bitumen membrane. Some moss accumulation was noted on the shaded roof areas. Where reviewed the membrane and associated flashings appeared to be in good condition. No leaks were reported or observed during the course of this review.	Good	2010	Remove moss/organic growth accumulation on an annual basis as part of a roofing maintenance program. Replace torn and damaged areas of the membrane on an as-needed basis as part of the operational budget to extend serviceability.	Repair Allowance	3 - Renewal	8	7	2	5%	100%	N	\$2,000

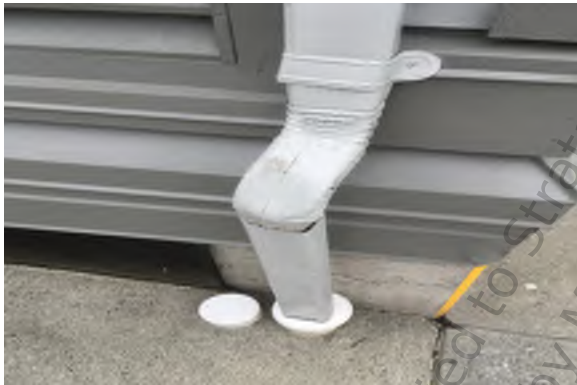
Photo 15

Photo #15	B301005	Eaves troughs and Downspouts - Replacement	Prefinished steel eaves troughs at the eaves of all pitched roofs. Drainage is collected and diverted to drain outlets below grade via prefinished steel rainwater leaders. Some downspouts were noticed to not be connected.	Good	1996	Replace eaves troughs and downspouts at the end of their service life. Clean eaves troughs on a semi-annual basis as part of a roofing maintenance program. Unblock above-grade cleanouts at downspouts to ensure free-flowing drainage to sub-grade perimeter drains.	Replacement	3 - Renewal	22	50	28	5%	100%	N	\$5,000
Photo #16	B201008	Soffits and Fascia - Replacement	Continuously vented, aluminum soffit installed on the underside of the pitched roof eaves.	Good	1996	Replace metal soffits at end of service life and at same time as siding to reduce cost. Replace/refit damaged or dislodged sections on an as needed basis to prevent insect/avian nesting, and to restore appearance.	Replacement	3 - Renewal	22	50	28	5%	100%	Y	\$5,000

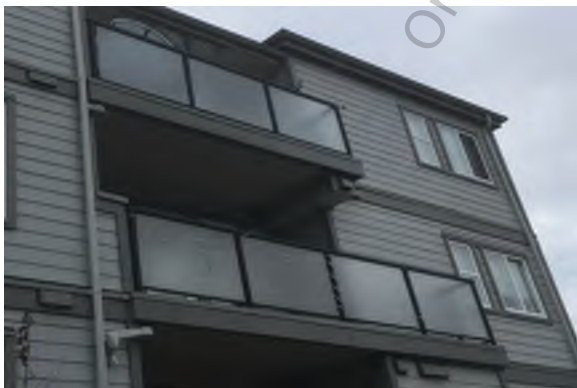
Photo 17

Photo #17	B201007	Balcony/Patio Railing - Repair	Glass panel guards with steel posts and rails.	Good	2003	Replace at end of service life.	Replacement	3 - Renewal	15	50	35	5%	100%	Y	\$104,000
Photo #18	A103001	Concrete patio - Repair	Concrete pavers set below grade with concrete retaining walls.	Good	1996	Replace any broken pavers and patch any patio wall cracks on an as-needed basis.	Replacement	4 - Discretionary	22	30	8	5%	100%	N	\$2,000
Photo #19	B301002	Balcony membrane - Replacement	Vinyl deck membrane installed over wood framing.	Good	2003	Replace at end of service life.	Replacement	3 - Renewal	15	20	5	5%	100%	Y	\$20,000
<b>MECHANICAL AND ELECTRICAL</b>															
Photo #20	D304007	Exhaust Ducting - Cleaning	Dryer exhaust vents and ducting. Clean existing assemblies on an annual basis to prevent clogged ducting.	Fair	2017	Clean out dryer exhaust ducts on an annual basis as part of maintenance budget. As this service item is often overlooked, it is recommended that the Strata implements a program for duct cleaning into the maintenance/operational budget. Rectify corrosion as required in the same manner as window flashing repairs.	Repair Allowance	3 - Renewal	1	1	0	5%	100%	Y	\$8,000

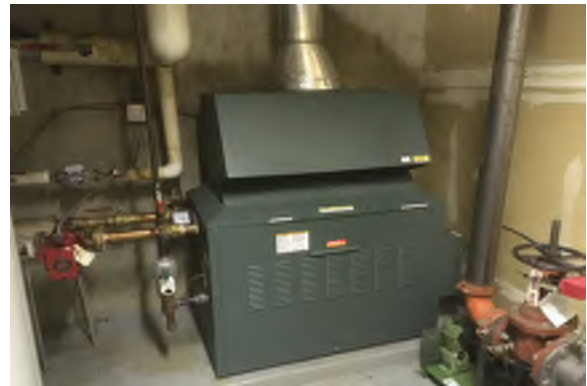
Photo 30

Photo #30	D302002	Gas Fired Boiler - Repair	Boiler provides hot water to building.	Good	2011	Allowance for regular maintenance to the gas fired boiler.	Repair Allowance	3 - Renewal	7	10	3	5%	100%	N	\$2,000
Photo #30	D302002	Gas Fired Boiler - Replace	Boiler provides hot water to building.	Good	2011	Allowance for replacement of the gas fired boiler.	Replacement	3 - Renewal	7	20	13	5%	100%	Y	\$14,000
No Photo	D202001	Back Flow Preventer Device	Backflow preventer devices protect potable water sources from backflow contamination.	Not Applicable	2021	Install backflow preventer device to meet CRD regulations. Installation has been slated for 2021.	Upgrade	2 - Deferred Maintenance	-3	40	43	5%	100%	Y	\$6,000
No Photo	D202001	Sanitary Drainage Piping - Sectional Replacement	The visible sanitary drainage piping was ABS piping. No active leakage was observed, nor was historic leakage reported.	Fair	1996	The ABS piping, installed in interior spaces, have a typical lifespan of 50 years. An allowance for sectional replacement as required has been included.	Repair Allowance	4 - Discretionary	22	50	28	5%	100%	Y	\$6,000

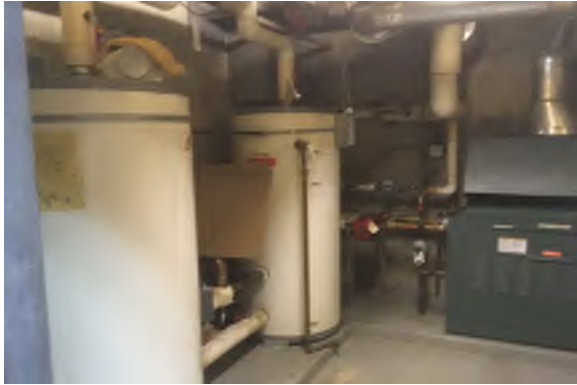
Photo 31

Photo #31	D202003	Hot Water Storage Tanks - Replace	Two storage tanks that supply hot water to the building. They appear to be the original tanks installed in 1996, but manufactured in 1994.	Poor	1996	Tanks are well beyond their expected service life. New storage tanks can be roughly 40% more efficient. Remove and replace with new tanks. Replace tanks on cycles with warranty expiration.	Replacement	1 - Immediate	22	10	0	5%	100%	N	\$3,000
Photo #32	D401001	Fire Suppression System - Repair	The complex is sprinkled with a hydraulically designed automatic suppression system. All fire suppression equipment is located in the basement sprinkler room. Water for fire suppression is supplied by a branch taken off of the fire/domestic water supply main.	Fair	1996	Ensure that all valves and valve assemblies are inspected, maintained and tested as per NFPA 25. Replace or refurbish components as they fail.	Repair Allowance	3 - Renewal	22	40	18	5%	100%	Y	\$18,000

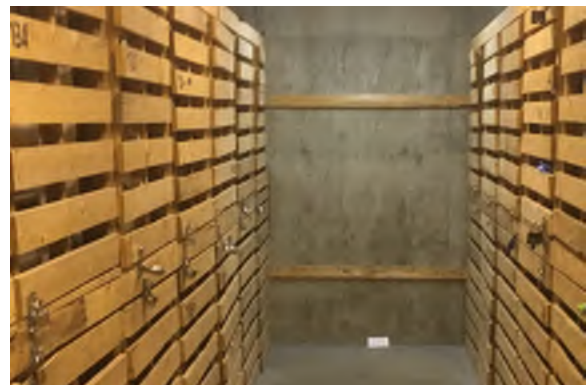
Photo 36

Photo #36	C301001	Concrete Walls - Repairs	The parkade level has concrete walls throughout in stairwells and mechanical rooms.	Good	1996	Concrete walls generally require minimal maintenance, but an allowance for crack repairs to minimize moisture ingress has been added.	Replacement	3 - Renewal	22	5	5	5%	100%	Y	\$25,000
Photo #37	B102099	Roof Access Ladder - Replace	Current roof access ladder does not meet Worksafe BC codes	Poor	1996	Remove existing ladder and install code compliant roof access ladder.	Replacement	1 - Immediate	22	50	0	5%	100%	N	\$2,000
<b>SITE</b>															
Photo #1	G202003	Drive Aisle and Parking Lot - Resurface	The drive aisle ramp leads to the underground parkade as well as the mechanical and electrical rooms. All are of concrete construction.	Good	1996	Complete resurfacing of concrete drive aisle, parkade, and auxiliary rooms at end of service life. Isolated repair work, such as crack sealing, is recommended and assumed to be covered under maintenance budget.	Replacement	3 - Renewal	22	40	18	5%	100%	Y	\$96,000

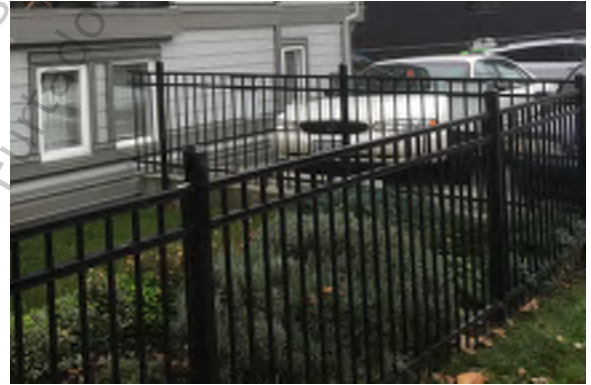
Photo 40

No Photo	G205007	Garden Sprinklers - Replacement	Sprinklers located throughout the common grounds.	Good	2018	Replace sprinkler system at end of service life.	Replacement	3 - Renewal	0	25	25	5%	100%	N	\$2,000
Photo #40	B201007	Steel Entrance Railings - Repaint	Welded steel railings at the north elevation. Repainted in 2017.	Fair	2017	Replace the existing stucco fences at the end of their service life with new wood fences. Complete ongoing repairs to the posts, gates and stucco finish as required as part of the buildings maintenance budget.	Repair Allowance	3 - Renewal	1	7	6	5%	100%	N	\$2,000
Photo #41	G204001	Wood Fencing - Replacement	Wood fencing is present on the west and south property line.	Good	2018	Replace wood fencing at end of service life. Complete minor repairs as required under the maintenance budget.	Replacement	3 - Renewal	0	21	21	5%	50%	N	\$4,000
Photo #41	G204001	Wood Fencing - Repair and Repaint	Wood fencing is present on the west and south property line.	Good	2018	Replace the existing stucco fences at the end of their service life with new wood fences. Complete ongoing repairs to the posts, gates and stucco finish as required as part of the buildings maintenance budget. Repaint on 7 year cycles.	Repair Allowance	3 - Renewal	0	7	7	5%	100%	N	\$2,000

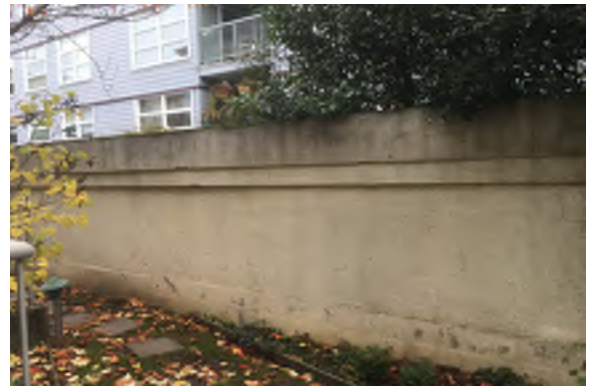
Photo 42

Photo #42	G204001	Stucco Fencing - Repair and Repaint	Stucco fencing is present on the west property line. Plant growth was noticed on the top of the wall. Stucco is beginning to spall off and crack, exposing metal stucco accessories.	Poor	1996	Repair and repaint stucco fence. Complete minor repairs as required under the maintenance budget.	Repair Allowance	2 - Deferred Maintenance	22	25	3	5%	50%	Y	\$6,000
No Photo	G204001	Underground Connections - Repair	Underground service connections (storm, sewer, water supply). No issues associated with underground service connections were reported at the time of this review.	Not Applicable	2018	Contingency for repair of underground connections. Costs have not been carried into the capital plan as the estimated costs are expected to arrive below the threshold value of this report.	Contingency	3 - Renewal	0	15	15	5%	100%	Y	\$6,000
Photo #43	G205005	General Landscaping	Landscaping and garden areas provide cosmetic appeal to the common areas.	Not Applicable	2018	Allowance for partial replacement of some landscaping aspects.	Contingency	3 - Renewal	0	10	10	5%	100%	N	\$2,000
