The District of North Vancouver REPORT TO COUNCIL

March 20, 2014
File: 3060-20/28.13

SUBJECT: **BYLAWS 8024 AND 8025 – OCP AMENDMENT AND REZONING FOR A MIXED APARTMENT/TOWNHOUSE PROJECT AT 3829/3919 DOLLARTON HIGHWAY**

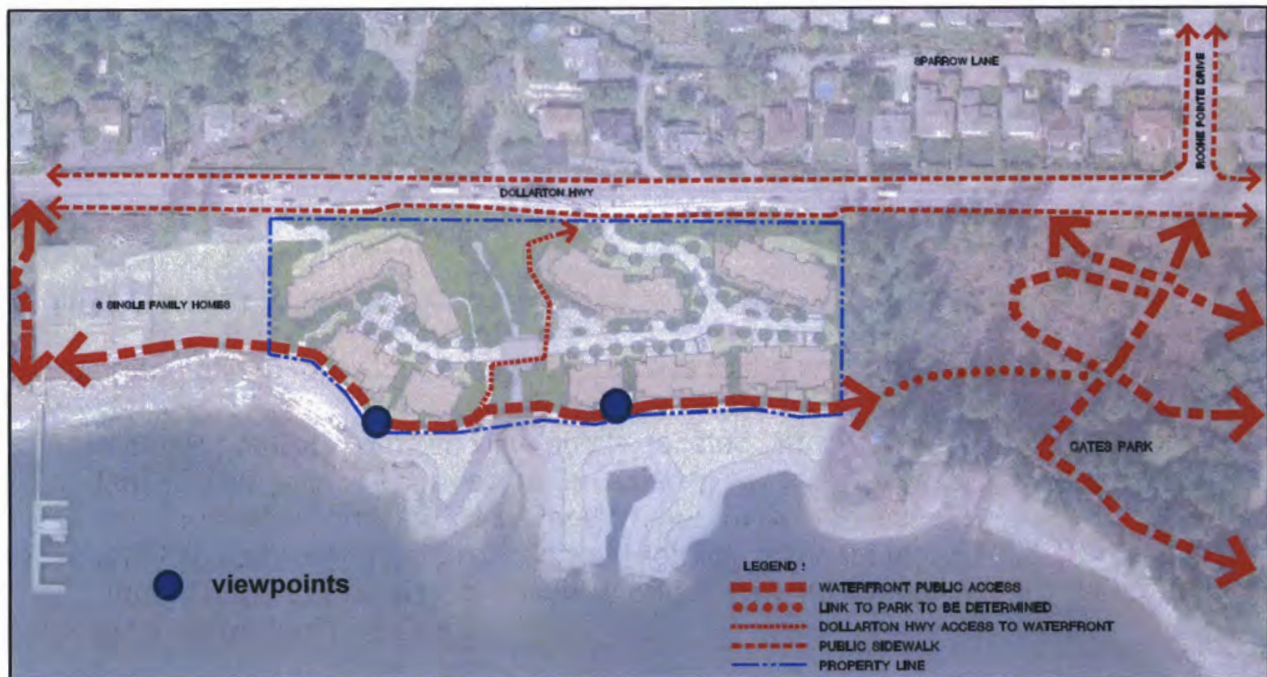
As illustrated on the following plan, public access to the waterfront is encompassed by:

- a public pathway with two view points, located immediately upland of the foreshore lands. This path will connect to the existing waterfront path to the west and the existing trail network in Cates Park/Whey-au-Wichen; and
- a public path, leading from Dollarton Highway adjacent to the Roche Point Creek riparian area to the internal driveway with a connection down to the waterfront trail, west of Roche Point Creek.

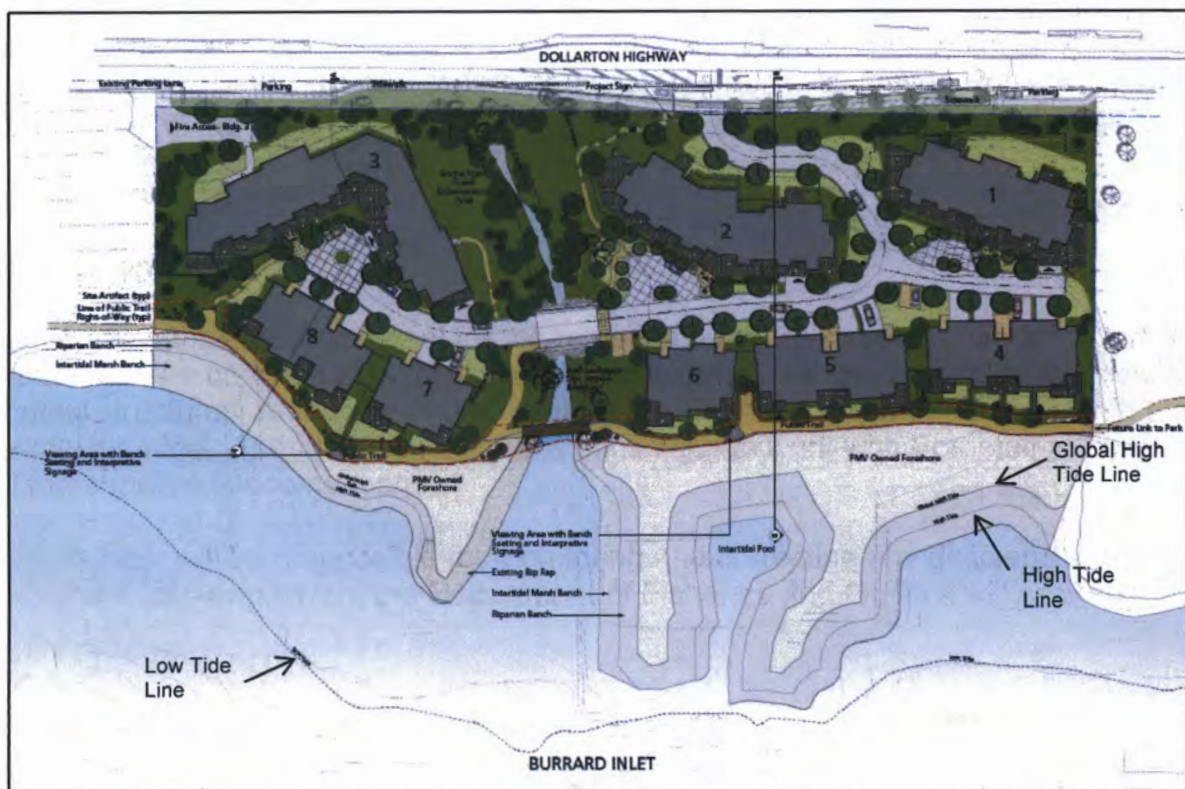
Foreshore Enhancement Plan Concept

Polygon has submitted a proposal for the remediation of the foreshore lands to Port Metro Vancouver. The conceptual plan, illustrated below, involves the removal of the existing industrial structures, reshaping and armouring the shoreline and introducing marsh and intertidal planting. At this point, Polygon is continuing to work with Port staff to develop a final foreshore enhancement plan.

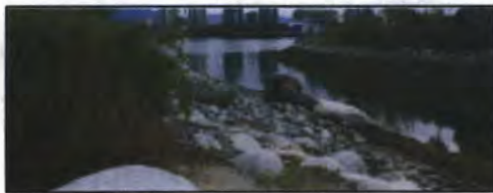
Rip Rap Shoreline

The following photographs are examples of what the foreshore lands could look like once they are re-contoured and planted/armoured.

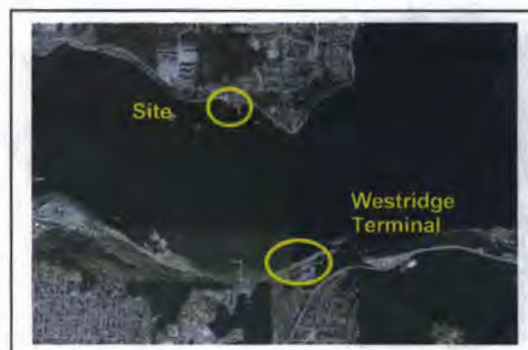
For Council's reference, the accompanying image illustrates the location of the subject site and the existing Westridge Terminal on the south side of the harbour which are approximately 1.6km apart.

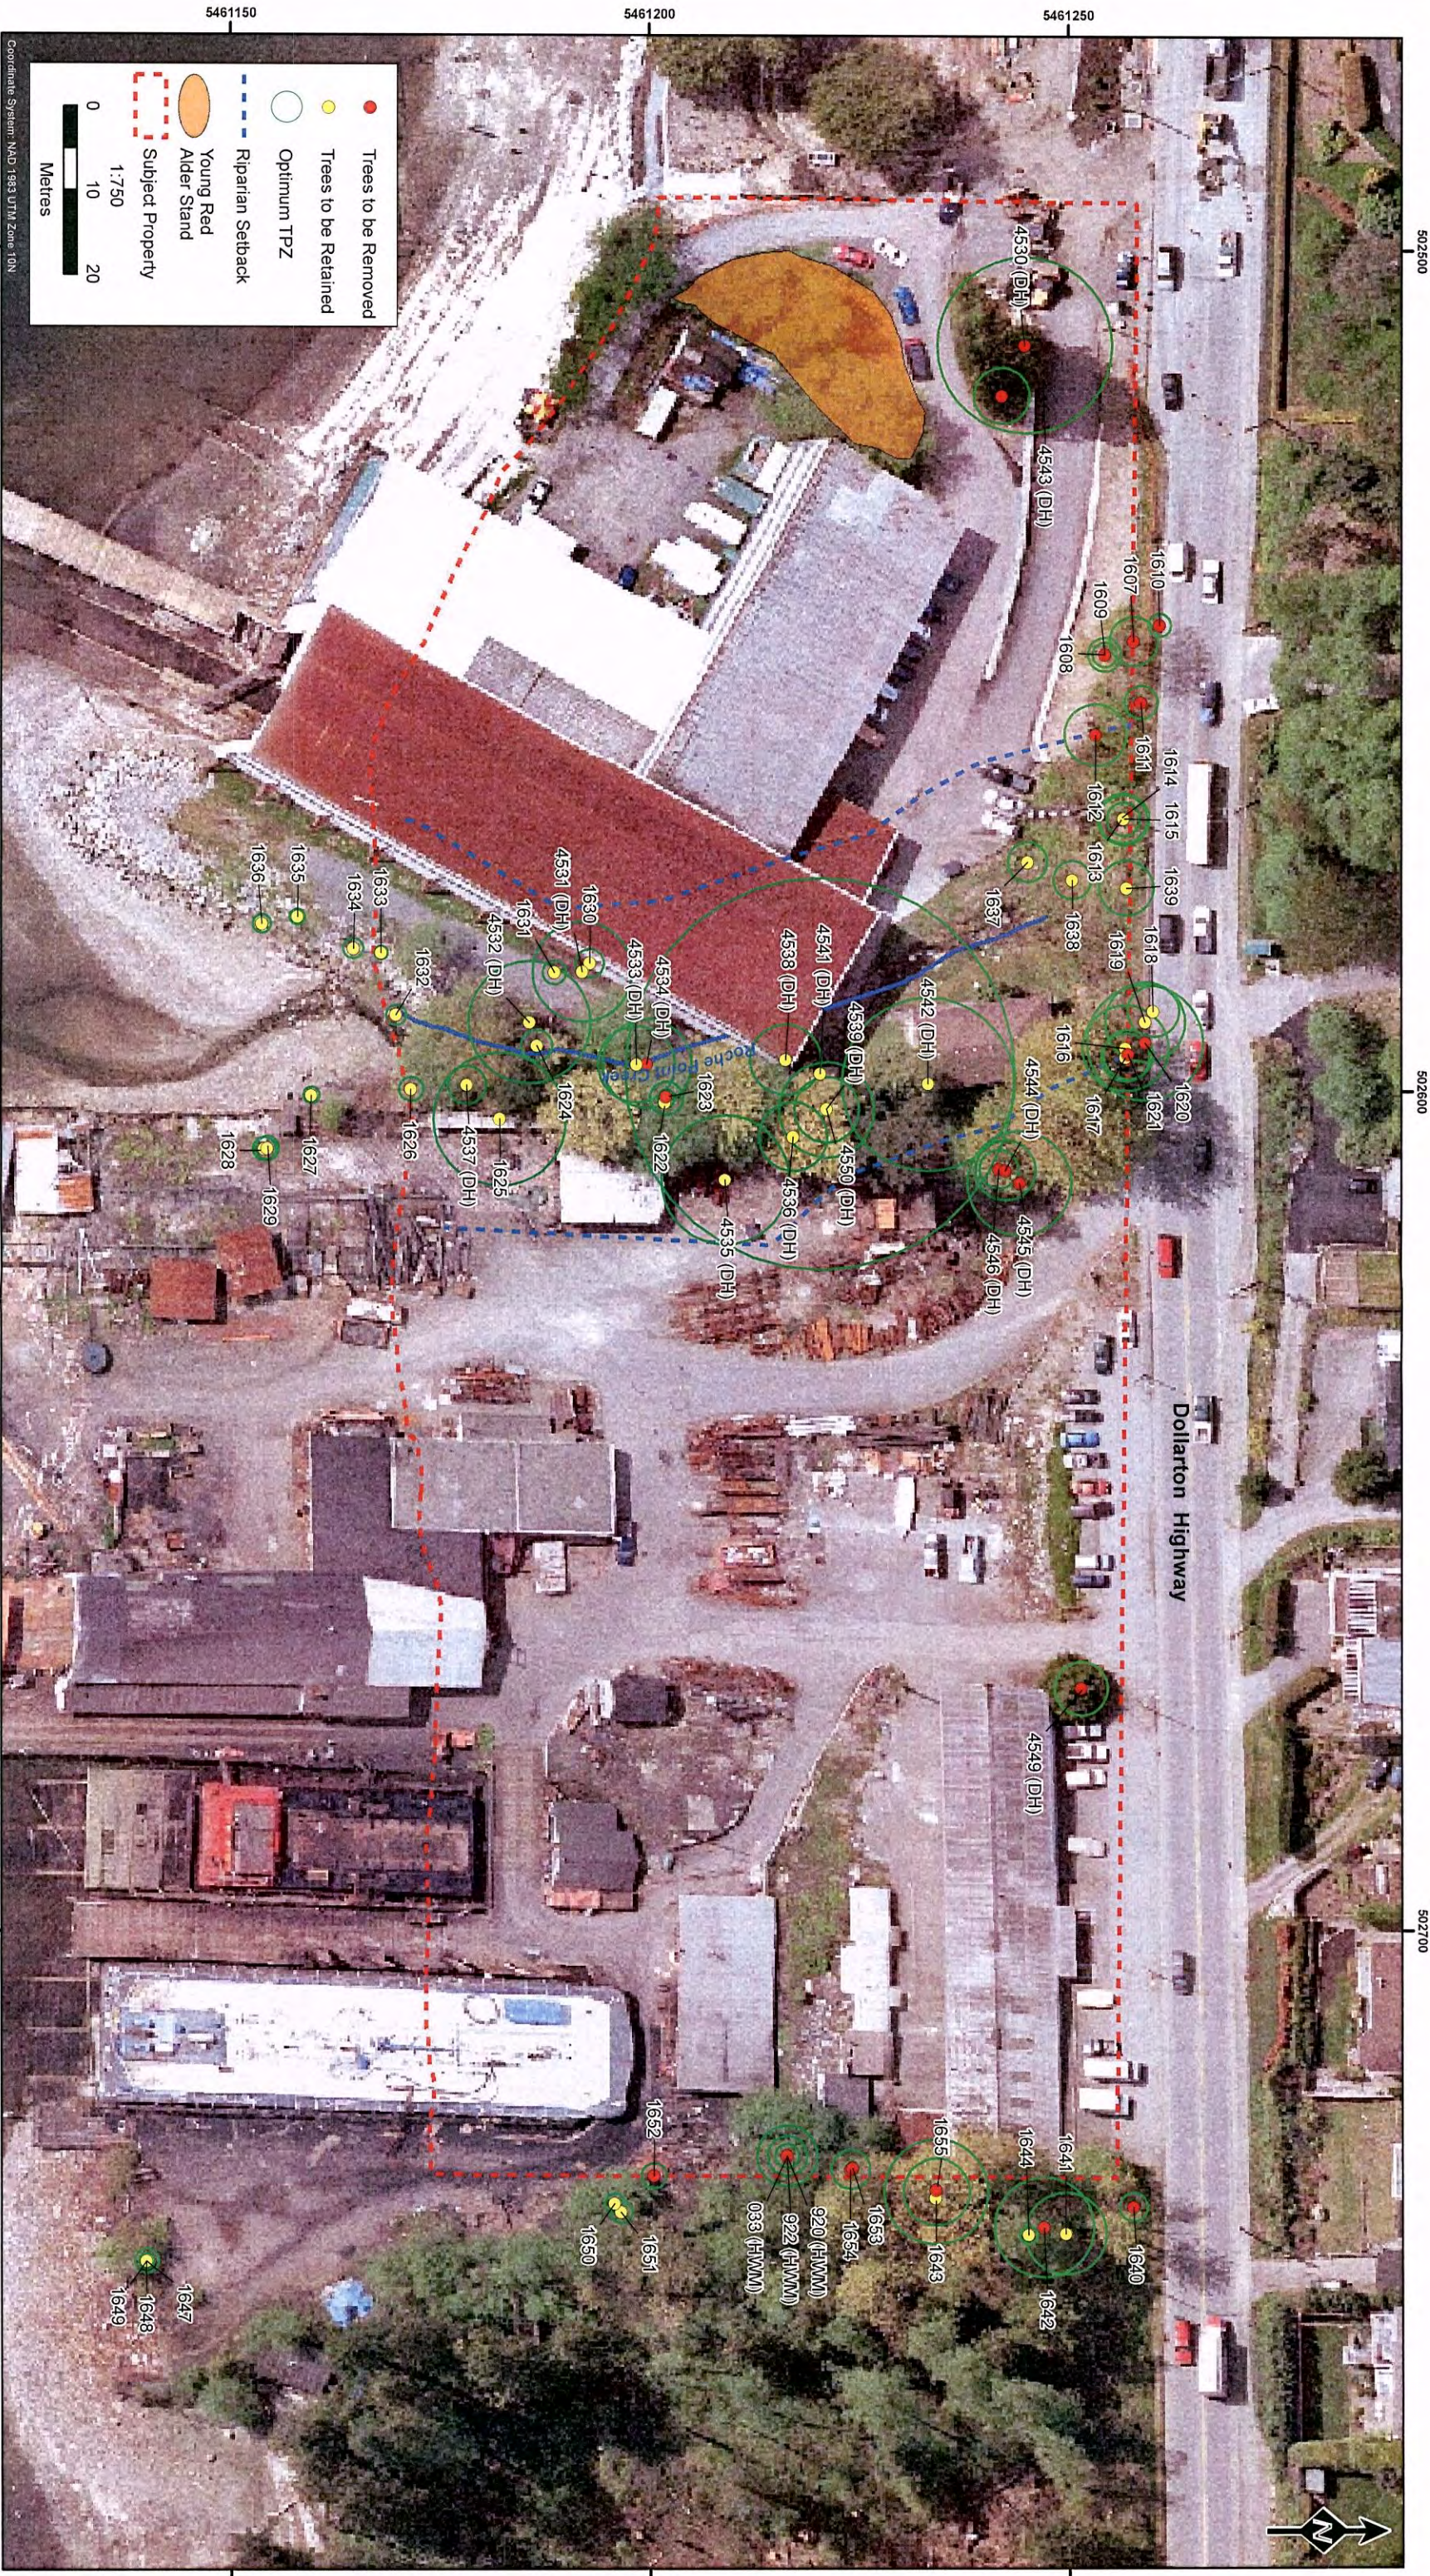
Figure 1: Preliminary Tree Retention Plan

Small stand of early seral deciduous trees in the western portion of the Site (Figure 1)

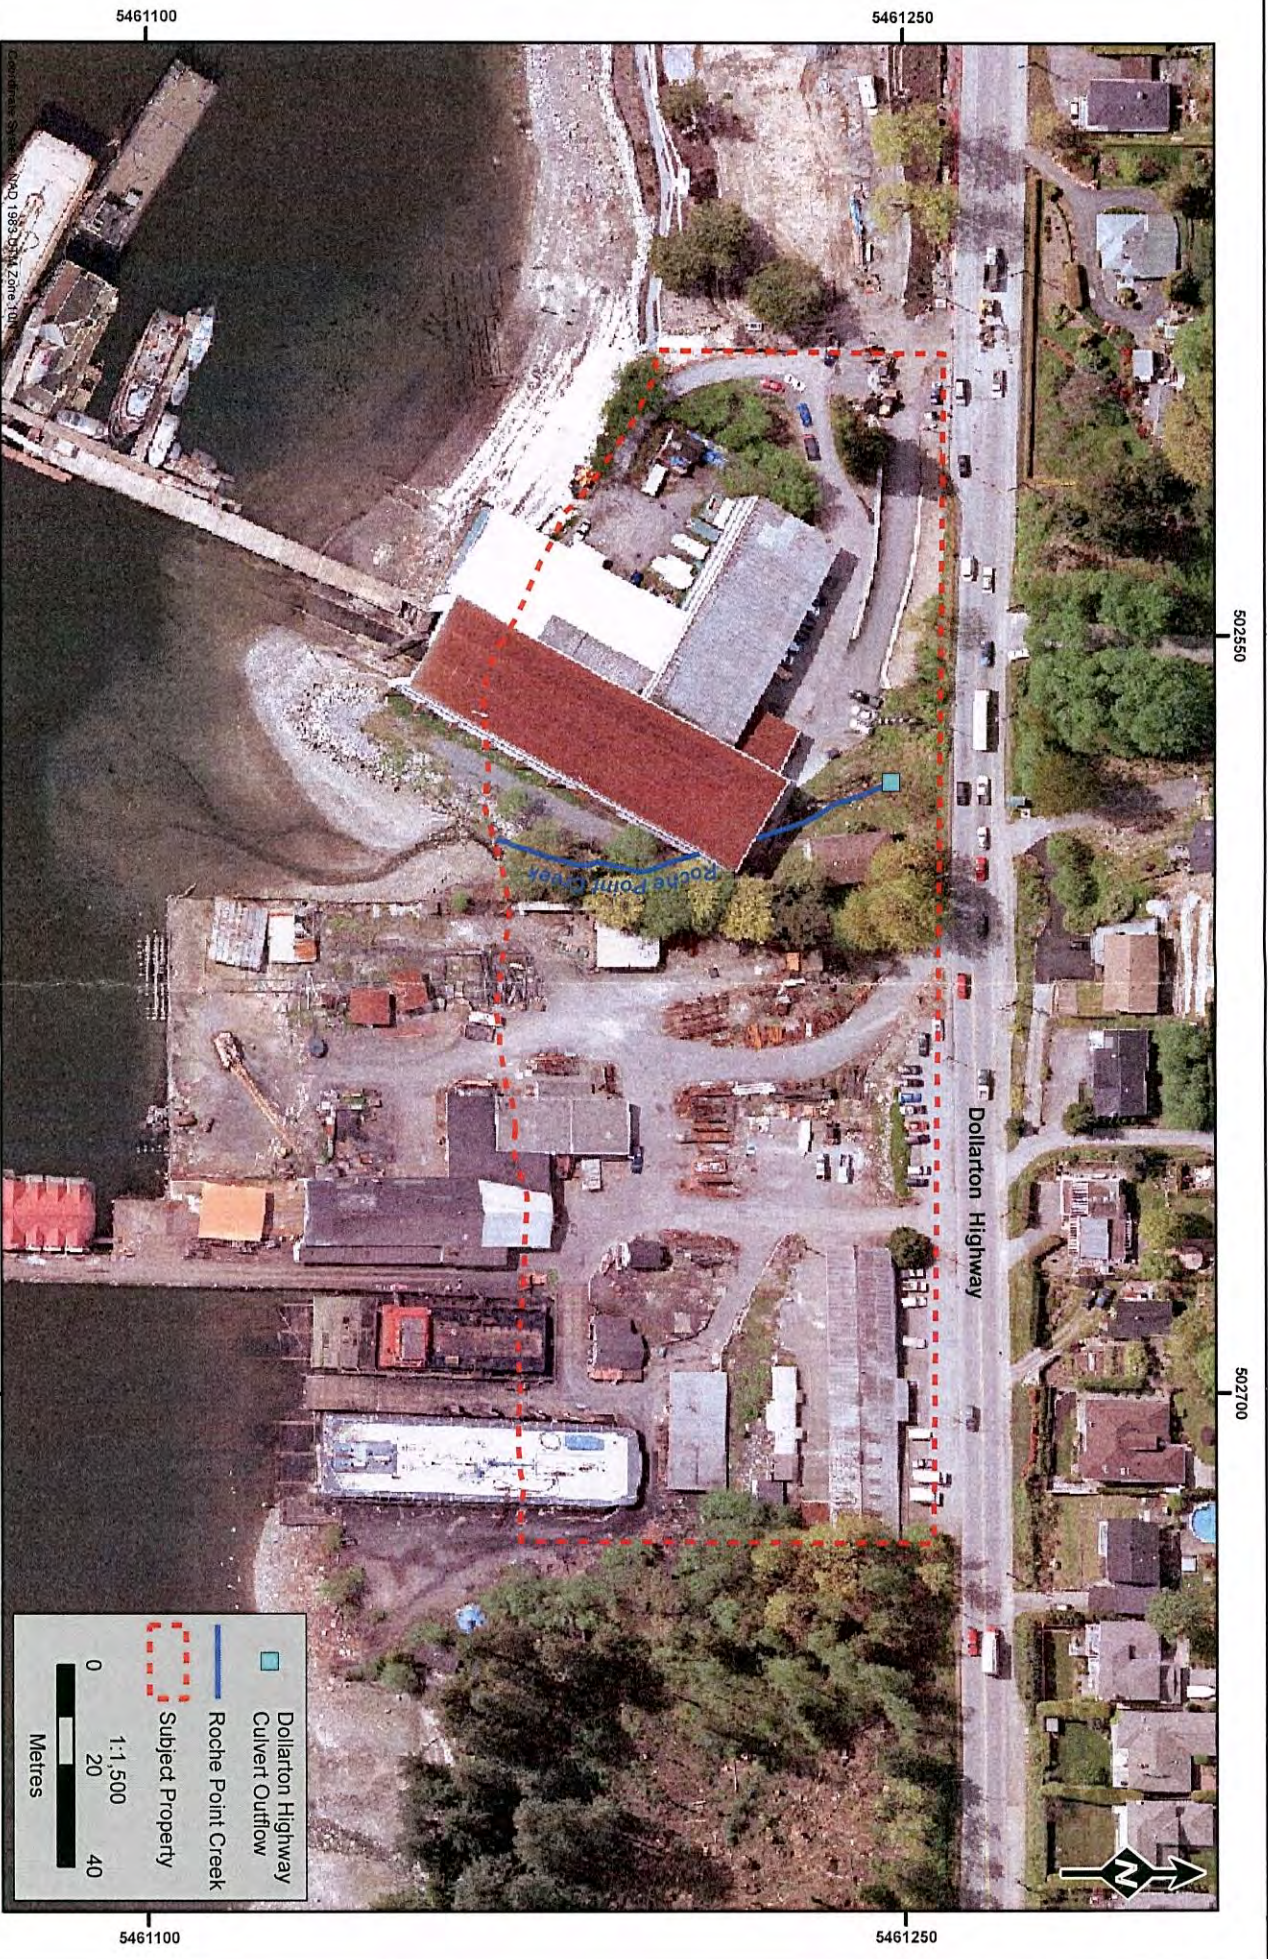
Map ID: 1543-09-02_001

Figure 2: Site Plan

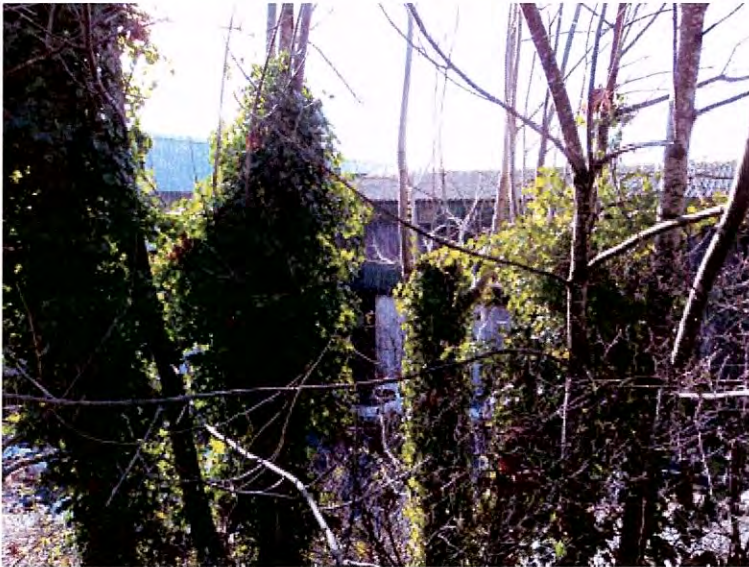
Photograph 1:

Topped bigleaf maple trees adjacent to Dollarton Highway with significant populations of English ivy on main stems

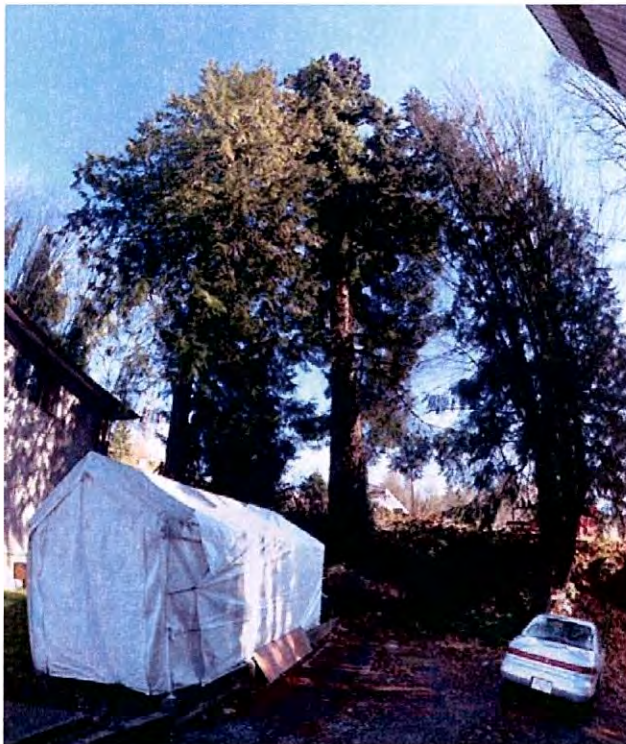
Photograph 2:

Large-diameter, veteran western redcedar and Douglas-fir in the Roche Point Creek riparian environment [Tag #4541(DH) and 4542(DH)]

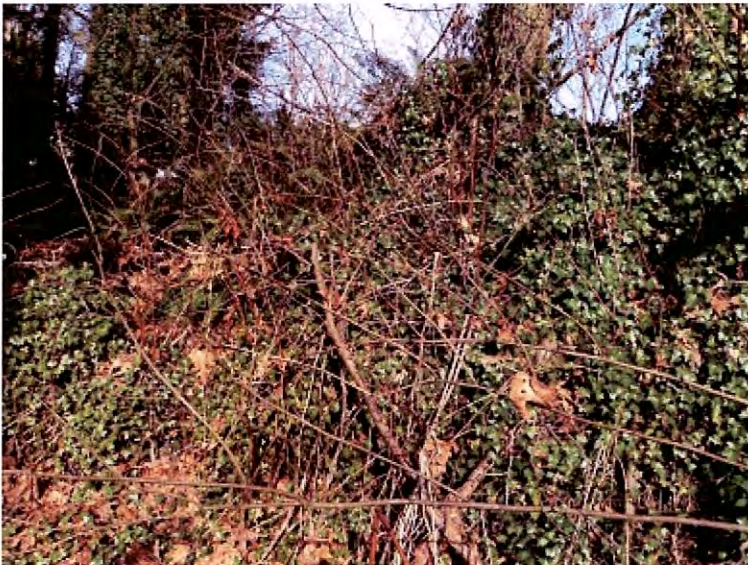
Photograph 4:

Significant population of English ivy occurring in the Roche Point Creek riparian environment

Significant populations of non-native English ivy were observed throughout the Site (Photograph 4). English ivy is an aggressive invasive species that can cause significant impacts to trees and ecosystems alike. English ivy has the ability to completely engulf standing trees (Photograph 5) adding weight and increasing risk of failure when exposed to strong winds. This invasive species also has the ability to girdle and inhibit growth of trees, as well as smother the understorey and prevent the growth of native shrubs, herbs, ferns, and regeneration tree seedlings.

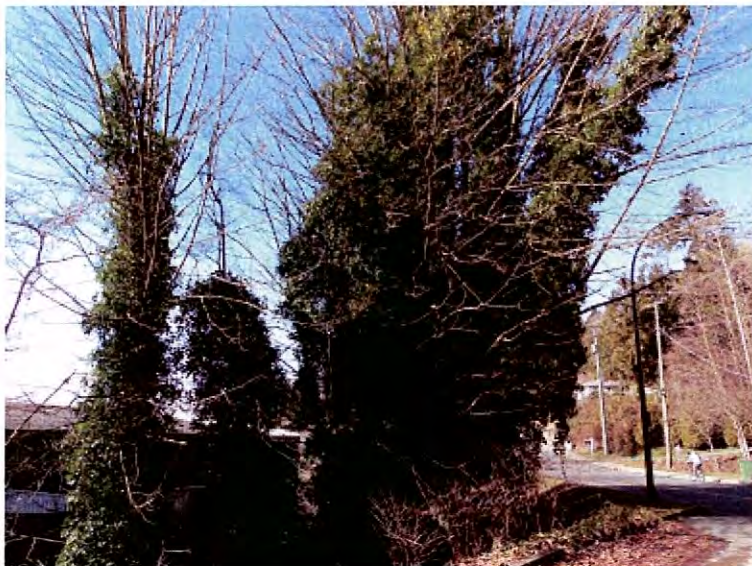
Photograph 5:

Significant populations of English ivy engulfing deciduous trees onsite

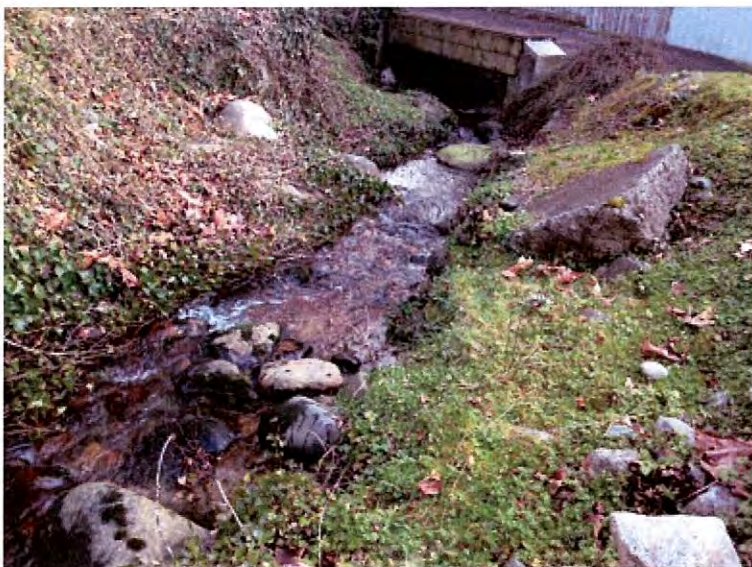
Photograph 6:

Riparian area habitat conditions on the north half of the Site. Facing downstream, east bank on the left, west bank on the right.

The onsite Roche Point Creek riparian area is a narrow vegetated corridor which is confined by the adjacent developments (i.e., pavement, buildings). On the north half of the Site the riparian area is situated next to a single-family home and as a result of this, some modification (e.g., landscaping) has occurred within the riparian area. Here, vegetation is dominated by English ivy on the east bank and non-native grasses (i.e., lawn species) on the west bank (Photograph 6). There were no trees or shrub cover, or woody debris observed within the riparian area on the north half of the Site.

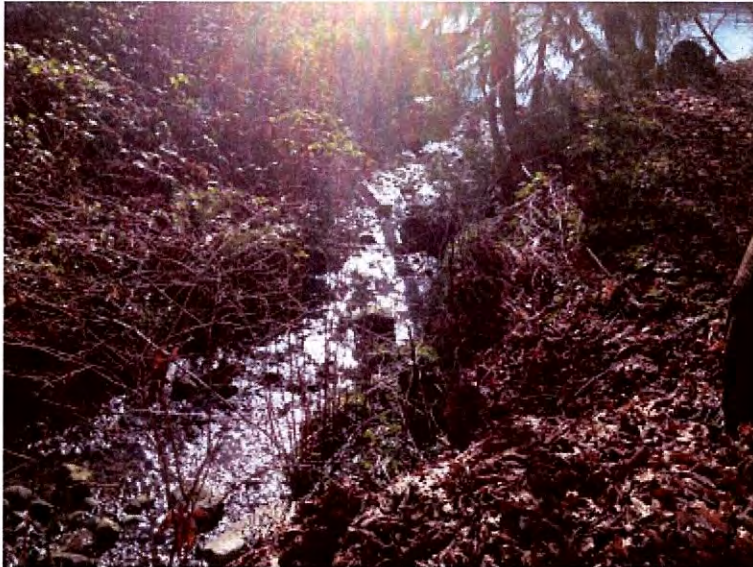
Photograph 7:

Riparian area habitat conditions on the south half of the Site. Facing downstream, east bank on the left, west bank on the right.

On the south half of the Site, the riparian area is less modified relative to the north half of the Site, but is still heavily influenced and confined by adjacent land uses. The riparian area on the south half of the Site exhibits some characteristics of a mixed forest community. The riparian ecology is disturbed and limited to a narrow corridor (Photograph 7). Tree species in the riparian area included western redcedar (*Thuja plicata*), and red alder. The most common native shrub species was salmonberry (*Rubus spectabilis*) but non-native invasive Himalayan blackberry (*Rubus discolor*) was also very prominent. Ground-level vegetation was dominated by English ivy.

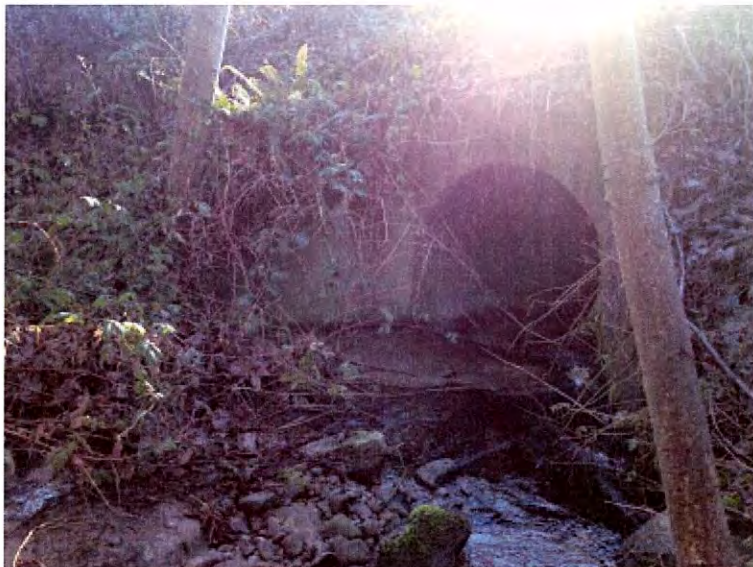
Photograph 8:

Dollarton Highway culvert, facing south towards the Site

Roche Point Creek has been highly modified in the project area by residential and industrial development, and the placement of Dollarton Highway. Immediately upstream of the Site, Roche Point Creek passes through a large concrete culvert underneath Dollarton Highway before entering the Site (Photograph 8). A small waterfall exists at the north end of the Site due to the raised outfall of the concrete culvert.

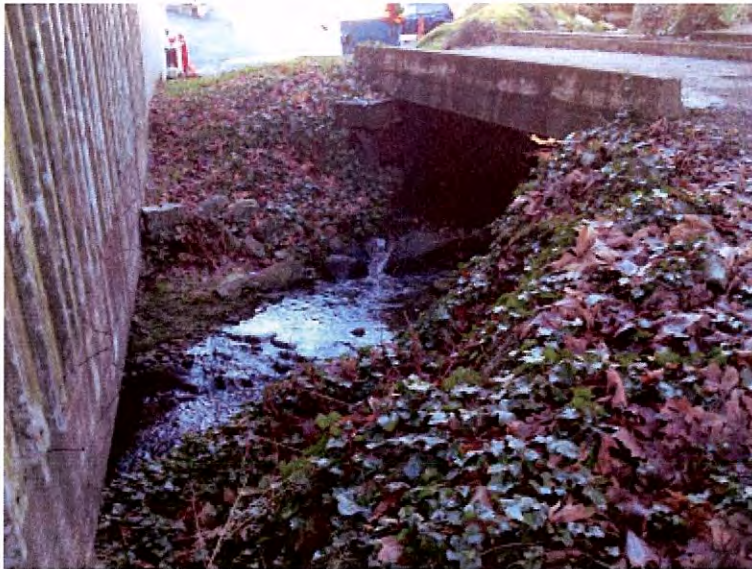
Photograph 9:

Creek channel passing underneath the bridge and building in the centre of the Site.

Roche Point Creek flows south across the Site for approximately 80m before entering Burrard Inlet. In the centre of the Site, the creek channel passes underneath a short vehicle bridge and the northeast corner of a building, before resurfacing at the south end of the Site (Photograph 9).

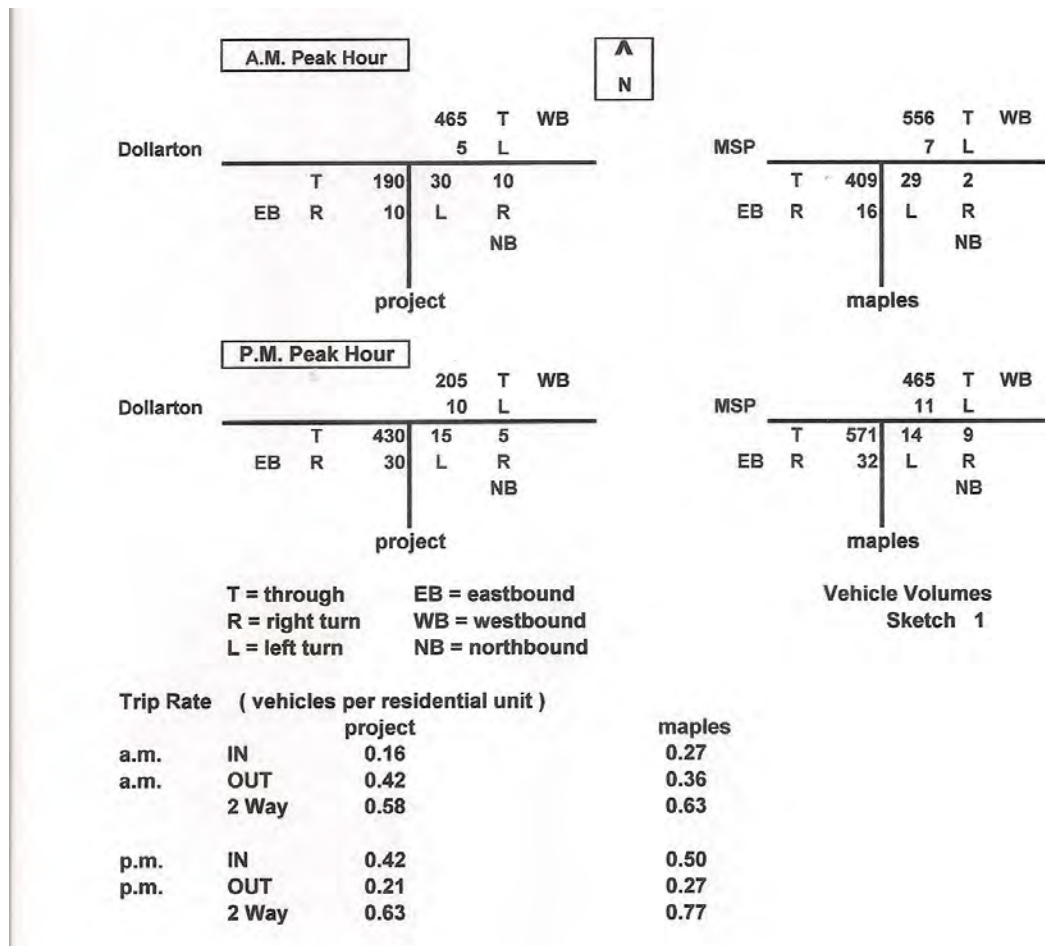
The comparative traffic data is shown below in Sketch 1. Comments about the data are provided also.

At Dollarton / project the EB and WB through are counted volumes while the turning volumes in and out of the project are calculated volumes. At MSP / maples all the volumes shown are counted volumes.

At the public information meeting held June 11, 2013 concerns were expressed by some attendees about traffic getting out of the project onto Dollarton Highway. Subsequently traffic data was collected at a similar location – the Maples development on the south side of the Mt. Seymour Parkway (MSP) just east of the Mt. Seymour Golf and Country Club. The Maples is an 86 unit town house development with a single access driveway onto Mt. Seymour Parkway. The Dollarton project is 15 town houses and 80 apartments.

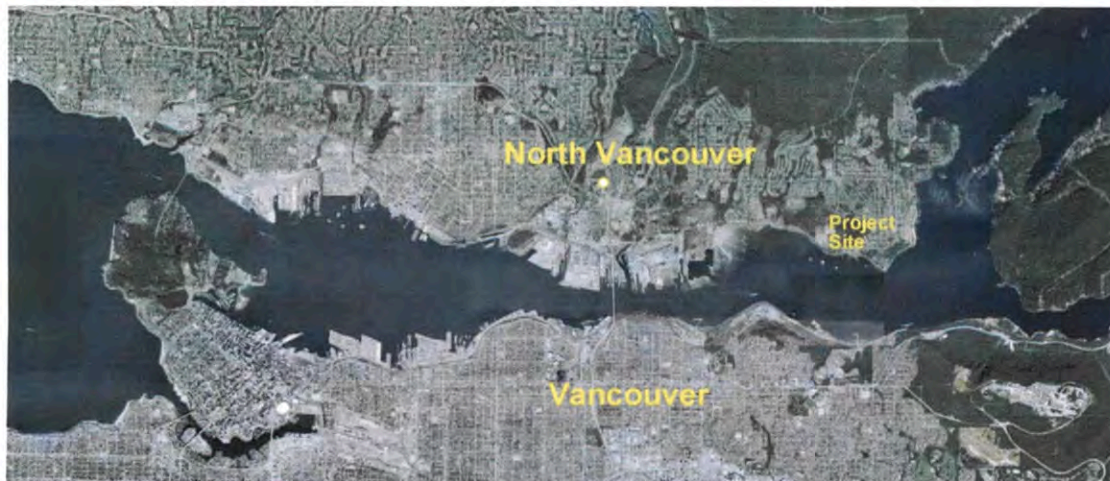
Figure 1: Noble Cove Residential Development Project Site

Polygon Homes Ltd. (Polygon) is in the process of developing the Noble Cove project at 3829 to 3919 Dollarton Highway in the District of North Vancouver. The project is on the north shore of Burrard Inlet adjacent to the west boundary of Cates Park (**Figure 1**) and is planned as 5 two story townhomes - 15 units total - and 3 four storey apartment buildings - an additional 80 units. Northwest Hydraulic Consultants Ltd. (NHC) has been retained to investigate potential coastal impacts to the site (such as flooding and erosion) as well as potential geomorphic effects of the project on adjacent lands and foreshore.

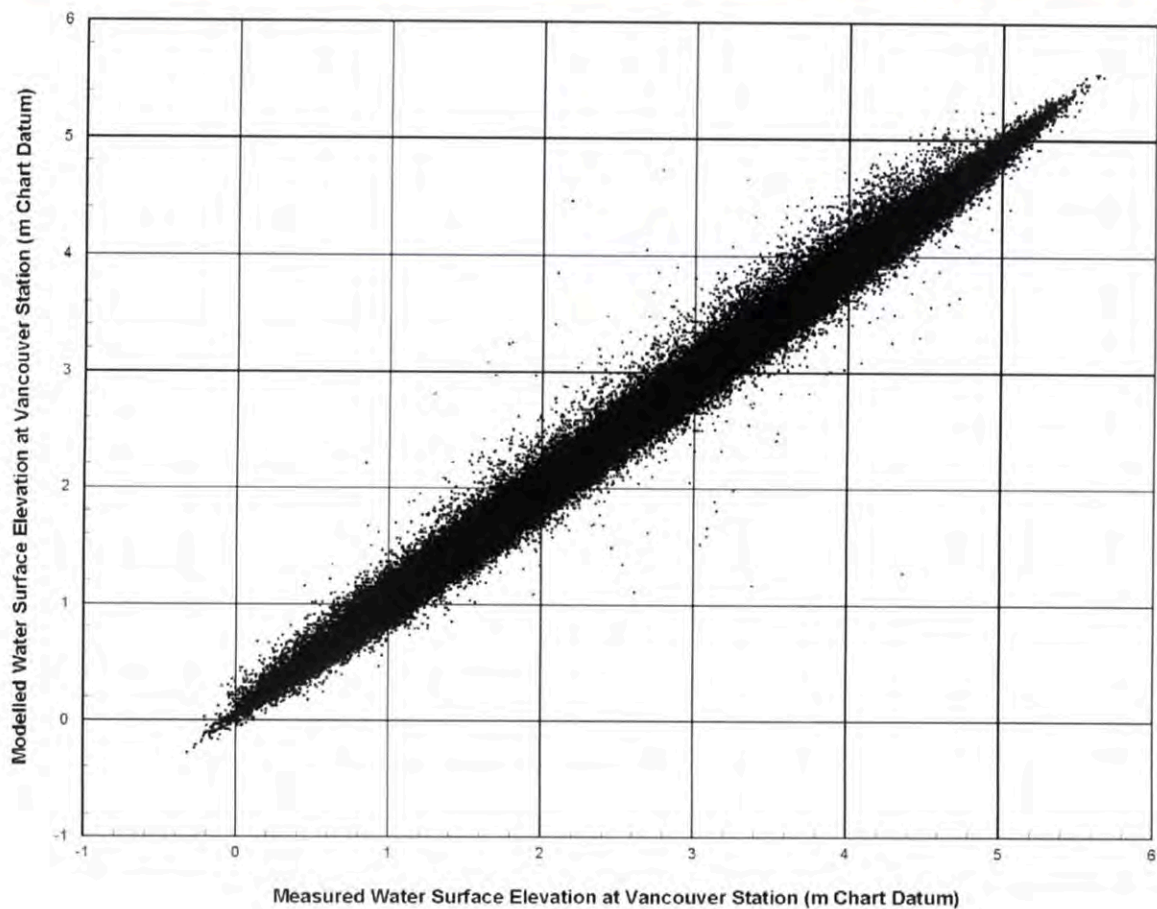
Figure 4: Modelled water surface elevation vs measured water surface elevation at CHS Vancouver Station

The model was simulated from 1953 to 2012 (excluding 1959, 1960 and 1961). The modelled water levels near the Canadian Hydrographic Service Vancouver Station (Station ID 7735) located inside Burrard Inlet were extracted and compared with the observed data (**Figure 4**). The mean difference between the modelled and observed water levels is 3 cm and the standard deviation is about 8 cm. Hourly hindcast water level at the project site was archived for the FCL analysis (**Section 3.4**).

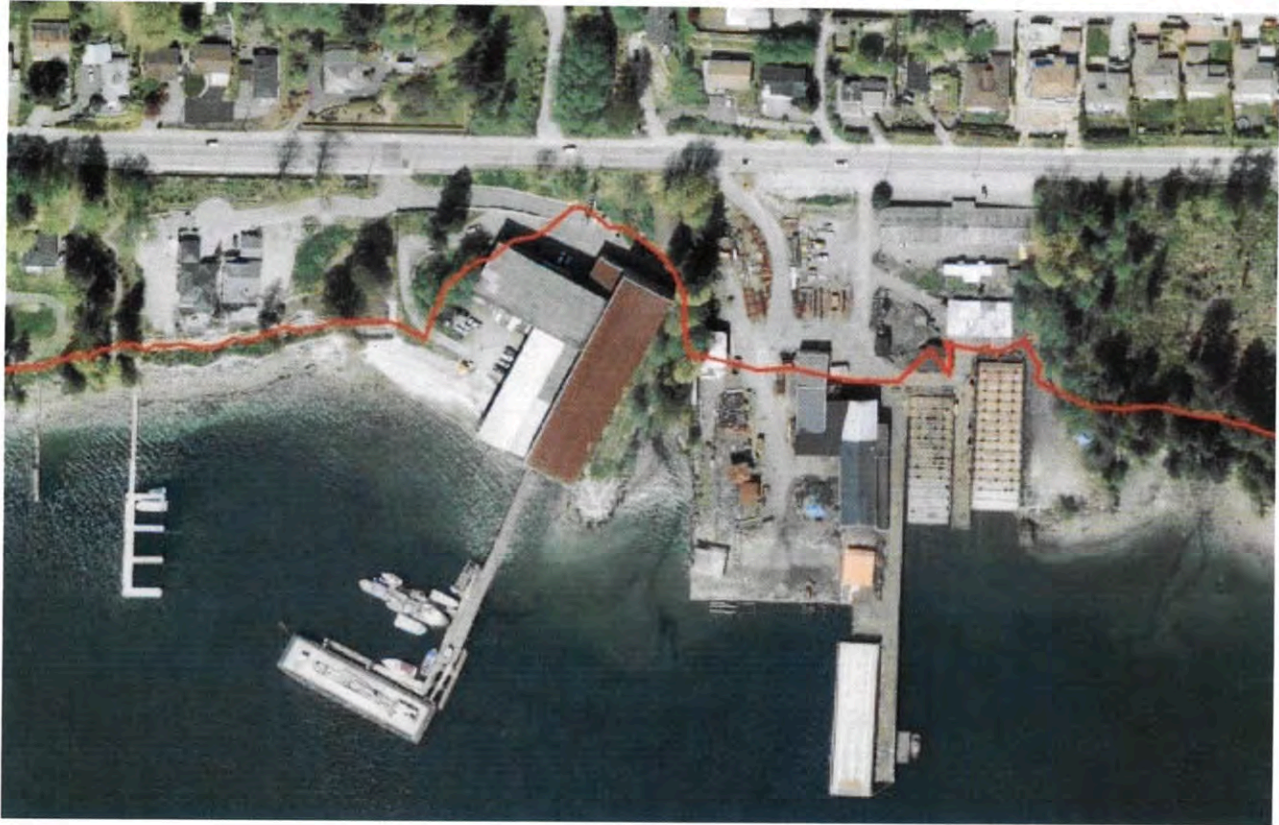
Figure 6: Approximation of coastal FCL of 5.3 m for current site geometry

The following figure (**Figure 6**) presents an approximation of the projection of the year 2100 FCL for the project site based on present site geography, that is the 5.3 m GD contour.

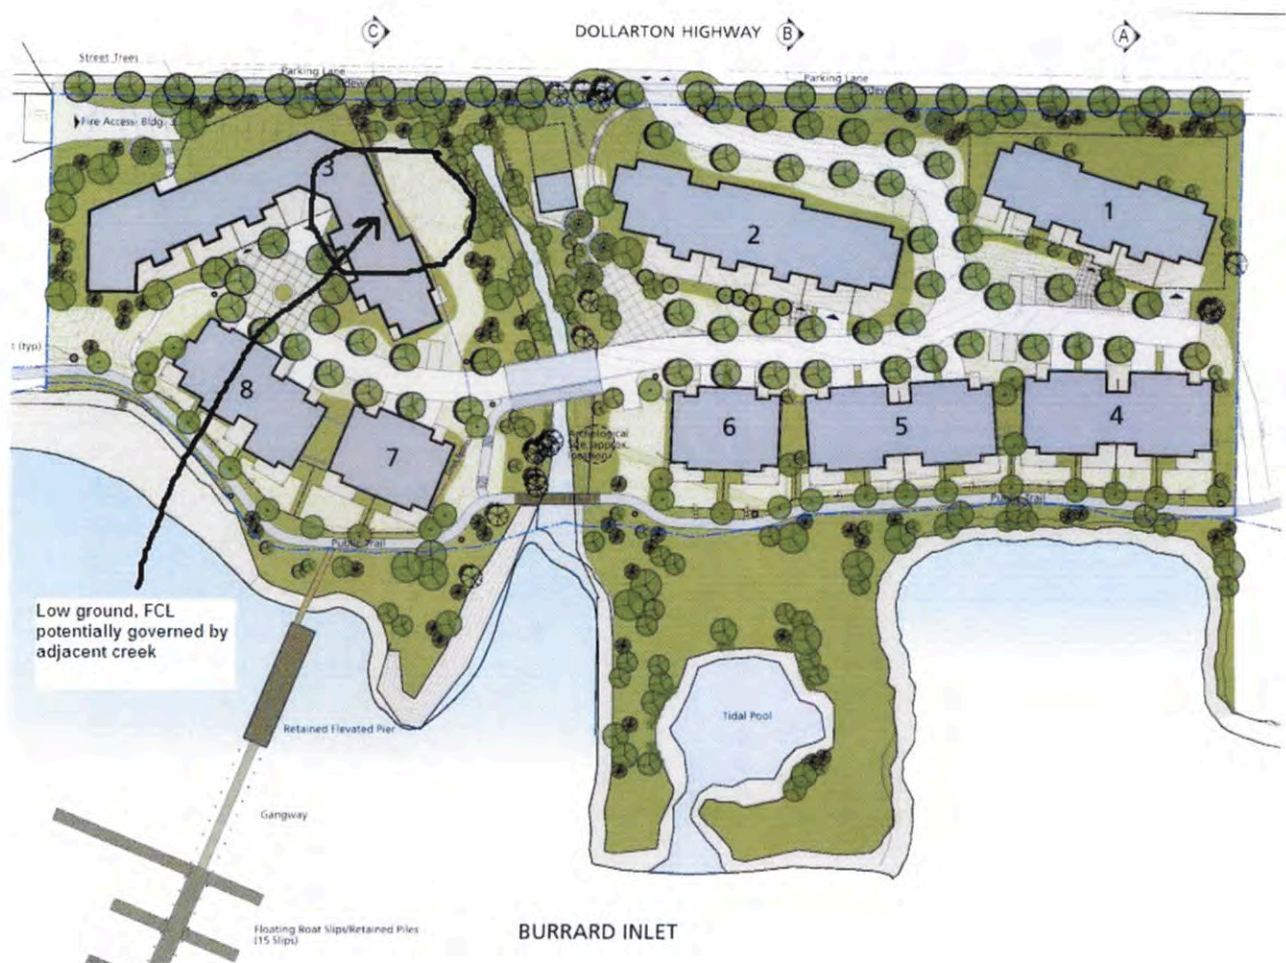
Figure 7: Location of low ground adjacent to creek

The existing ground is lower than the adjacent creek along the right bank of the creek that crosses the centre of the property (**Figure 7** and **Photo 9**). This should be filled or the creek embankment improved or further assessed to prevent overbank flow from the creek (more likely originating from seepage than embankment failure). As shown in **Figure 6** the coastal FCL appears to extend through this low lying portion of the property as well. The steep gradient of the creek and relatively small flow negates any need to investigate simultaneous occurrence of high coastal water levels and high creek flows, such condition associated with a similar probability would not govern the FCL.

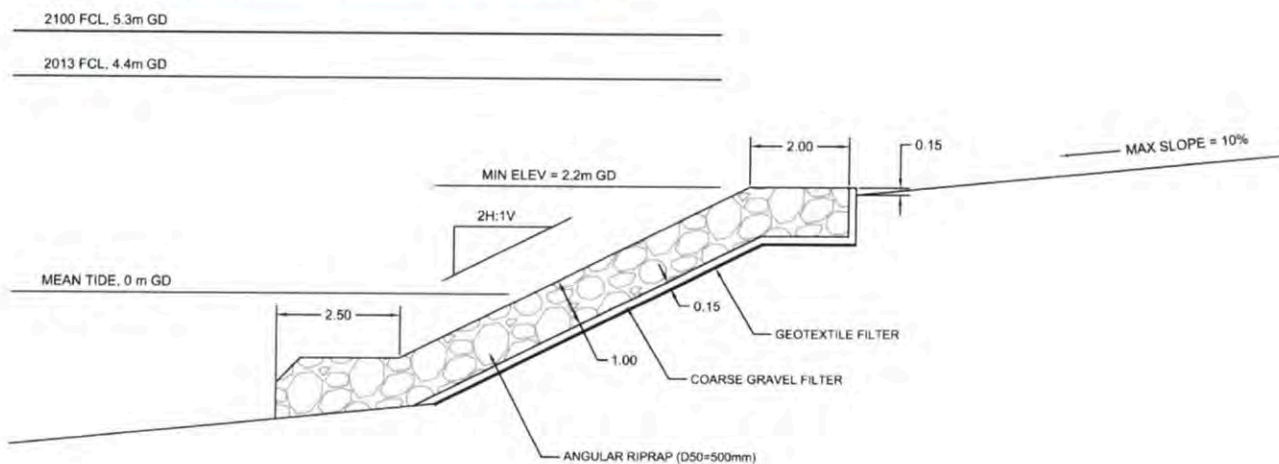
Figure 12: Typical section of coastal bank armouring

Figure 12 provides a sketch of typical shoreline bank armouring. Habitat benches are often incorporated in armoured banks to provide local aquatic habitat compensation. The design should be refined and further detailed as survey data is available for the intertidal zone, habitat benching requirements are defined (elevation, width, soil thickness), and proposed shoreline profile is known.

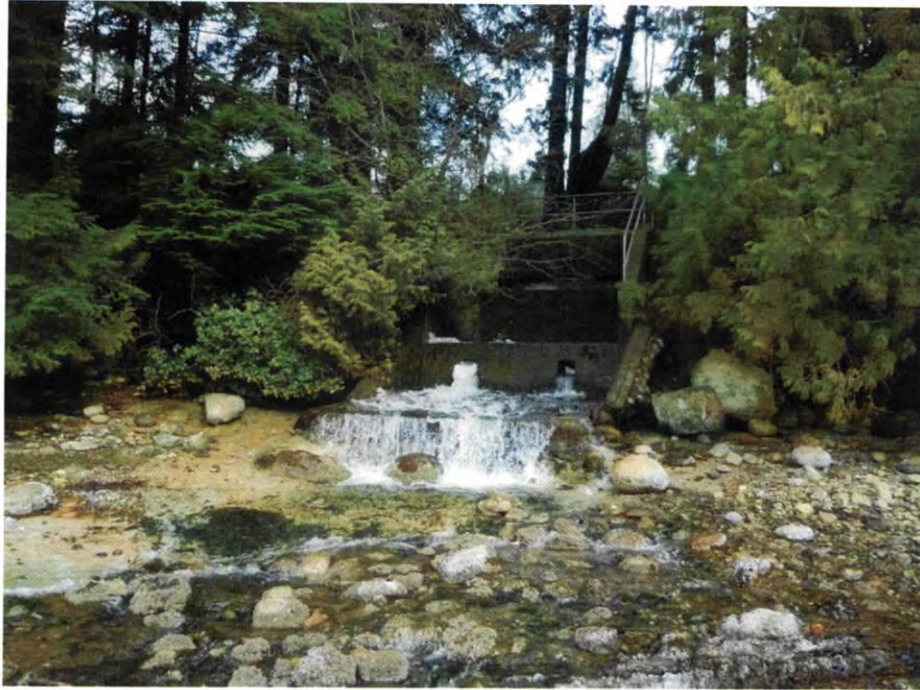
Photo 8: Upstream view of creek near east side of property

A small creek runs through Cates Park near the east boundary of the project discharging to Burrard Inlet through a concrete orifice and weir fish ladder (**Photo 8**). A second slightly larger creek bisects the property with the east side of the property noticeably higher in elevation than the west. This creek flows under Dollarton Highway through a 1.8 m diameter corrugated metal pipe (CMP) culvert - perched about one-half metre above the grade of the downstream channel bed, creating a small plunge pool. The downstream channel is entrenched within steep banks composed of boulders, waste concrete slabs, and well vegetated earth. A local resident stated they had never observed the creek flooding outside its banks. This statement and current condition of the channel

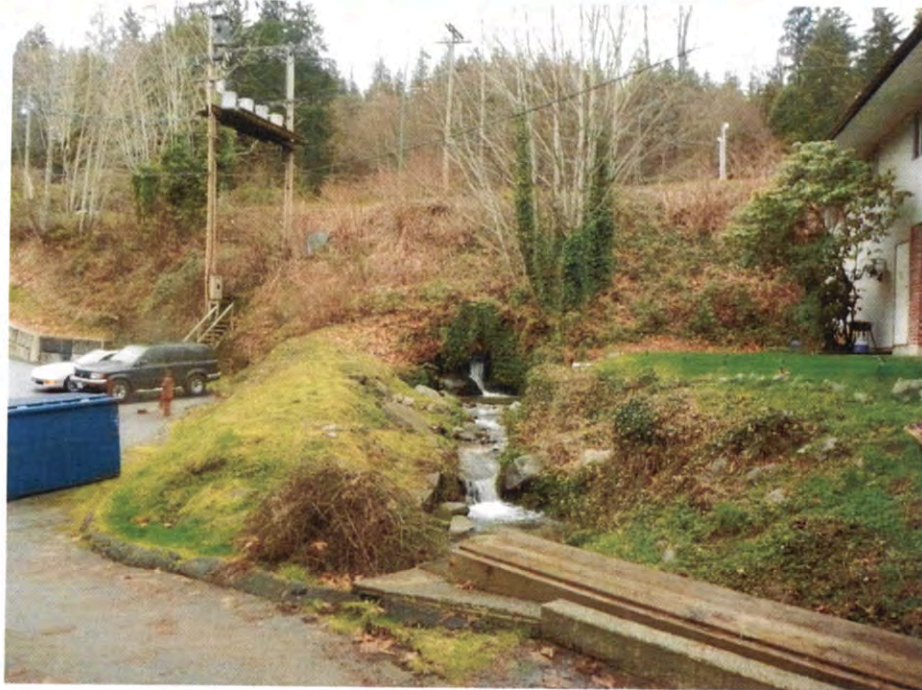
Photo 9: Upstream view of creek near centre of property, view towards Dollarton Hwy crossing

suggests the banks are relatively stable and not frequently inundated. However, the earth embankment forming the right bank (facing downstream) is steep, narrow, and potentially maintains the channel above the adjacent ground (**Photo 9**).

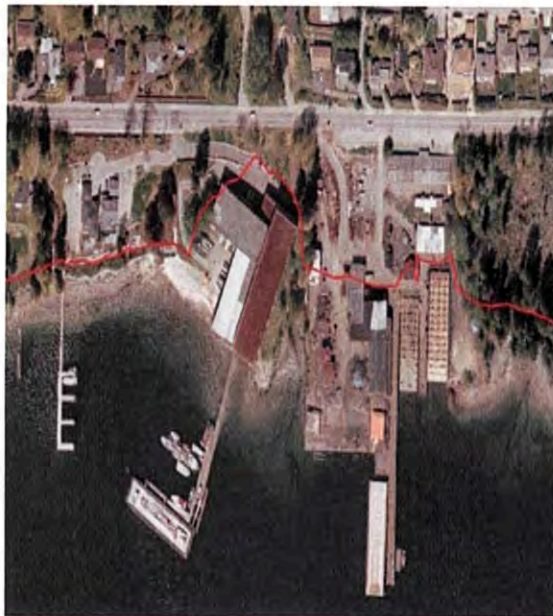
Picture 2- Approximation of coastal FCL of 5.3 m for current site geometry - from NHC

Further to flooding hazards posed by the creek the site is subject to flood hazards posed by the sea. NHC have proposed a FCL of 5.3 m geodetic for the whole site. The approximate current location of the 5.3 m contour can be seen in Picture 2 from NHC below. For the majority of the site the 5.3 m FCL is the governing design criteria as it is generally higher than 1.0 m above the creek bed. NHC have identified a specific area to the west of the creek where particular attention should be paid to FCL in relation to the creek bed elevation. Here the existing ground is above 5.3 m geodetic but less than 1.0 m above the adjacent creek bed. See Figure 2 below and Picture 4 on page 4.

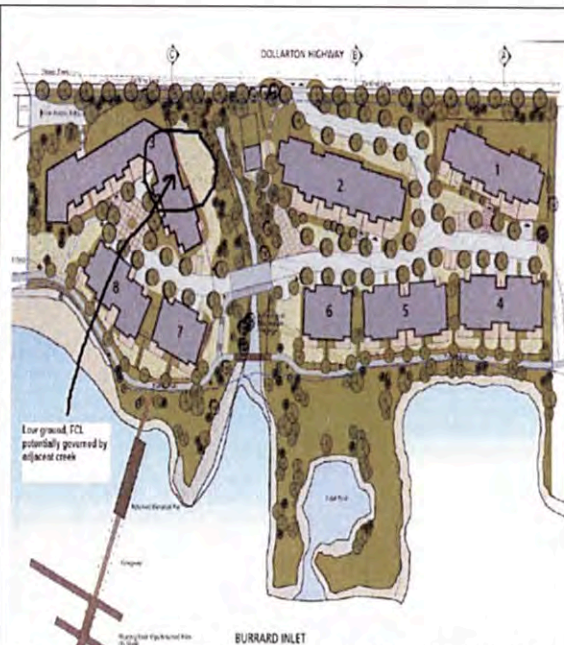
Figure 2- Location of low ground adjacent to creek - from NHC

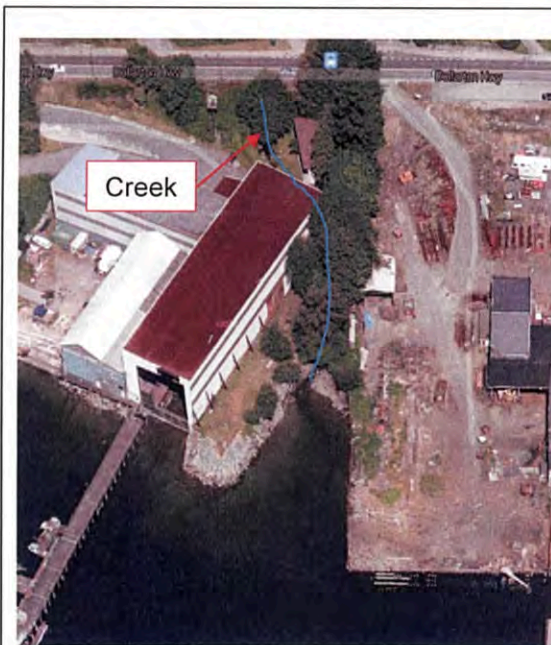
Picture 3-Creek location

Upstream of the subject property Roche Point Creek flows in its natural state, in a large forested gully. The creek flows under Dollarton Highway and enters the site via a 1.8 m diameter corrugated metal pipe (CMP) culvert. The culvert is perched above the creek bed creating a small plunge pool at the culvert outlet. From the culvert the creek flows in an open channel for roughly 20 m. The channel banks are steep and well defined with boulders, waste concrete and well vegetated soil. See Picture 3 and Picture 4 below. Downstream of the open channel the creek flows under a concrete deck before discharging to the Burrard Inlet.
