The District of North Vancouver REPORT TO COUNCIL

March 20, 2014
File: 3060-20/28.13

SUBJECT: **BYLAWS 8024 AND 8025 – OCP AMENDMENT AND REZONING FOR A MIXED APARTMENT/TOWNHOUSE PROJECT AT 3829/3919 DOLLARTON HIGHWAY**

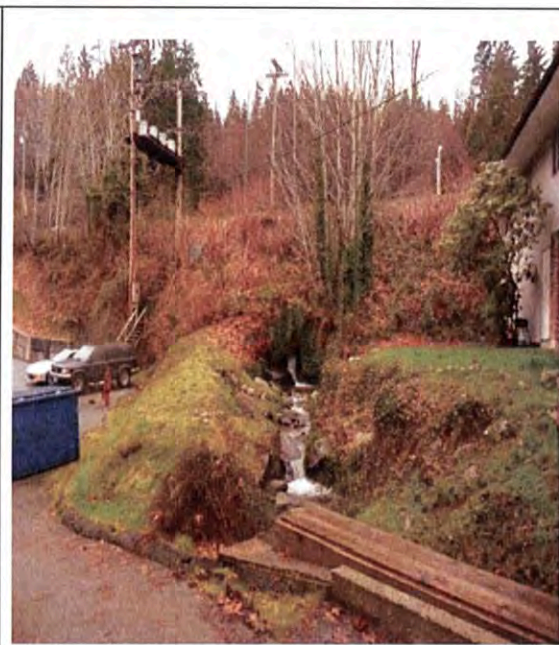
Picture 4- Upstream view of Roche Creek - from NHC
note: low area to the left

Further to flooding hazards posed by the creek the site is subject to flood hazards posed by the sea. NHC have proposed a FCL of 5.3 m geodetic for the whole site. The approximate current location of the 5.3 m contour can be seen in Picture 2 from NHC below. For the majority of the site the 5.3 m FCL is the governing design criteria as it is generally higher than 1.0 m above the creek bed. NHC have identified a specific area to the west of the creek where particular attention should be paid to FCL in relation to the creek bed elevation. Here the existing ground is above 5.3 m geodetic but less than 1.0 m above the adjacent creek bed. See Figure 2 below and Picture 4 on page 4.

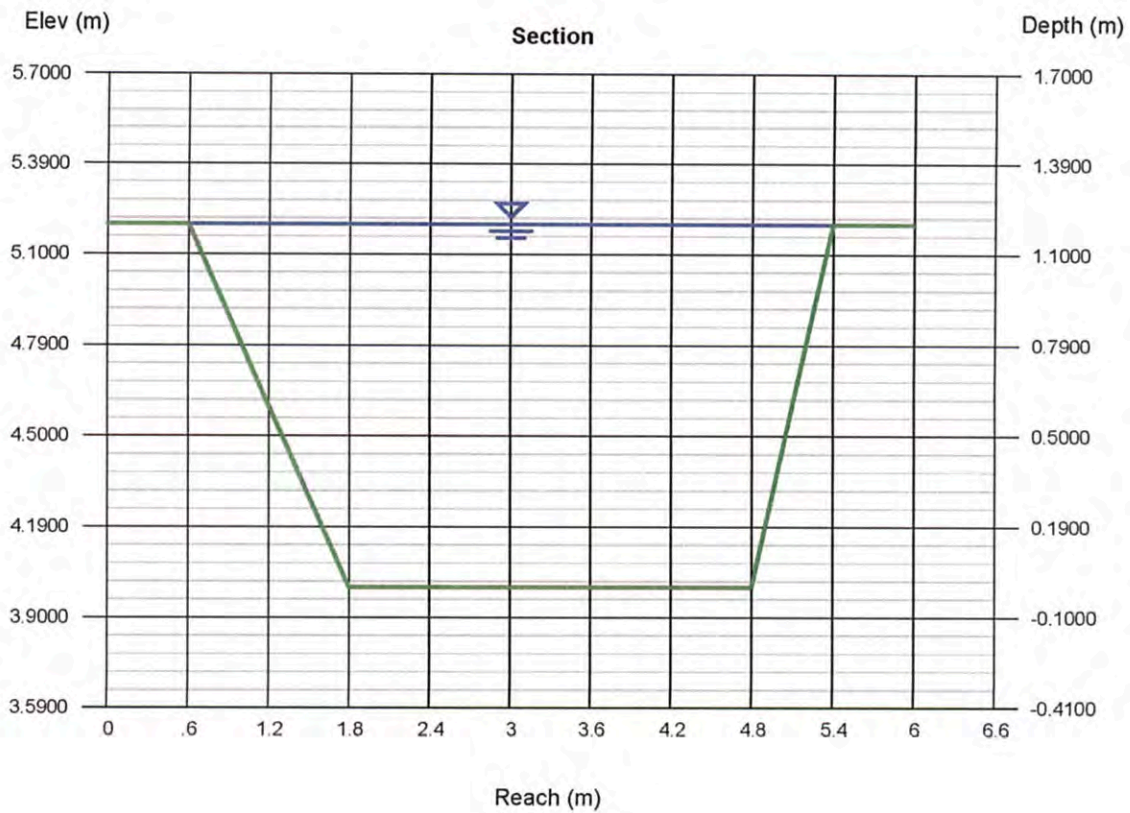
FIGURE 2: EXISTING CHANNEL – DESIGN STORM

Depth (m) = 1.2000
Q (cms) = 30
Area (sqm) = 4.6800
Velocity (m/s) = 6.4771
Wetted Perim (m) = 6.0387
Crit Depth, Yc (m) = 1.2000
Top Width (m) = 4.8000
EGL (m) = 3.3399

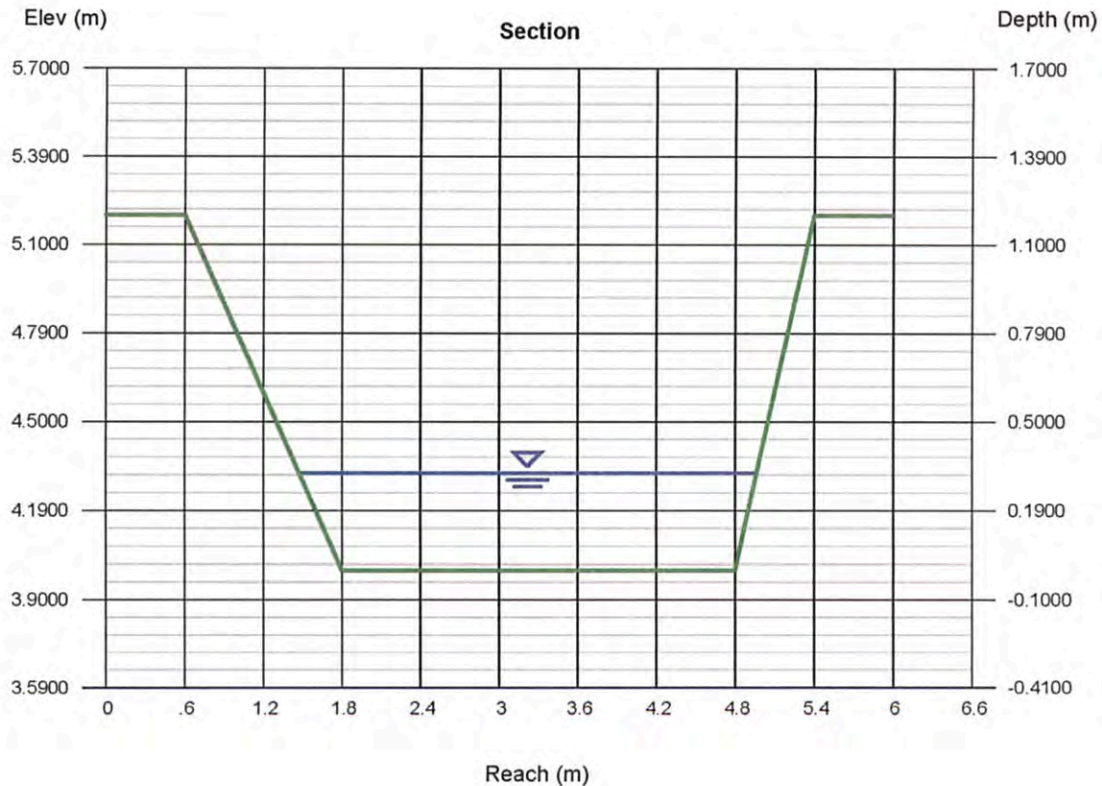
FIGURE 3/4: PROPOSED CHANNEL

Depth (m) = 0.3261
Q (cms) = 3.4000
Area (sqm) = 1.0582
Velocity (m/s) = 3.2130
Wetted Perim (m) = 3.8259
Crit Depth, Yc (m) = 0.4877
Top Width (m) = 3.4892
EGL (m) = 0.8527

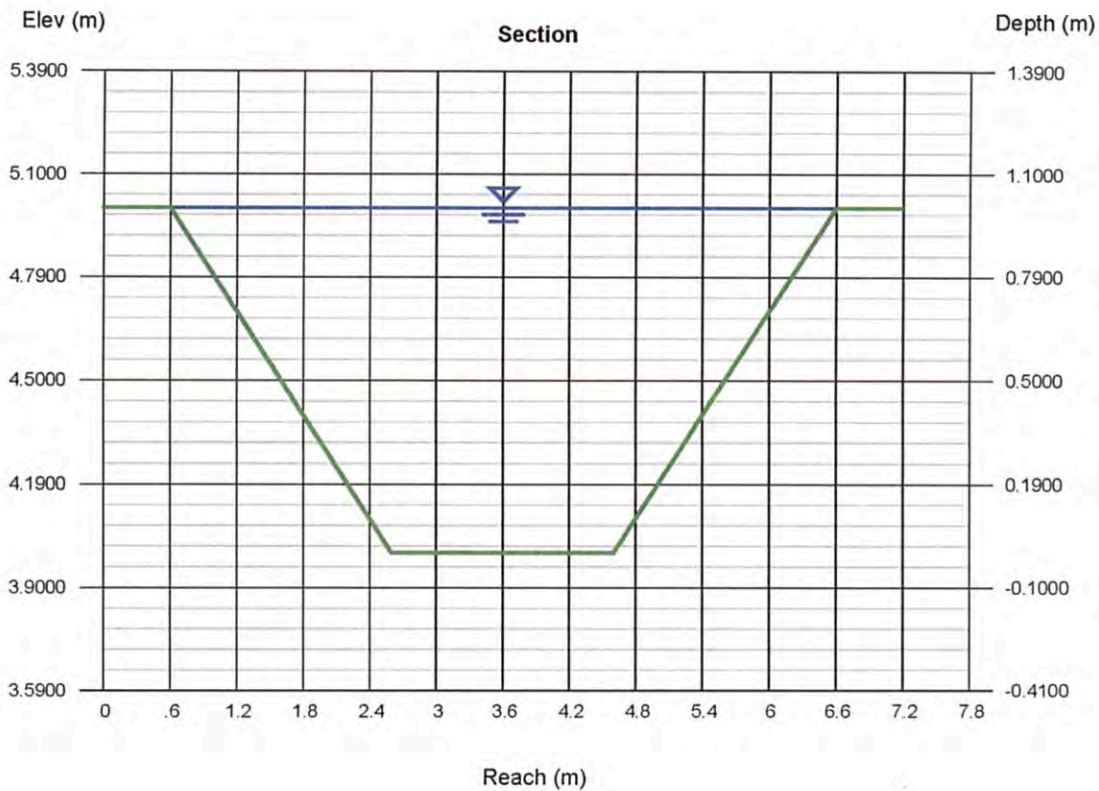
FIGURE 6: PROPOSED CHANNEL - DESIGN STORM

Depth (m) = 1.0000
Q (cms) = 22.2782
Area (sqm) = 4.0000
Velocity (m/s) = 5.5695
Wetted Perim (m) = 6.4721
Crit Depth, Yc (m) = 1.0000
Top Width (m) = 6.0000
EGL (m) = 2.5822

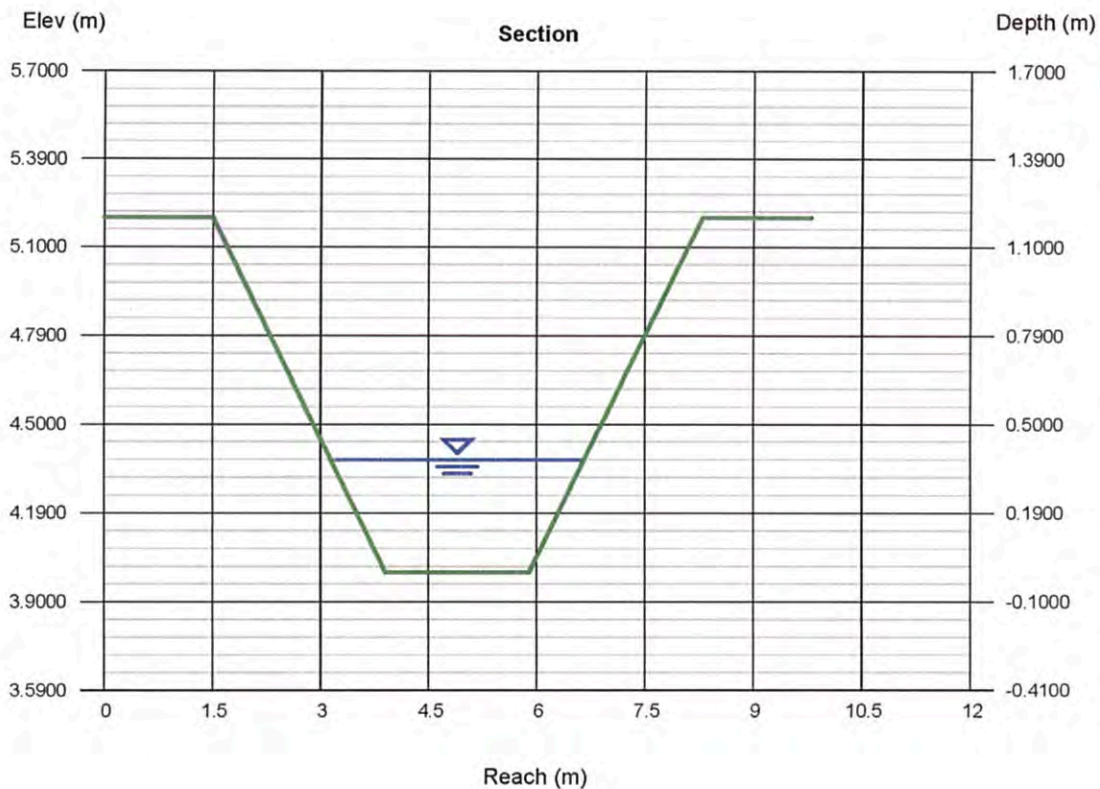
Depth (m) = 0.3780
Q (cms) = 3.4000
Area (sqm) = 1.0416
Velocity (m/s) = 3.2642
Wetted Perim (m) = 3.6903
Crit Depth, Yc (m) = 0.5517
Top Width (m) = 3.5118
EGL (m) = 0.9214

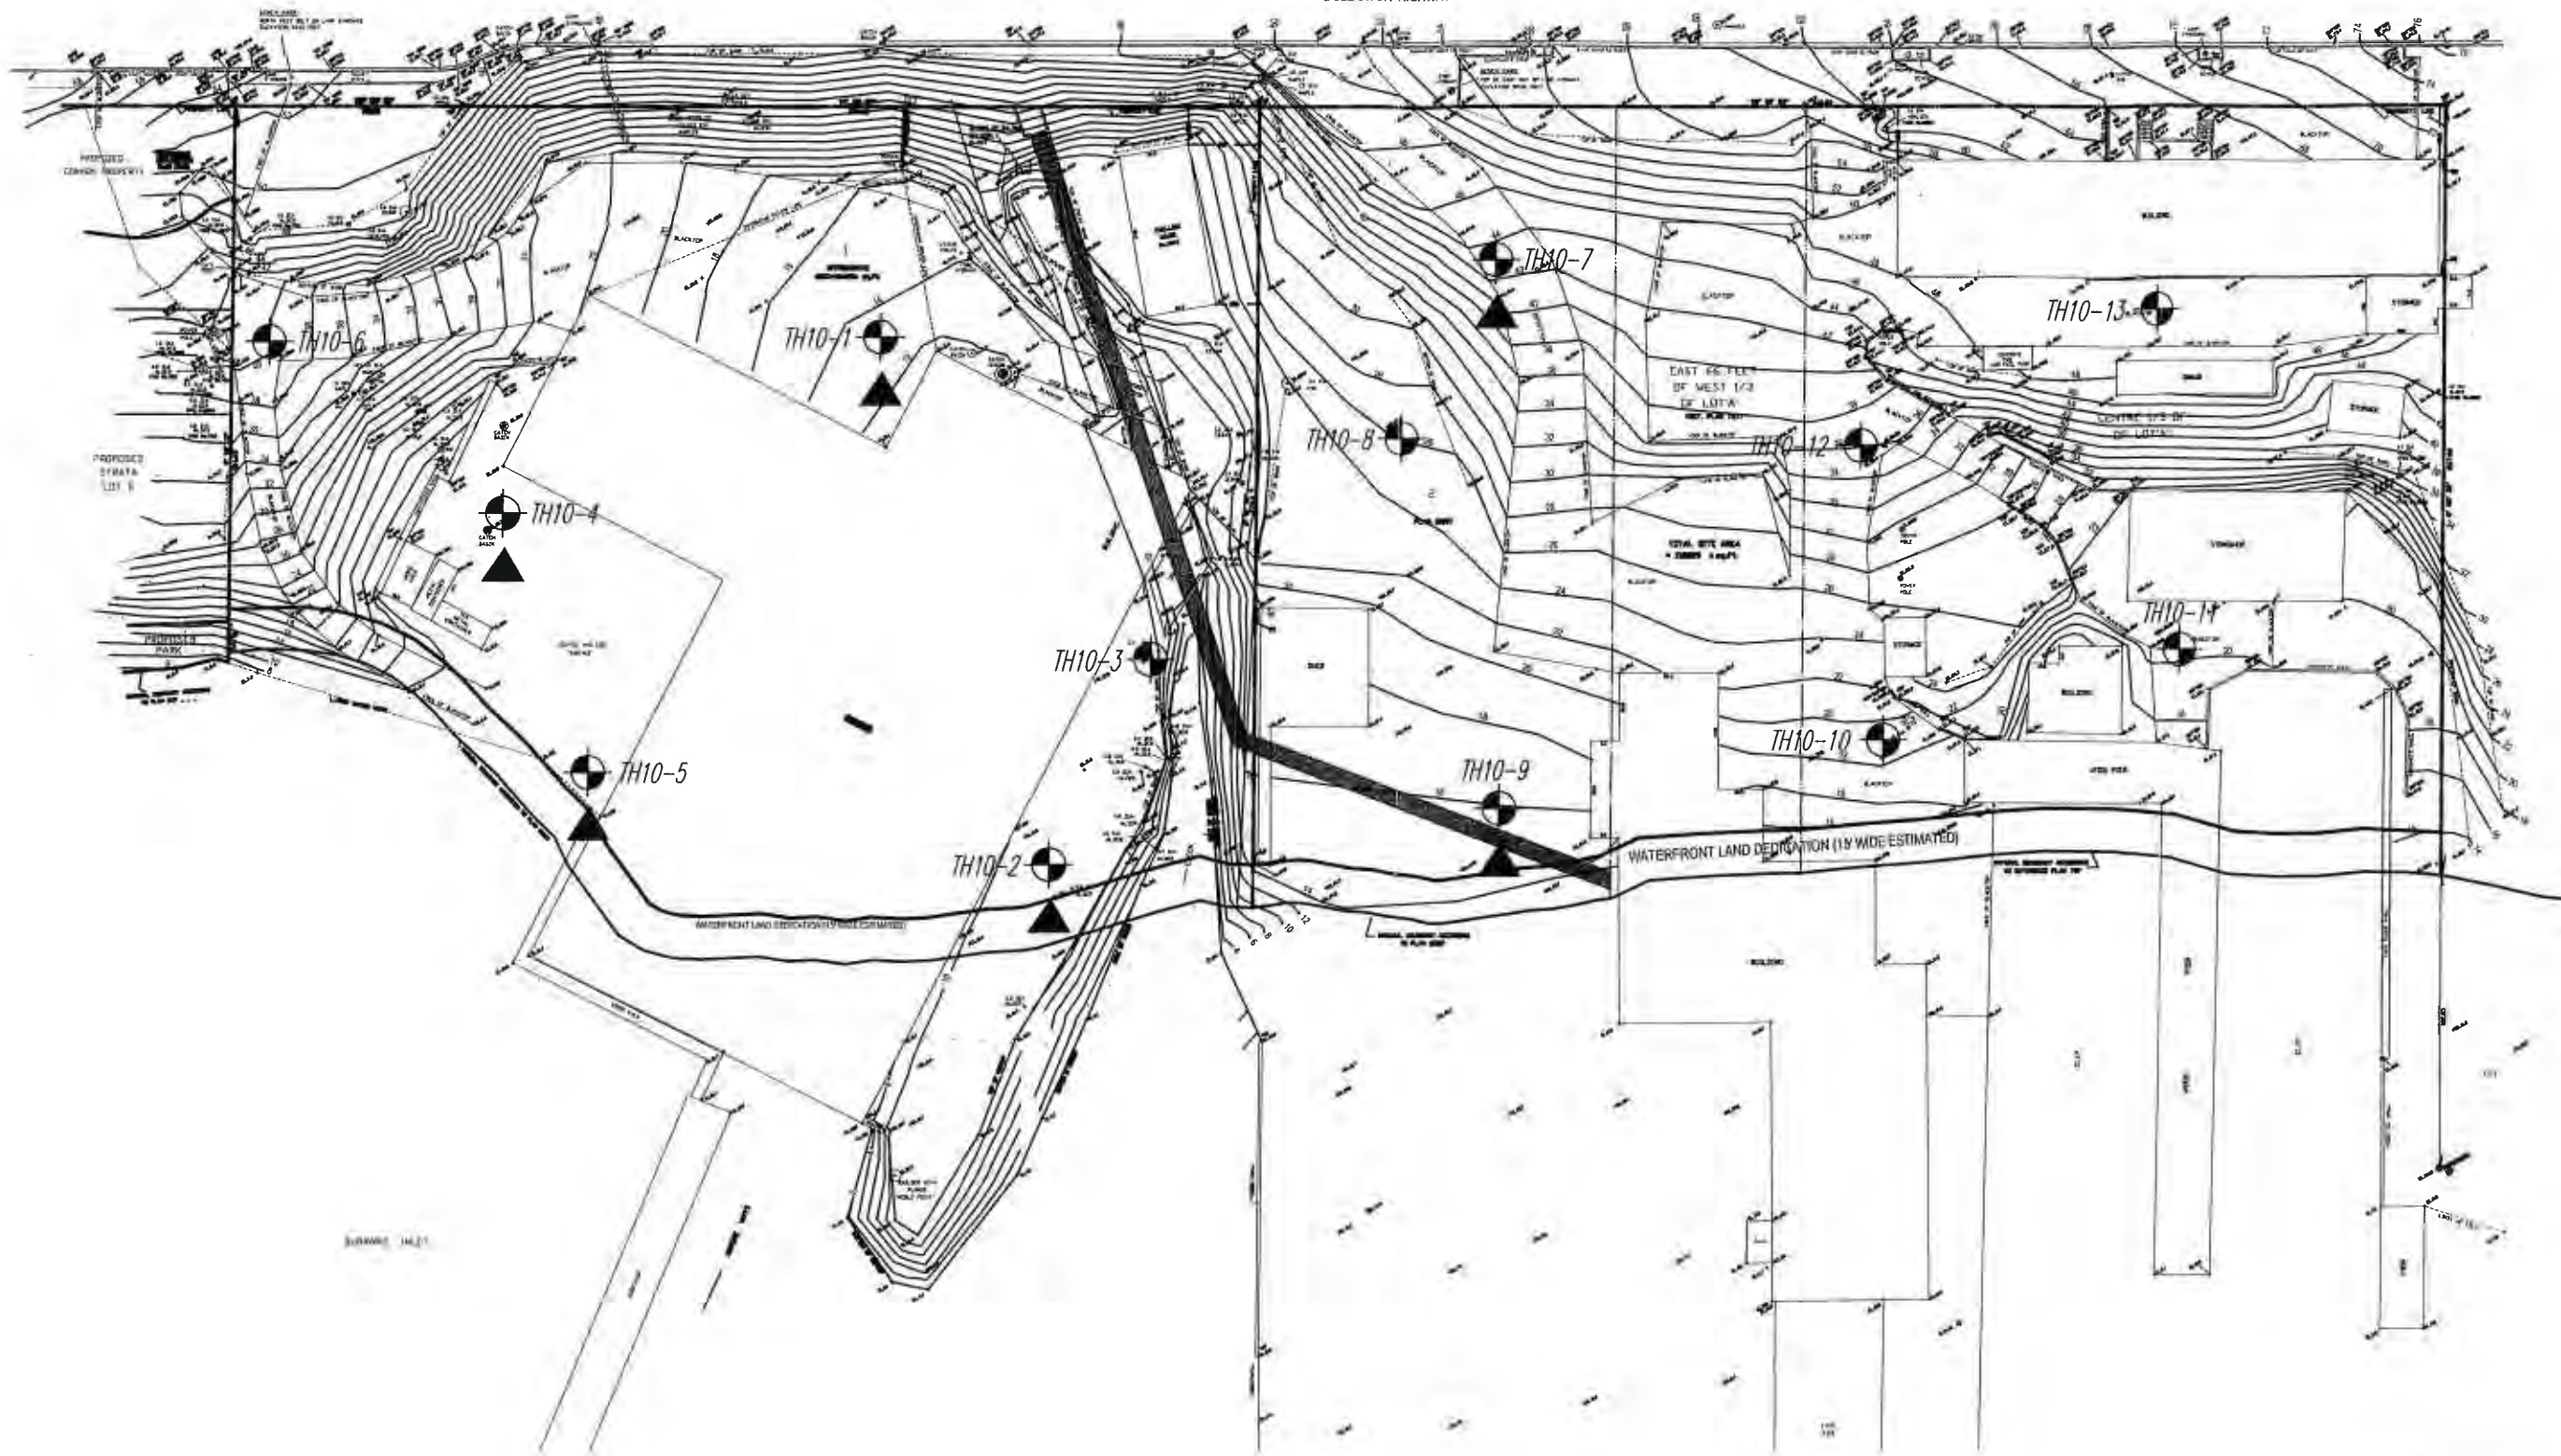
DOLLARTON HIGHWAY

- TH-# TEST HOLE LOCATION (TH)
DCPT # DYNAMIC CONE PENETRATION TEST

The site is presently improved with a number of industrial buildings and infrastructure related to a shipyard that operated on the site. Some stockpiles of metals and debris were noted on the property. The site has some minor vegetation along the steeper slopes adjacent to Dollarton Highway and the central creek channel. The location of the site, the existing topography and buildings are shown on the attached plan, Drawing 9170-1.
