February 11, 2022

**Re: Tantalus Resort Lodge – 4200 Whistler Way, Whistler  
Garage, Roof, and Siding Evaluation - DRAFT**

Sense's Project No. 22vR006A

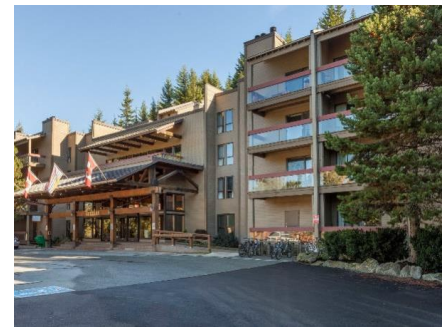
*Photo 1: General Photo of Tantalus Resort Lodge*
