1041 Firbirn Rd, Roberts Creek, BC December 4, 2017

Report No. 1159

www.truestarhomeinspections.com

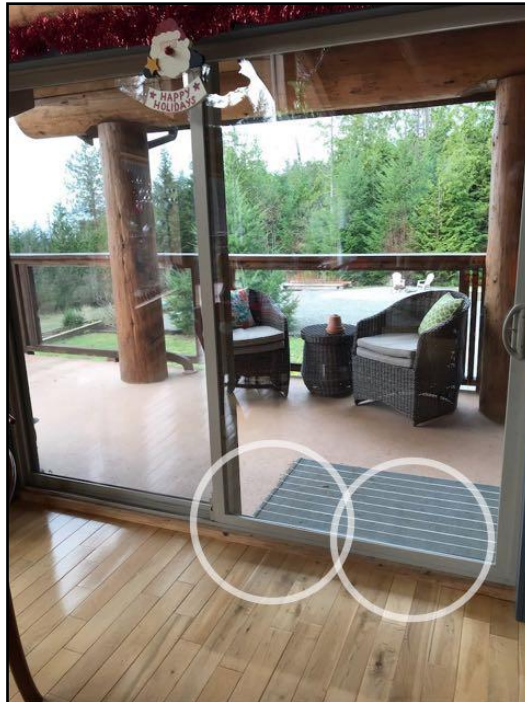
- Inspected
- Large slider stiff but operable

164. Inspected
