10530.0000
Southpoint Ridge
15-mth & 2-yr Warranty Review

Regarding: **15-mth & 2-yr Warranty Review**

Method Engineering and Building Services Ltd. (METHOD) was retained by Strata Plan EPS 5294 to complete a review related to the 15-month and 2-year warranty at phase 1-3 of the Southpoint Ridge Townhouses in Langford, BC.

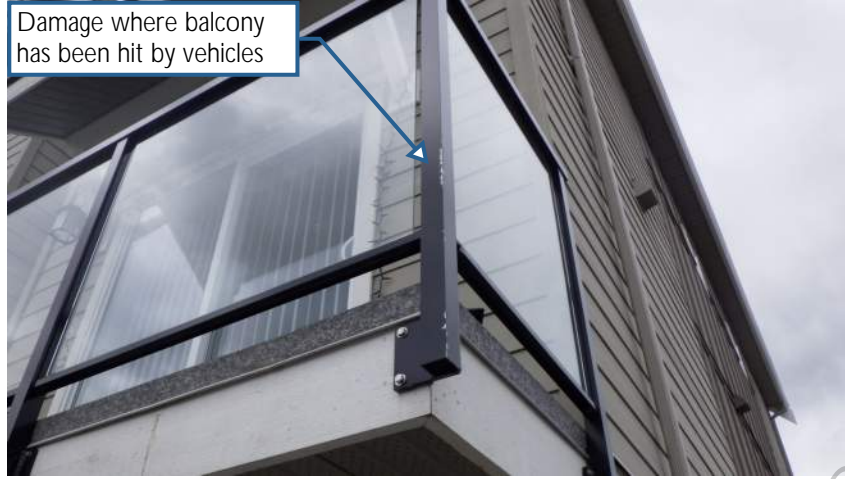
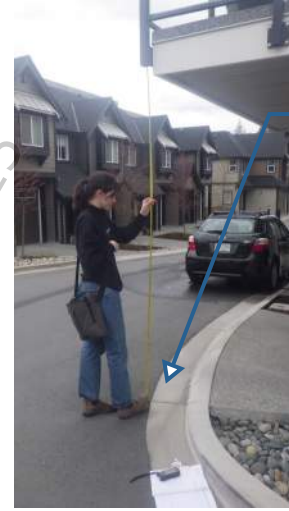
Item ID	Location	Policy Number	Photo Sequence	Observations
A01 - A	Unit 1223 Balcony	80250933	OBS A01-01 to OBS A01-02	<ul style="list-style-type: none"> Balcony overhangs the common property road and has been hit by vehicles on several occasions. This condition has caused damage to balcony guardrails and presents the risk of damage to the balcony structure. Photo OBS A01-02 illustrates the extent that the balcony overhangs the road below. This condition is not a building code issue. It is however, a safety concern. We recommend modifications are considered and implemented to eliminate future risk.
A02 - A	Unit 1223	80250933	OBS A02-01	<ul style="list-style-type: none"> Inconsistent paint finish at metal flashing. This is a cosmetic workmanship item and not a performance concern.
A03 - A	Unit 1223	80250933	OBS A03-01 to OBS A03-02	<ul style="list-style-type: none"> Surface damage or discolouration on pre-finished cement board siding. This is a cosmetic workmanship item and not a performance concern.

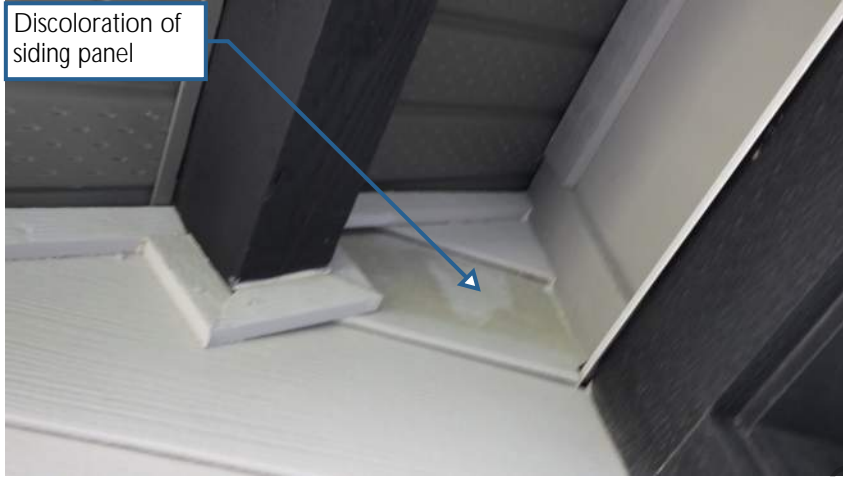
OBS A03-02

Discoloration of siding panel

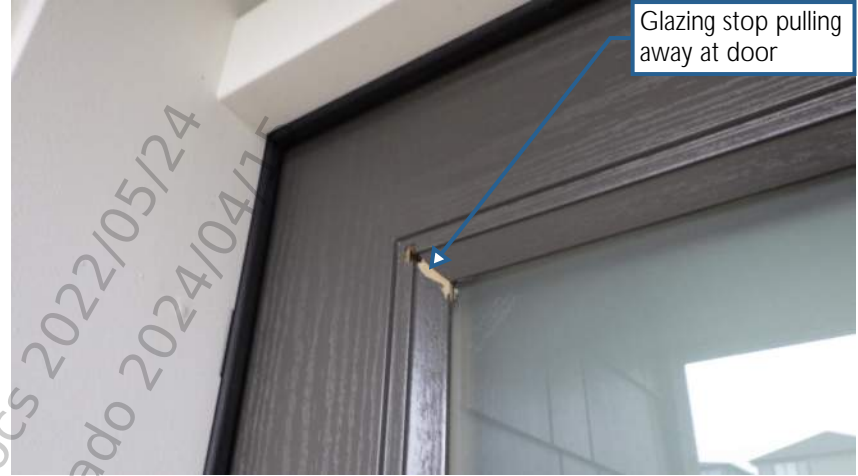
OBS A08-01

Glazing stop pulling away at door

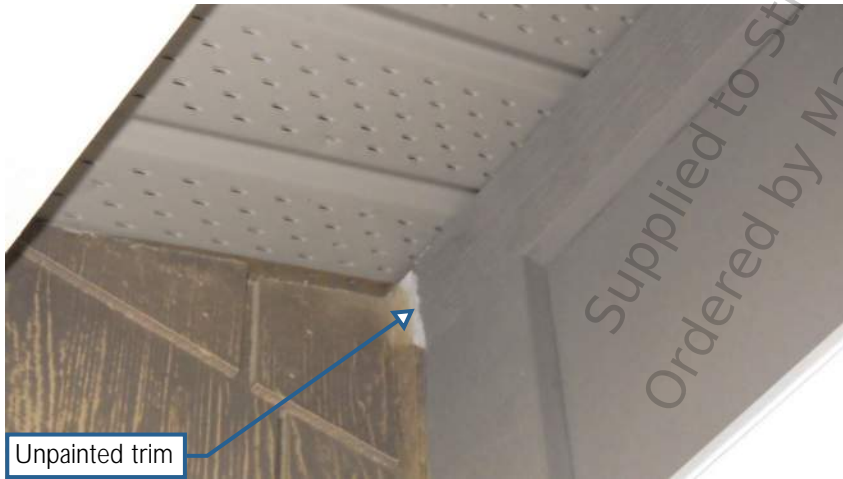
OBS A09-01

Unpainted trim

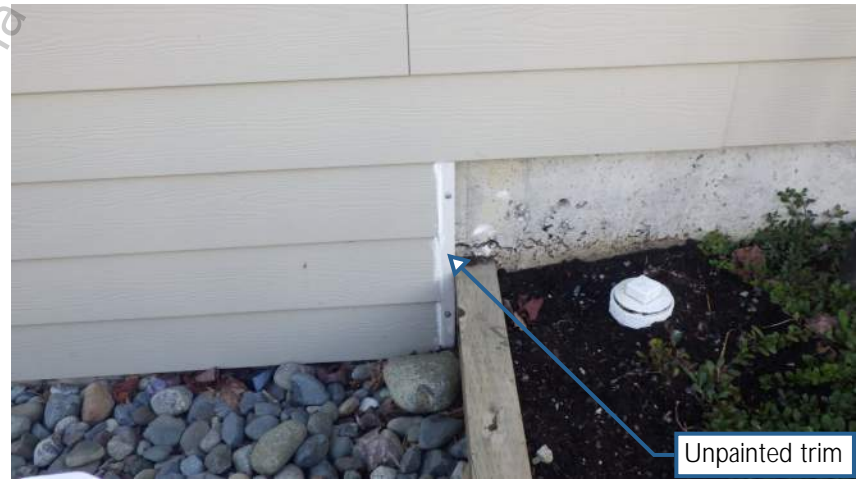
OBS A09-02

Unpainted trim

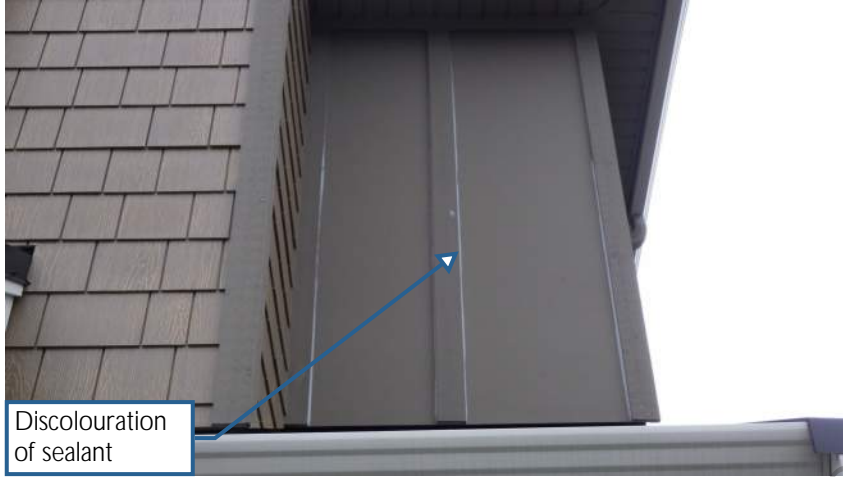
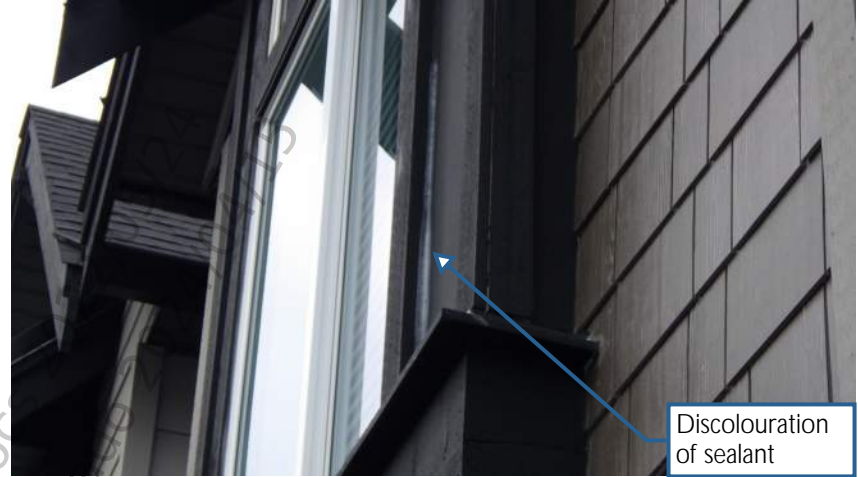
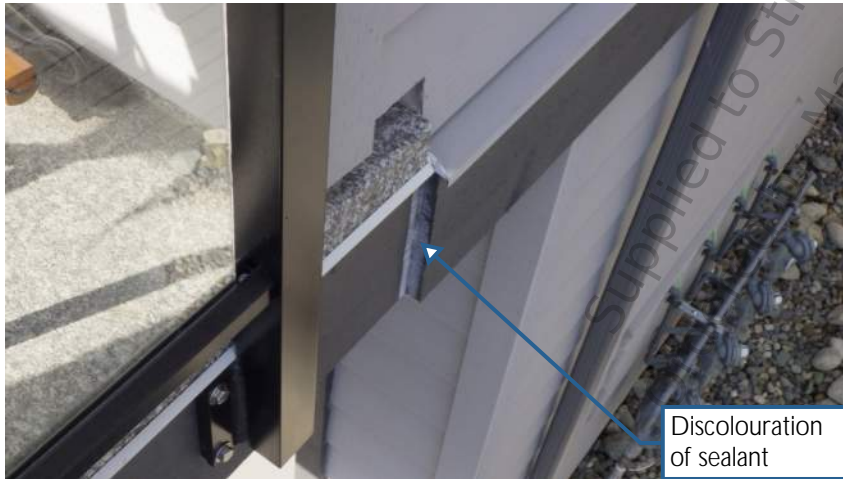
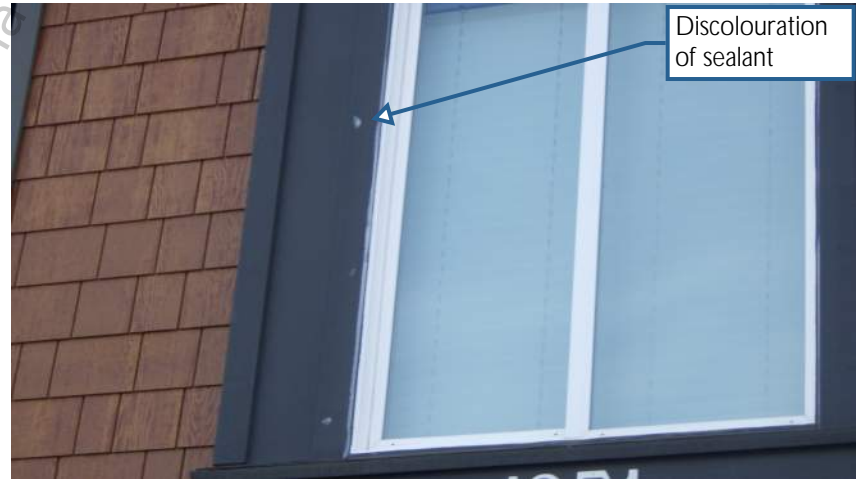
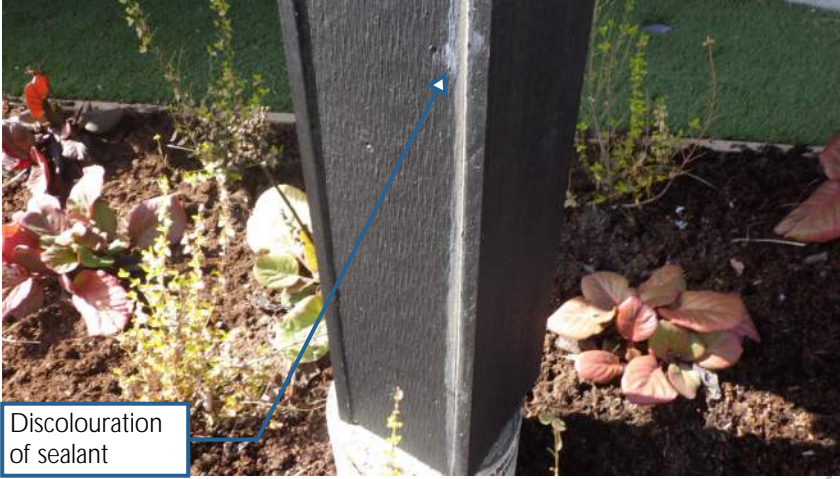
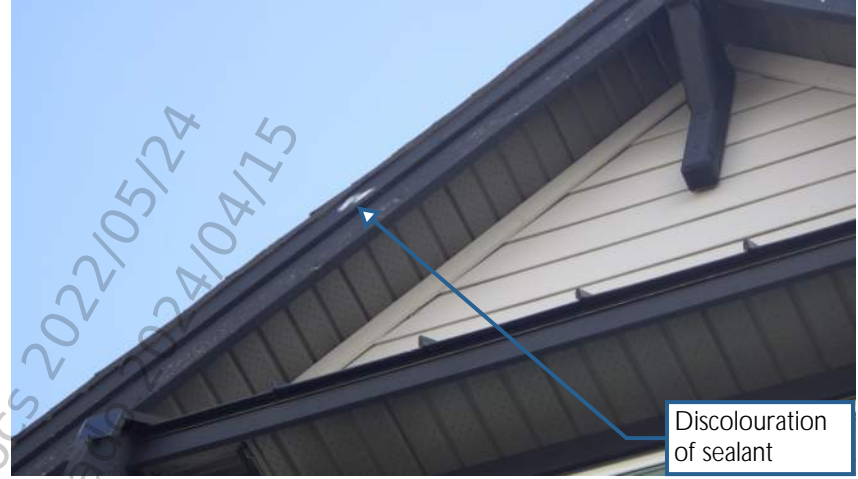
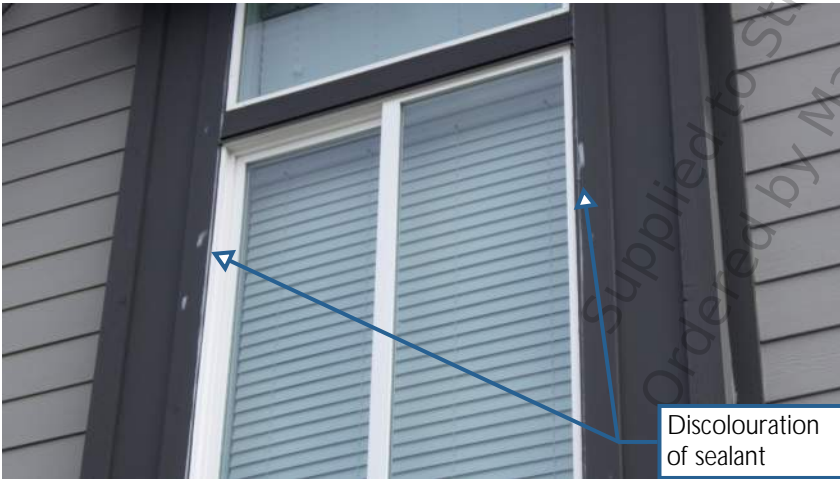
A11 - A	Unit 1229	80250933	OBS A11-01 to OBS A11-07	<ul style="list-style-type: none"> Unpainted sealant. This is a cosmetic issue and not related to building performance.
A11 - B	Unit 1235, 1231, 1233, 1237	80250968		
A11 - C	Unit 1239	80250963		
A11 - D	Unit 1247, 1251, 1253	80252844		
A11 - F	Unit 1224, 1228	80267576		
A12 - B	Unit 1231, 1233, 1235	80250968	OBS A12-01 to OBS A12-04	<ul style="list-style-type: none"> Paint delamination/deterioration on the combed face trim. This is a cosmetic issue and not related to building performance. It is common for combed face trim to require repainting due to the poor quality of the primer applied during manufacture.
A12 - D	Unit 1247	80252844		
A12 - F	Unit 1224, 1228	80267576		
A13 -	Systemic		OBS A13-01 to OBS A13-03	<ul style="list-style-type: none"> Noted a gap between the exterior wall siding and comb-faced trim at the roof overhang fascia. Roof overhang framing is visible at the gap and does not include waterproofing.

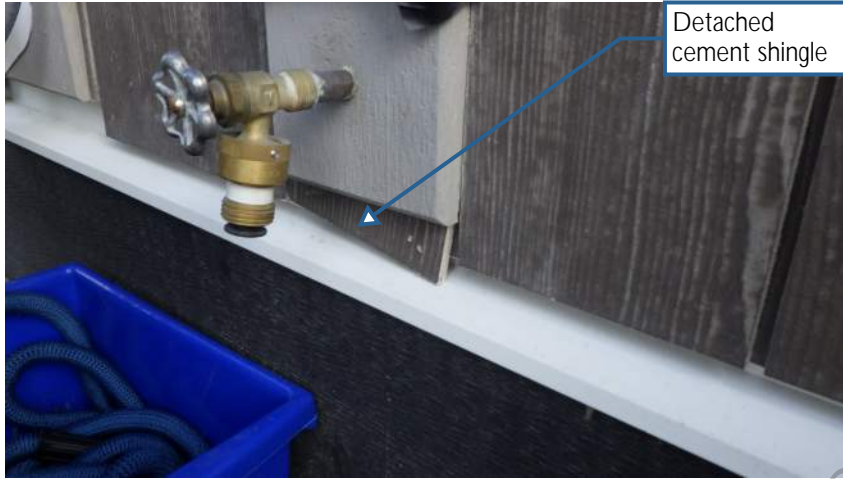
OBS A16-03

Detached cement shingle

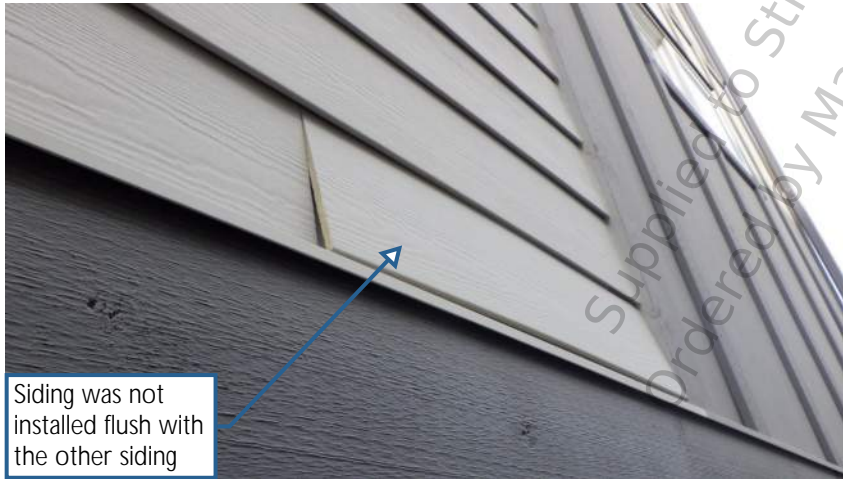
OBS A16-05

Siding was not installed flush with the other siding

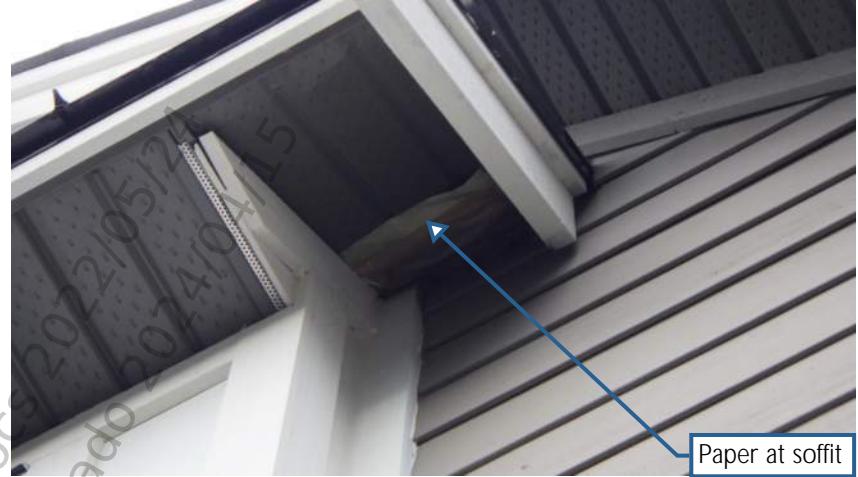
Item ID	Location	Policy Number	Photo Sequence	Observations
A18 - C	Unit 1239	80250963	OBS A18-01	<ul style="list-style-type: none"> Noted paper installed at the soffit. Paper appears to be installed to protect the soffit panels during painting of cladding but was not removed after painting was completed. This is a housekeeping issue from the original construction work that was not addressed.
A19 - C	Unit 1241	80250963	OBS A19-01 to OBS A19-04	<ul style="list-style-type: none"> Paint on soffit. This is a cosmetic workmanship item and not a performance concern.
A19 - F	Unit 1216	80267576		
A19 - E	Unit 1257, 1259	80252839		
A19 - D	Unit 1251	80252844		
A20 -	Systemic		OBS A20-01 to OBS A20-04	<ul style="list-style-type: none"> At sloped roof overhangs, soffit panels have been bent to fit into horizontally installed J-trims. This has created an uneven finish in the soffit panels. This is a cosmetic workmanship issue.

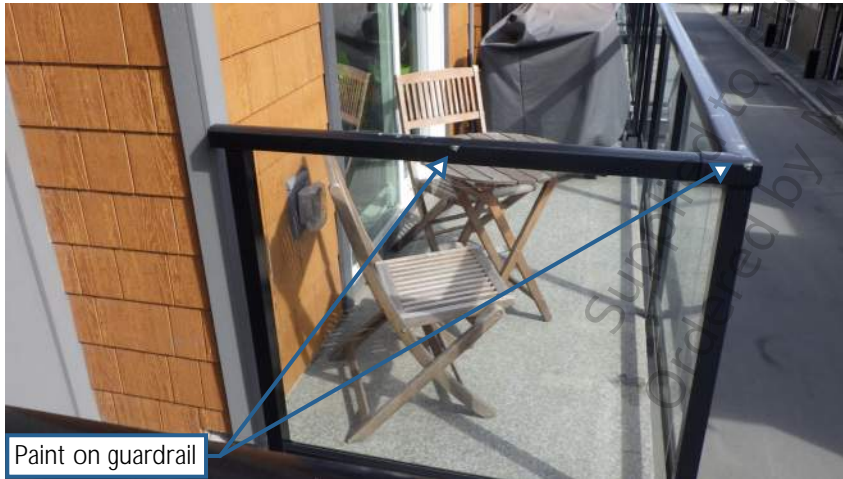
A21 -				Item number omitted
A22 - C	Unit 1245, 1243	80250963	OBS A22-01 to OBS A22-03	<ul style="list-style-type: none"> Paint on guardrail. This is a cosmetic workmanship item and not a performance concern.
A23 - D	Unit 1249	80252844	OBS A23-01 to OBS A23-03	<ul style="list-style-type: none"> Cement board shingle siding is damaged at the gas outlet head flashing resulting in a poor aesthetic finish. This is not a performance issue.
A24 - D	Unit 1249	80252844	OBS A24-01	<ul style="list-style-type: none"> Soffit panel is loose.
A25 - D	Unit 1251	80252844	OBS A25-01 to OBS A25-11	<ul style="list-style-type: none"> Exposed sheathing paper and tuck-tape at the base of cladding. This is a cosmetic/workmanship issue and not related to building performance.
A25 - F	Unit 1220, 1216, 1224, 1228	80267576		
A25 - E	Unit 1261	80252839		
A26 - D	Unit 1253	80252844	OBS A26-01 to OBS A26-02	<ul style="list-style-type: none"> Paint on door. This is a cosmetic workmanship item and not a performance concern.

Paint on guardrail

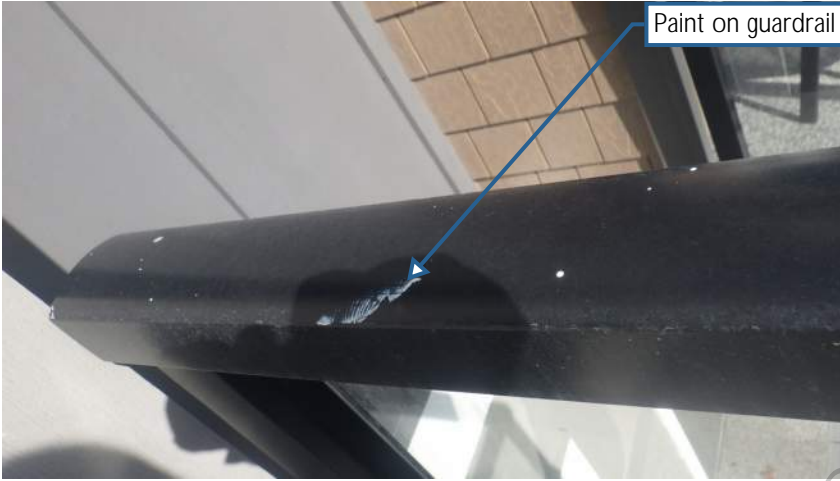
OBS A22-03

Paint on guardrail

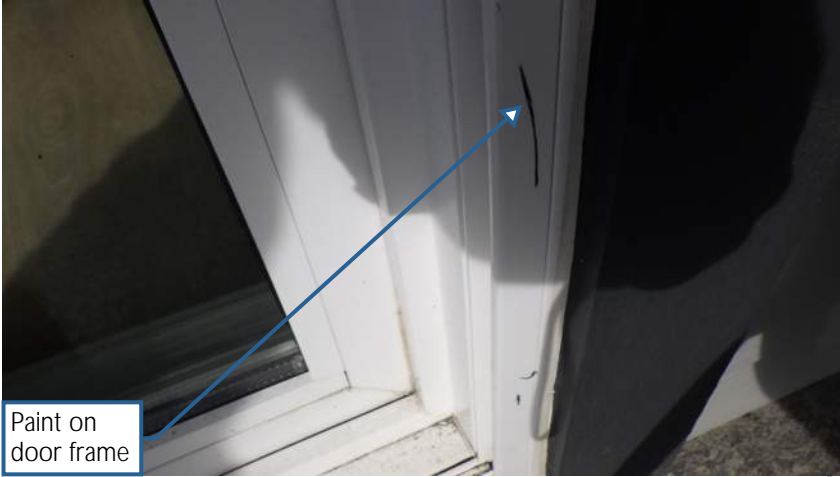
OBS A26-01

Paint on door frame

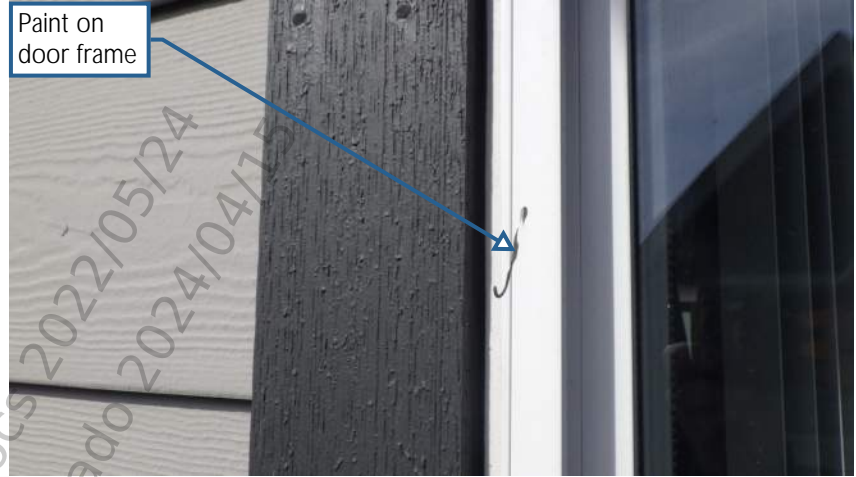
OBS A26-02

Paint on door frame

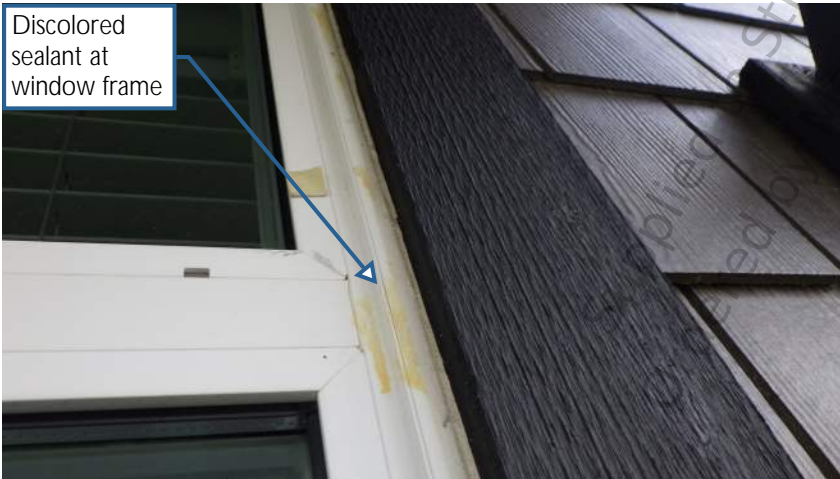
A27 - E	Unit 1257	80252839	OBS A27-01 to OBS A27-02	<ul style="list-style-type: none"> Discoloured sealant at door frame/window frame. This is a cosmetic/workmanship issue and not related to building performance.
A27 - F	Unit 1220	80267576		
A27 - A	Unit 1223, 1225, 1227	80250933		
A27 - B	Unit 1233	80250968		
A27 - C	Unit 1243	80250963		
A28 - E	Unit 1257	80252839	OBS A28-01 to OBS A28-04	<ul style="list-style-type: none"> Surface damage to vinyl waterproofing membrane. The damage is limited to the surface finish and does not affect the waterproofing. Recommend this area is reviewed annually.
A28 - F	Unit 1216	80267576		
A29 -				Item Omitted
A30 - F	Unit 1216, 1220, 1224, 1228	80267576	OBS A30-01 to OBS A30-05	<ul style="list-style-type: none"> Noted sections of unperforated soffit panels. This condition does not allow for soffit venting and provides inconsistent finish.
A31 - F	Unit 1216, 1220, 1224, 1228	80267576	OBS A31-01 to OBS A31-05	<ul style="list-style-type: none"> Missing diverter at balcony saddle allowing water to be directed behind the cladding at this location. At this location, the cross-cavity flashing butts up to the vinyl membrane and does not tuck underneath. This is not a building code defect but the installation of diverters is a preferred building method and a Travelers insurance requirement.

Discolored sealant at window frame

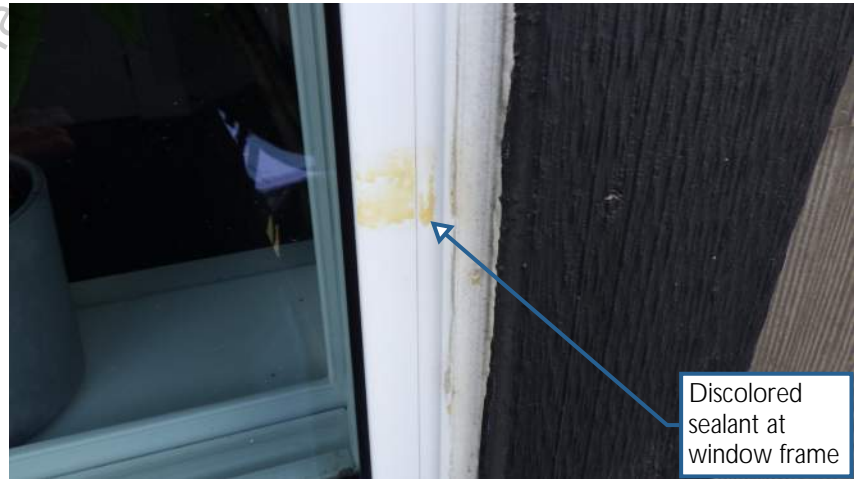
OBS A27-02

Discolored sealant at window frame

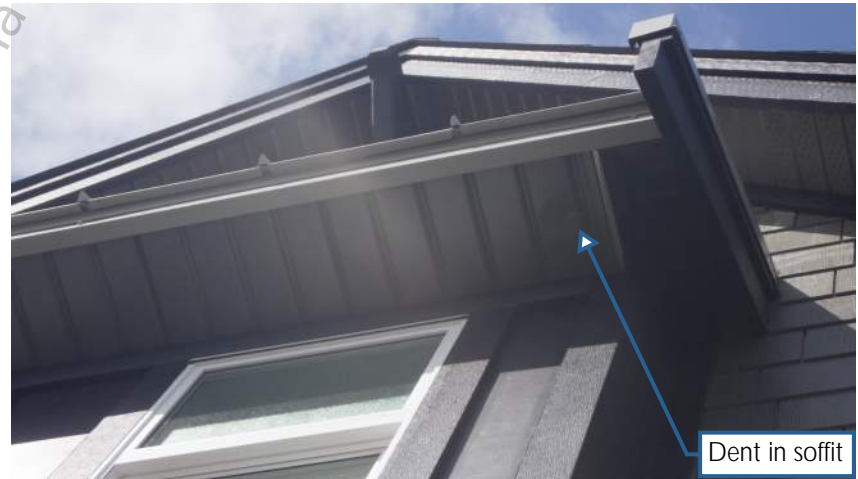
OBS A33-01

Dent in soffit

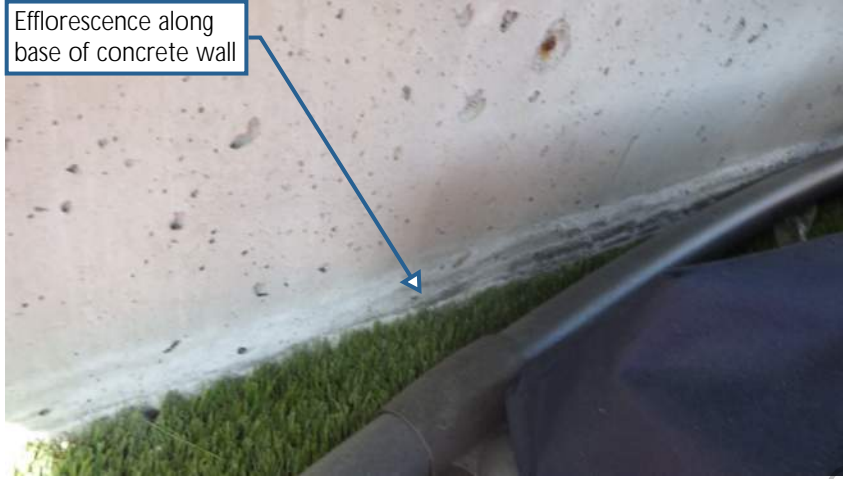
OBS A34-01

Efflorescence along base of concrete wall

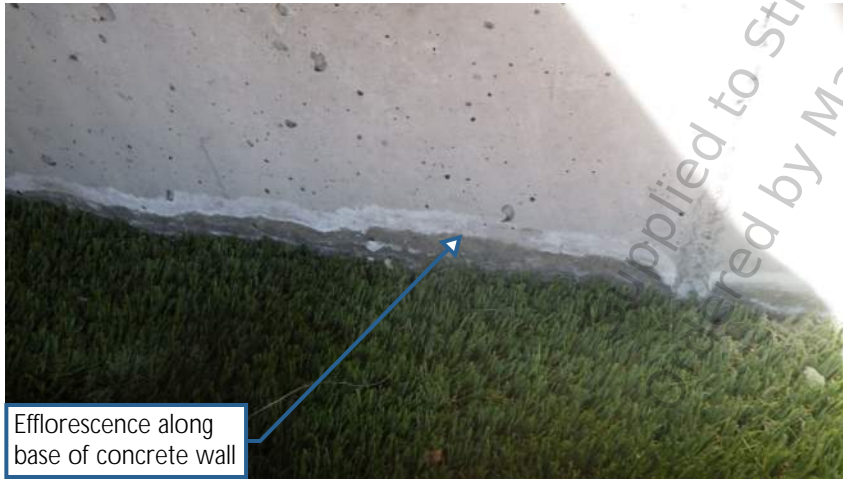
OBS A34-03

Efflorescence along base of concrete wall

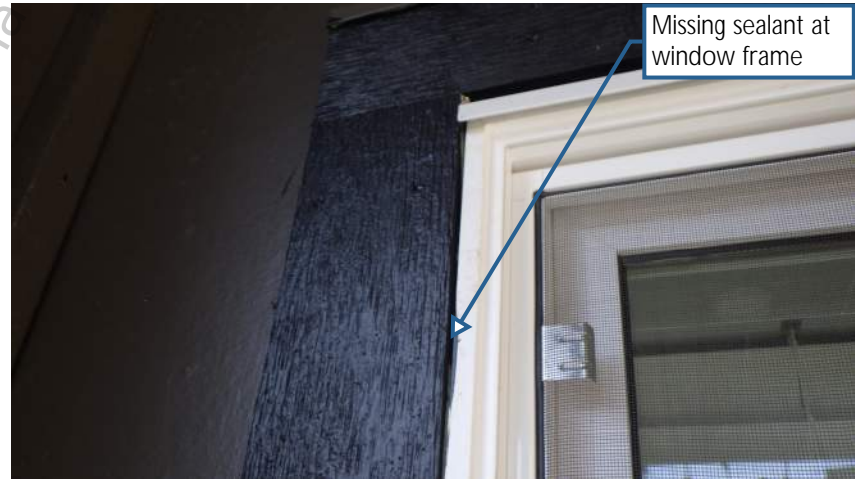
A38 -				Item Omitted
A39 -				Item Omitted
A40 - F	Unit 1220, 1216, 1228	80267576	OBS A40-01 to OBS A40-04	<ul style="list-style-type: none"> Missing sealant between window frame and trim at window jambs.
A40 - B	Unit 1237	80250968

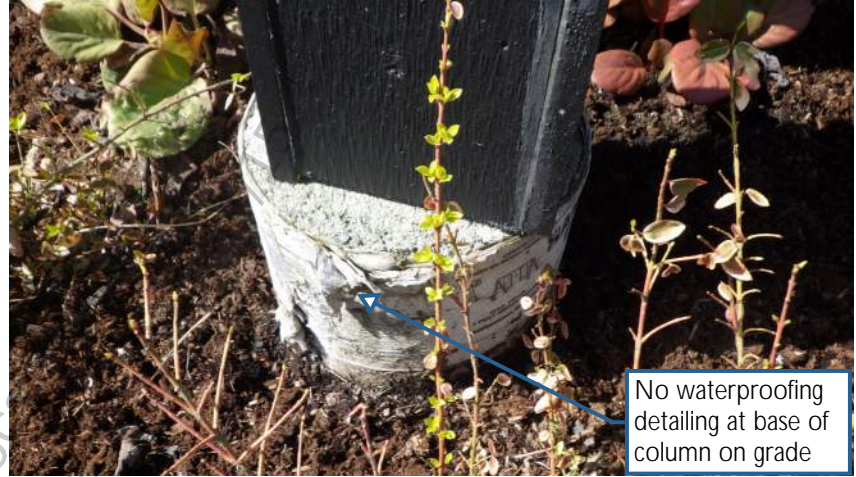
Item ID	Location	Policy Number	Photo Sequence	Observations
A41 - F	Unit 1220	80267576	OBS A41-01 to OBS A41-03	<ul style="list-style-type: none"> Balcony columns include sonotube concrete footings. No waterproofing has been installed at the footing and sonotube is exposed. Waterproofing may not be required if the column is installed on a stand-off saddle. It is recommended this is reviewed further to confirm. The remaining sonotube form is a housekeeping issue not removed during the original construction.
A42 - F	Unit 1216	80267576	OBS A42-01 to OBS A42-04	<ul style="list-style-type: none"> Sealant failure at trim around electrical and gas outlets and light fixtures.
A43 - F	Unit 1216	80267576	OBS A43-01 to OBS A43-04	<ul style="list-style-type: none"> Damage to cladding panel.
A43 - A	Unit 1227	80250933		
A44 - F	Unit 1216	80267576	OBS A44-01 to OBS A44-02	<ul style="list-style-type: none"> An exterior stairway is installed adjacent to Unit 1216 and does not include a railing. The stairway is blocked at the top but is accessible from below. This condition presents a fall hazard. We have advised the Strata to barricade the bottom of the stairs to prevent use until a guardrail is installed.

No waterproofing detailing at base of column on grade

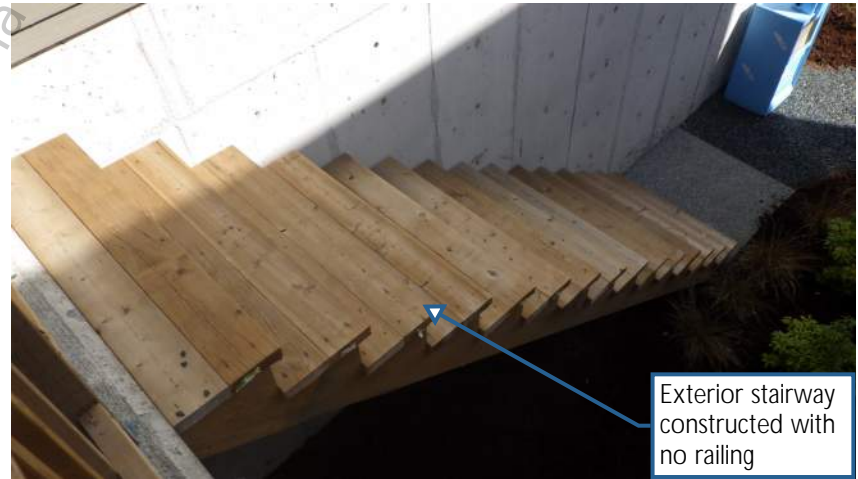
OBS A44-02

Exterior stairway constructed with no railing

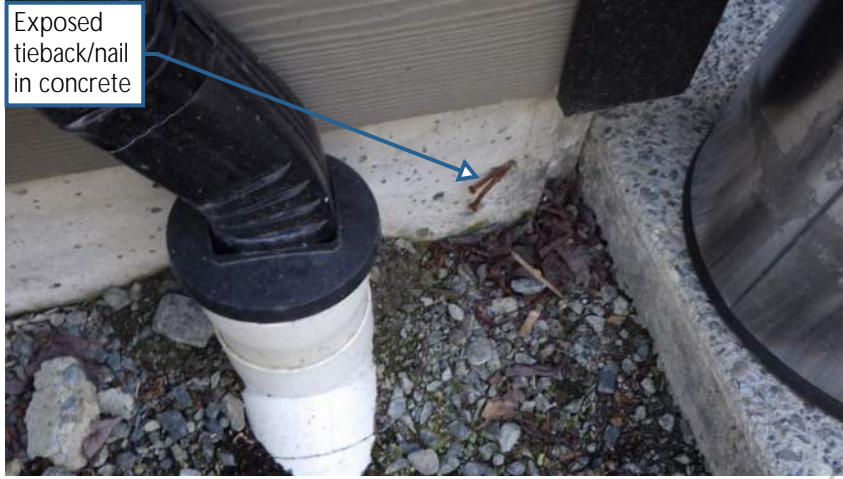
OBS A47-01

Exposed tieback/nail in concrete

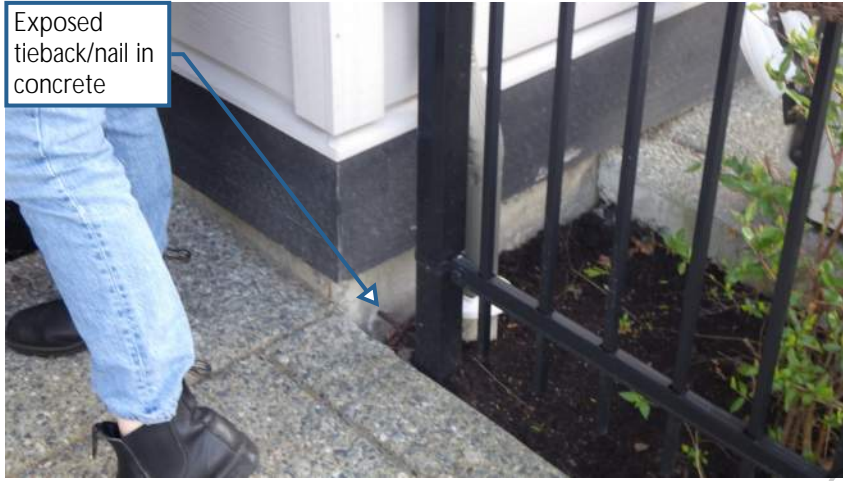
OBS A47-05

Exposed tieback/nail in concrete

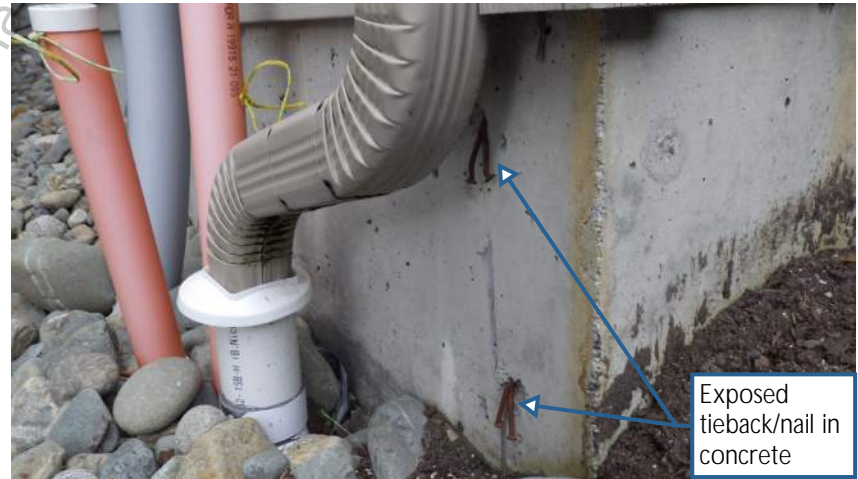
OBS A47-08

Exposed tieback/nail in concrete

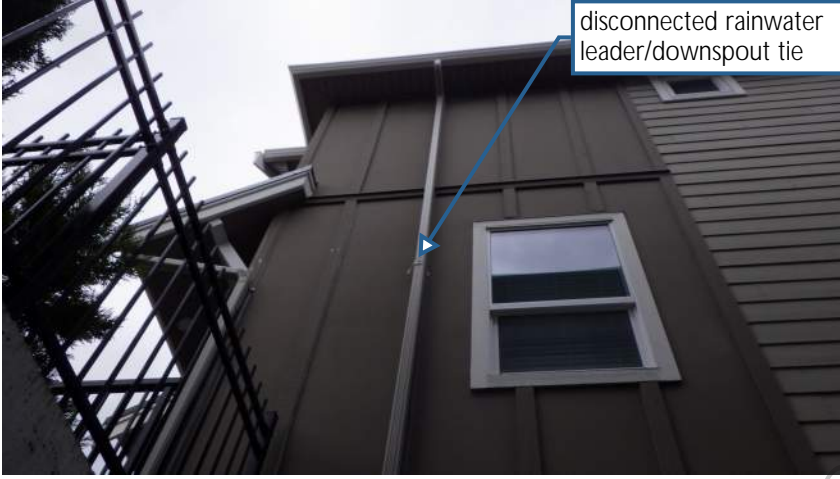
OBS A50-01

disconnected rainwater leader/downspout tie

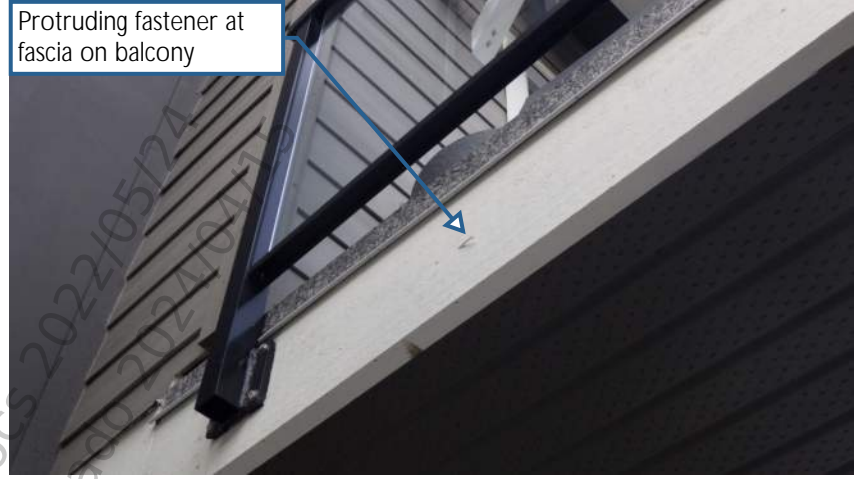
OBS A51-01

Protruding fastener at fascia on balcony
